Bridge Assessment and Ranking

Town of Lunenburg, MA

May 2024

BSC GROUP

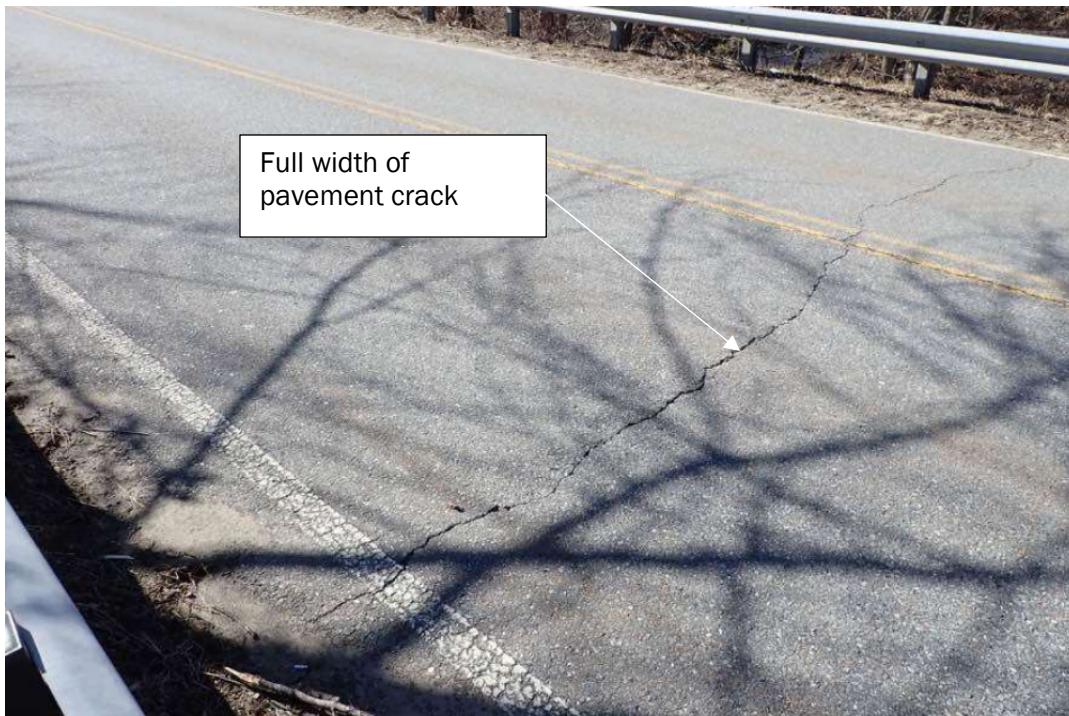
Based on the most recent MassDOT report from 3/8/2024, bridge L-17-025 has a deck rating of 5 (fair), a superstructure rating of 5 (fair), a substructure rating of 5 (fair), an approach rating of 6, and channel protection rating of 7 (satisfactory). The wearing surface has several minor cracks on the northbound lane and both approaches have a large crack spanning the width of the wearing surface (Figure 1-1).

Figure 1-1 L-17-025 North Approach

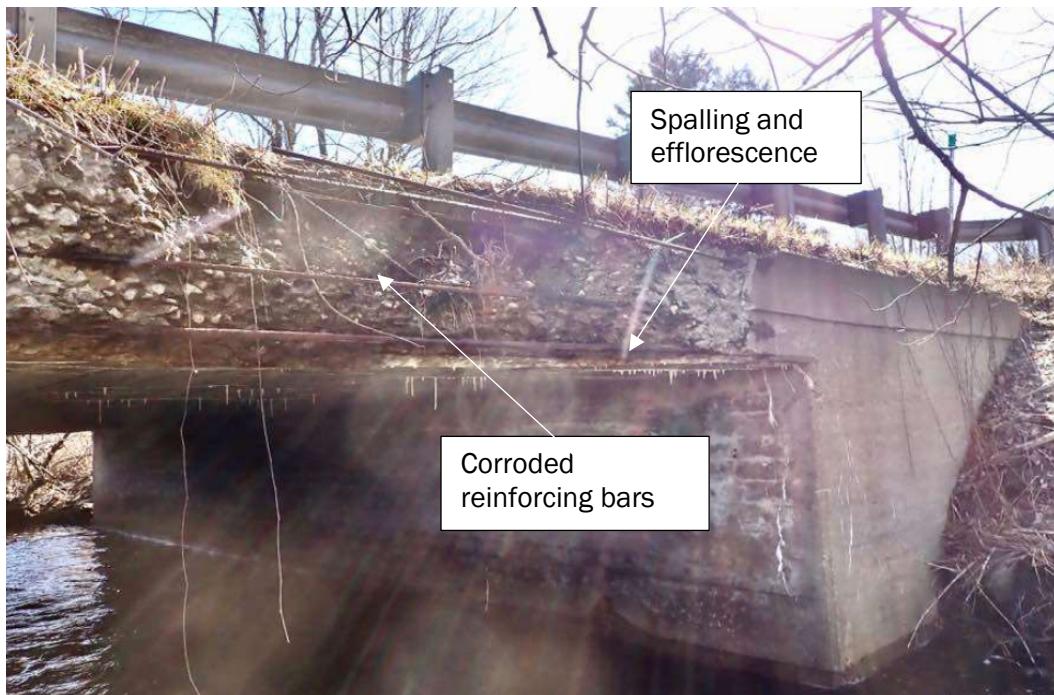
There are several areas of significant concrete deterioration. The west end of the deck slab has a 11'- 6" long by full height spall that is 16" deep and 13" wide on the underside, with exposed rebar that is heavily corroded and exhibits significant section loss (Figure 1-2). The east elevation has a 12'-6" long by full height by 6" deep spall with exposed corroded rebar (Figure 1-3). The deck has map cracking extending up to 7'-0" long with efflorescence throughout the underside (Figure 1-4).

Figure 1-2 L-17-025 West end of slab

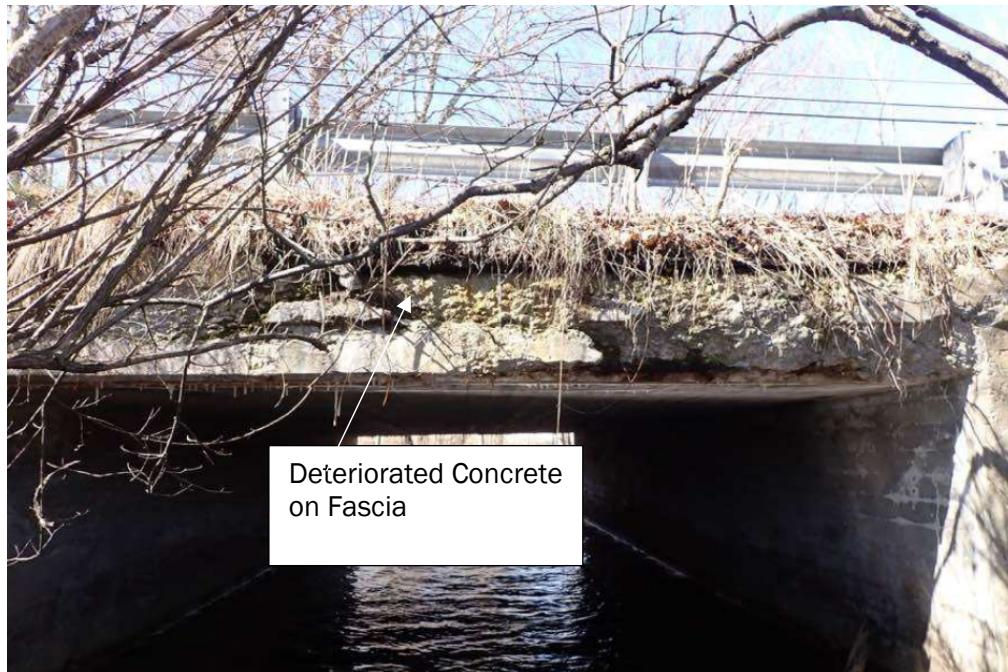
Figure 1-3 L-17-025 East end of slab

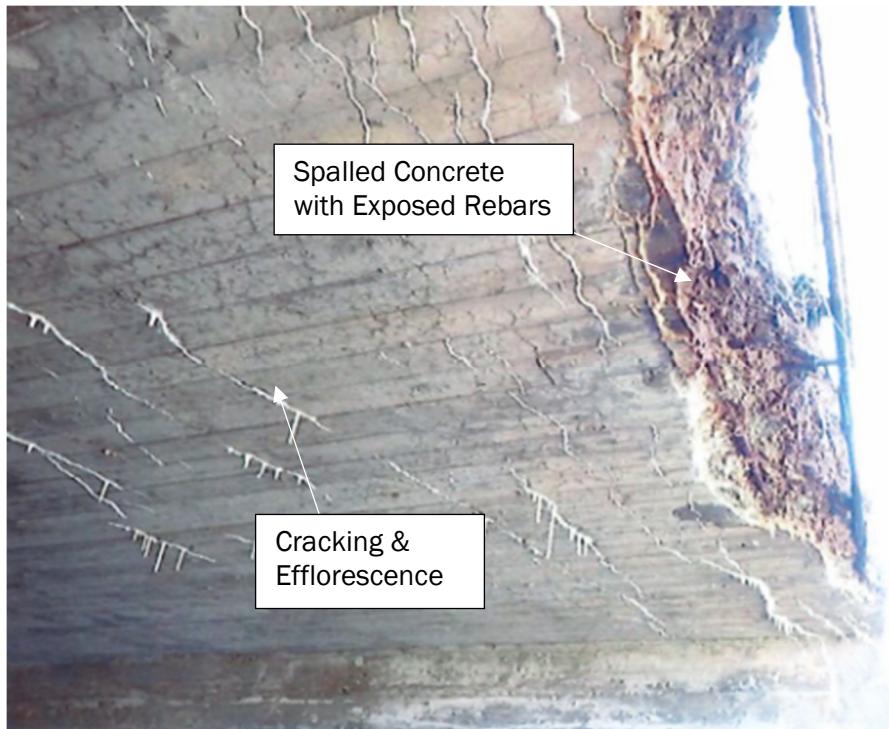
Figure 1-4 L-17-025 West End Underside

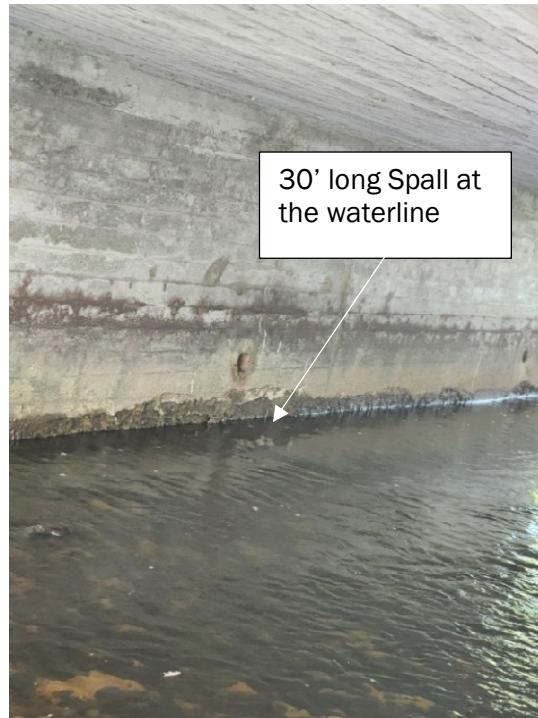
There is a 30' long x 20" high x 2" deep spall on the South Abutment and Southeast Wingwall at the water line (Figure 1-5). Efflorescence and hairline cracks are present and continue for the full height of the abutment. The structure is undersized for the current volume of water that passes through. According to Streamstats, an online water resources tool maintained by the USGS, the bankfull width at the location of the crossing is 23.2-feet. Debris can be seen both in the upstream and downstream directions, with the upstream debris greatly restricting flow due to large branches and other buildup (Figure 1-6).

Figure 1-5 L-17-025 South Abutment

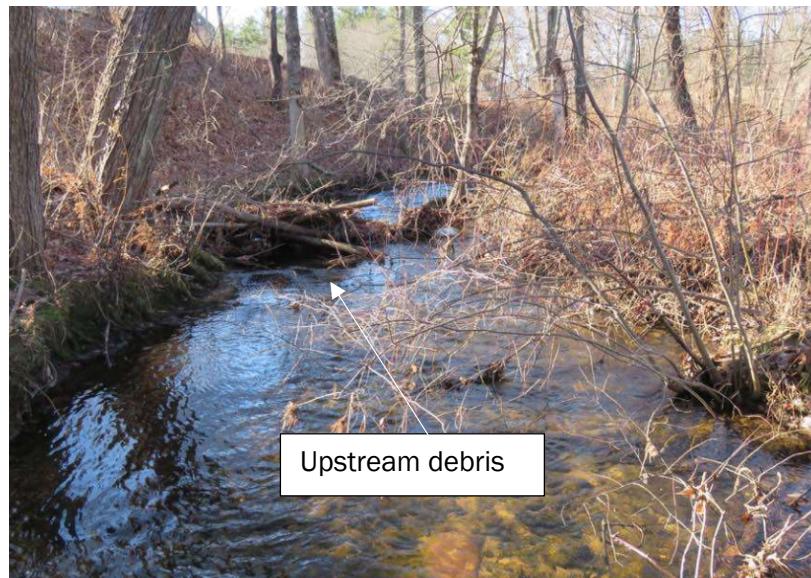
Figure 1-6 L-17-025 Upstream

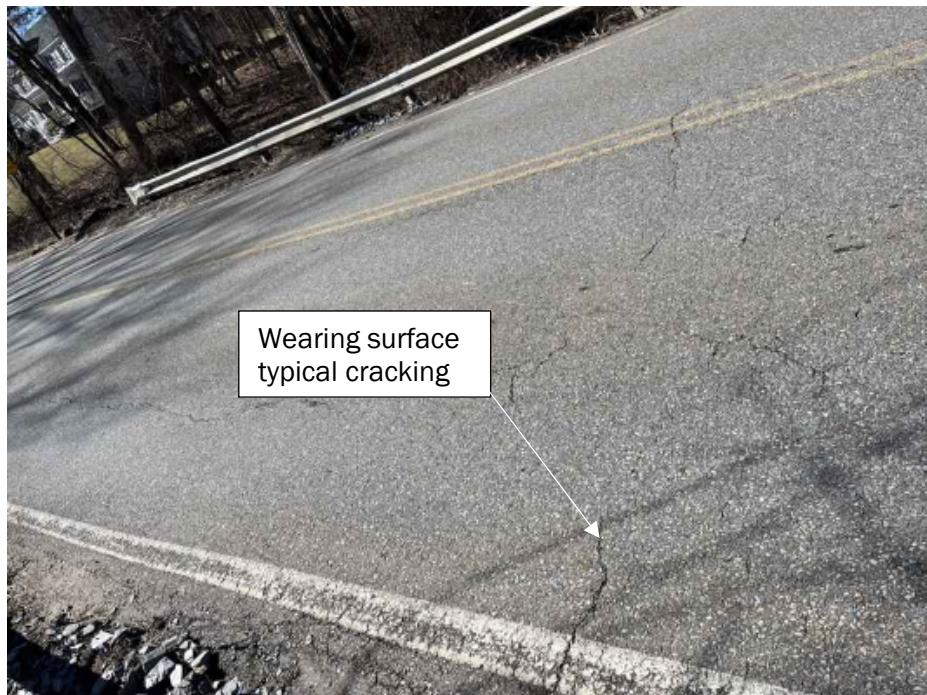
The wearing surface can be seen to have several cracks. There is a 10' longitudinal crack in the northbound lane and a 9' long transverse crack above pipe #3 (Figure 3-1). The west guardrail has collision damage and two bent posts (Figure 3-2). The east guardrail has moderate collision damage at the north end and is bent towards the slope (Figure 3-3). There is an area of erosion measuring the full slope height x 4' wide x 2' deep, present in the west embankment next to pipe #1 and minor erosion of the east embankment near pipe #3. Stone has been added to prevent further erosion. The headwalls on both the east and west elevations have voids up to 2' x 2' with a penetration depth of 2'. The east headwall has evidence of deformation over pipes #1 and #2 (Figure 3-4). Debris is visible in the upstream direction restricting water flow (Figure 3-5).

Figure 3-1 L-17-014 Wearing Surface

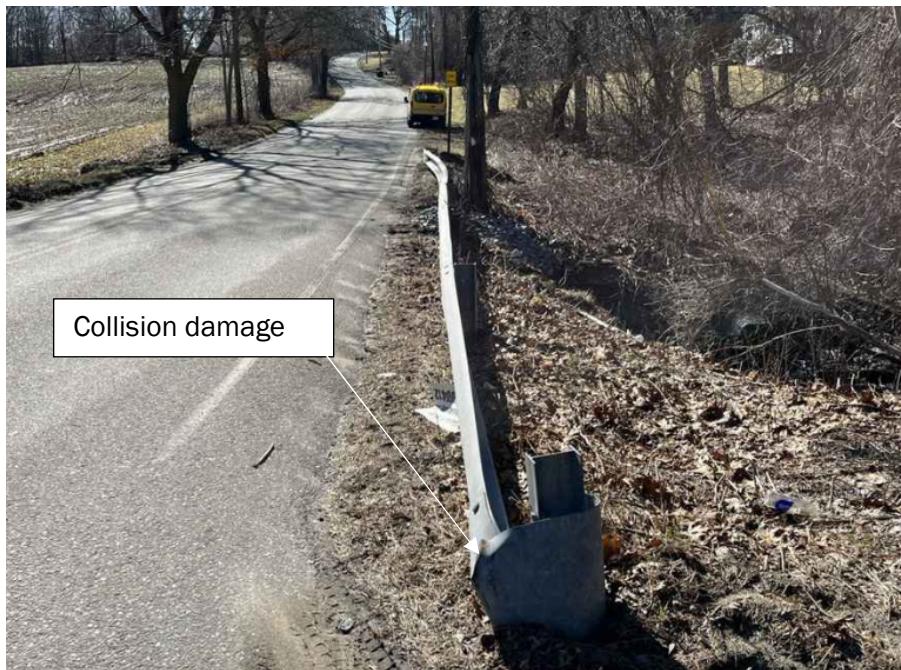
Figure 3-2 L-17-014 West Guardrail

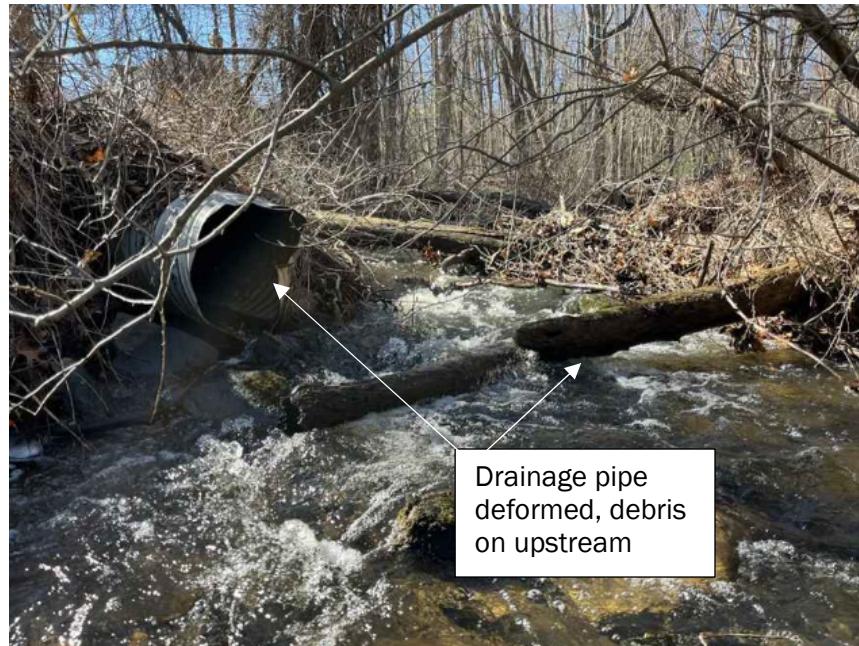
Figure 3-5 L-17-014 Upstream

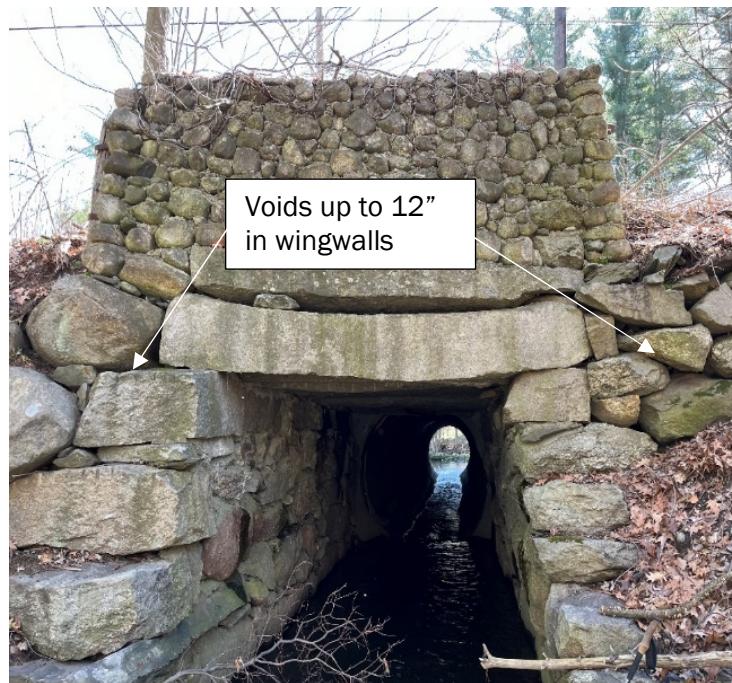
The wearing surface over the structure has some minor cracking but otherwise appears to be in good condition. The east elevation wingwalls show several voids up to 12" wide along with loose stones (Figure 4-1). The abutment walls in the stone section of the culvert have additional voids, up to 6" in diameter, due to deteriorated grout between the stones (Figure 4-2). The stone deck beams do not have a consistent shape or width. There are large gaps and deteriorating grout at the location where the stone culvert meets the pipe culvert (Figure 4-3).

Figure 4-1 L-17-031 East Elevation

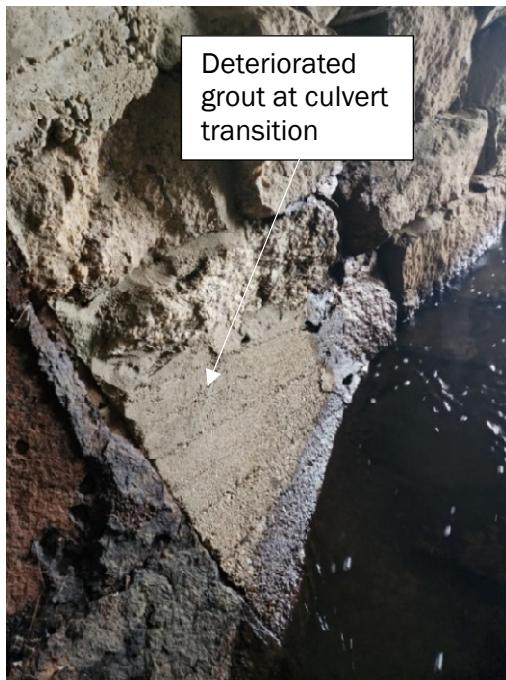
Figure 4-3 L-17-031 Grout at Culvert Transition

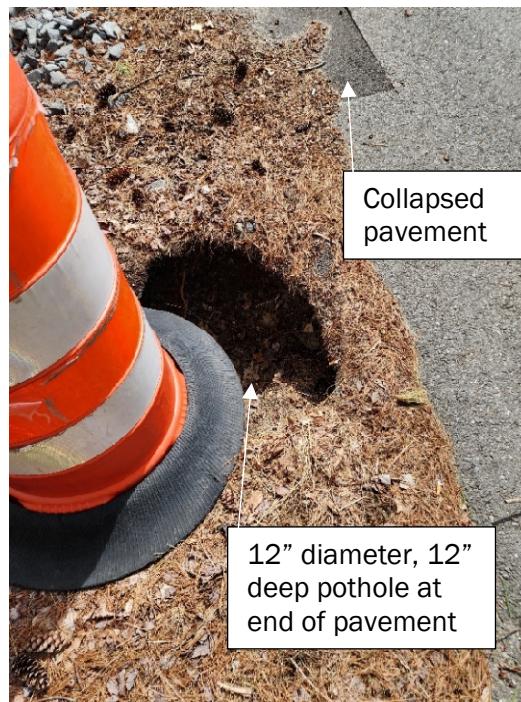
The culvert has no guardrail present, which can be a danger to vehicular traffic due to poor visibility of the structure and close proximity of the pavement to the edge of the culvert. The wearing surface over the culvert has several transverse cracks along the east approach (Figure 5-1). Close to the north elevation there is a 12" diameter pothole approximately 12" deep which is filled with debris. The hole is located directly above the wingwall and at the edge of the pavement (Figure 5-2).

Figure 5-2 L-17-030 Northwest Edge of Wearing Surface

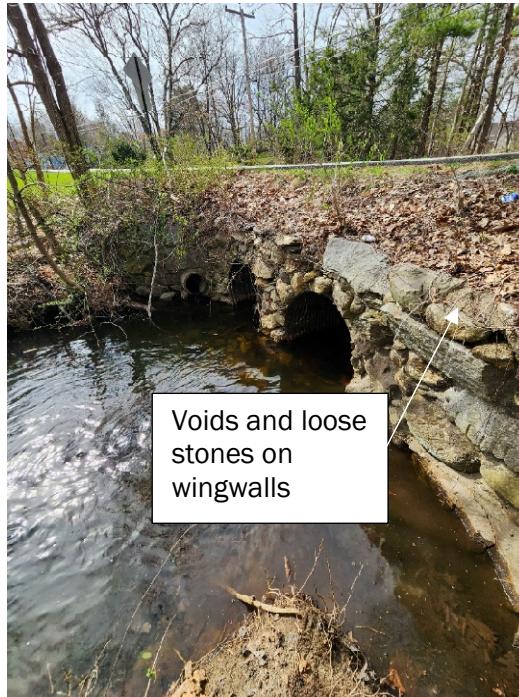
There are no guardrails on either side of the road over the structure, which can pose a major hazard to oncoming vehicles (Figure 6-1). The steel pipes both have section loss up to 2' long and 3' wide below the water line (Figure 6-2). Heavy rust is present along the full length of the pipes below the water line and smaller areas of rust appear throughout the pipes (Figure 6-3). The pipes at the north elevation have debris and vegetation severely restricting flow downstream (Figure 6-4). The current will cause further blocking of the water flow by pushing small branches and leaves downstream.

Figure 6-1 L-17-001 South Elevation

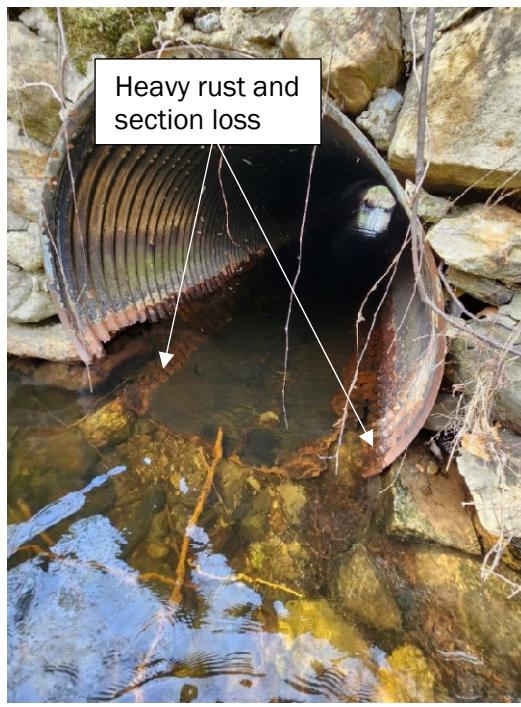
Figure 6-2 L-17-001 South Elevation Pipe 1

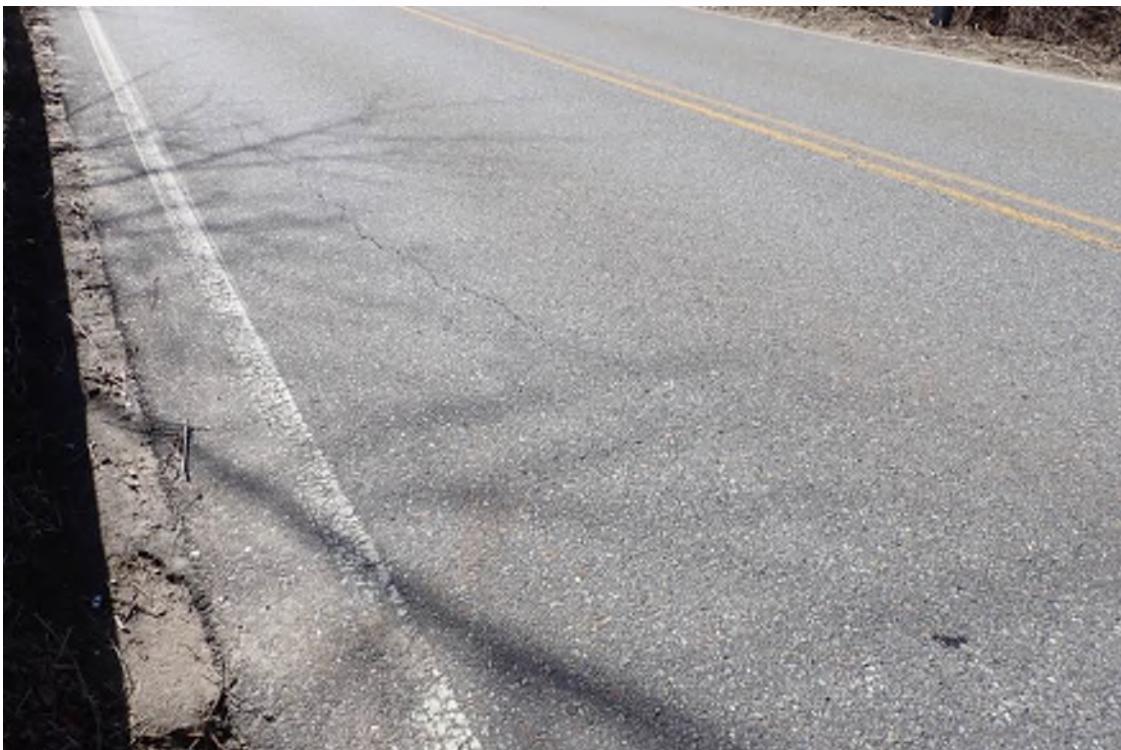
There is minor wheel line cracking in the northbound lane. **See photo 1.**

Photo 1: Cracking in the northbound lane.

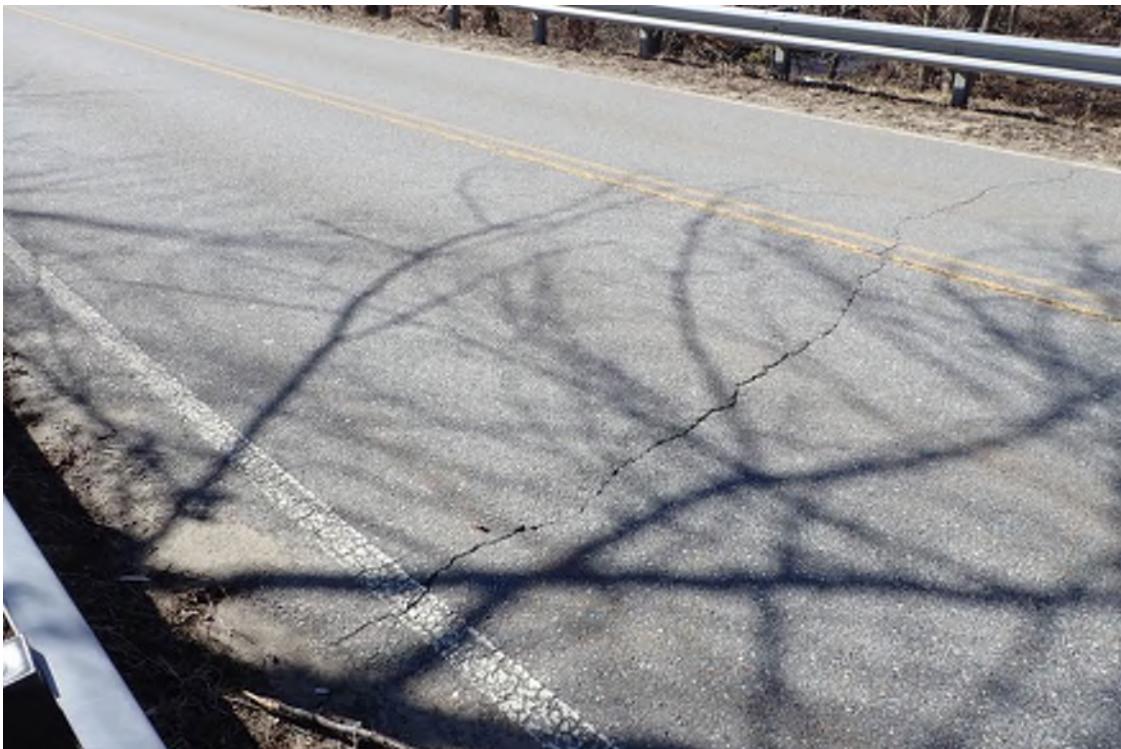
Both approaches have isolated transverse cracking. There is minor wheel line cracking in the northbound lane. **See photo 2.**

Photo 2: Approach pavement cracking.

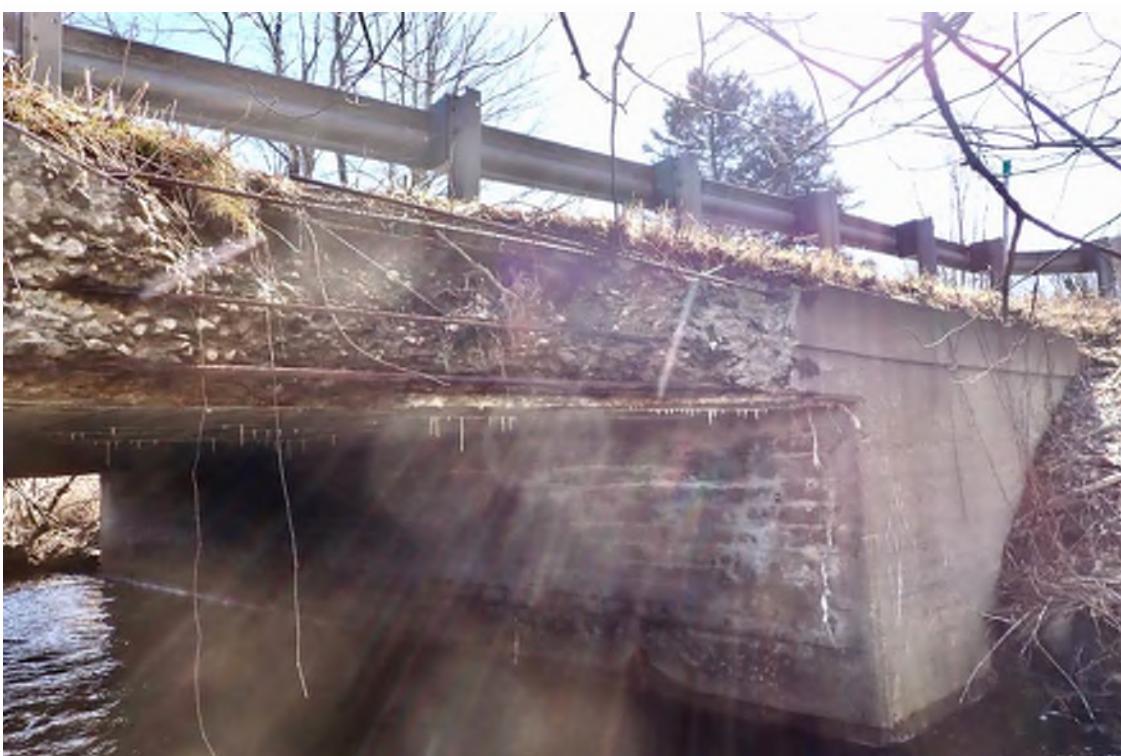
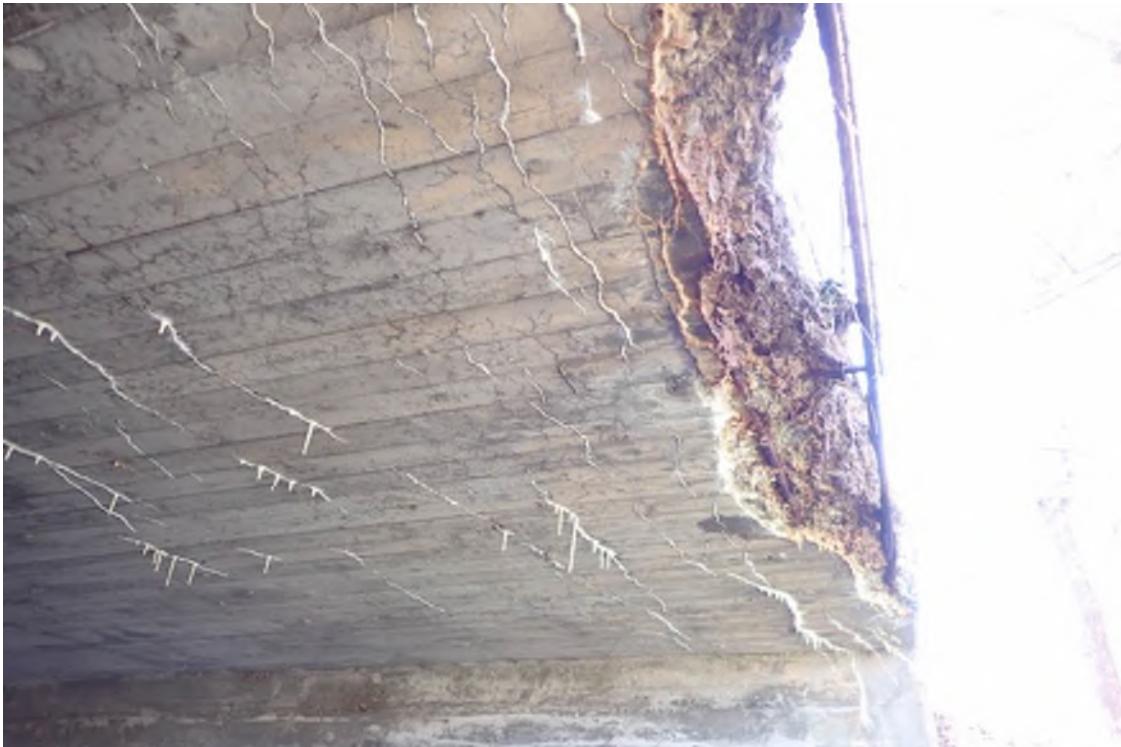
The West end has an 11.5' long x full height (21") x 16" deep spall x up to 16" wide along the bottom, exposing heavily corroded rebar with as little as 7/16" remaining section. **See photos 3 and 4.**

**Photo 3: West end of the slab.**

**Photo 4: West end of the slab, underside.**

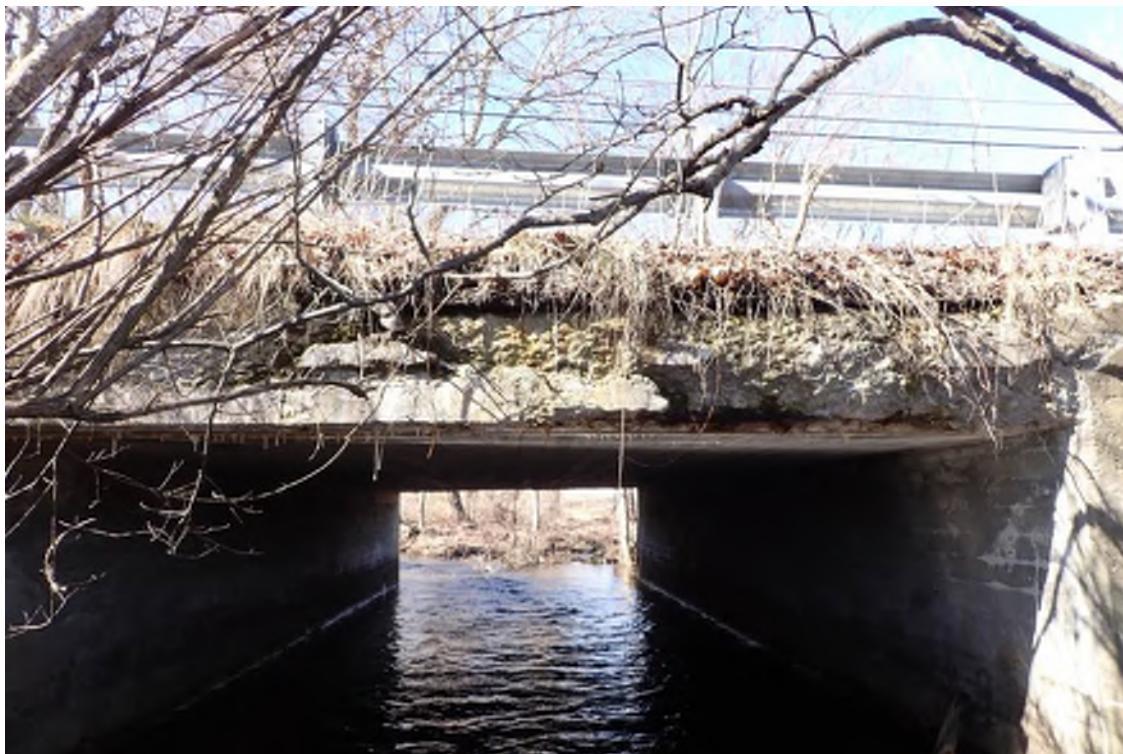
The East end has a 12.5' long x full height x 6" deep spall/delamination exposing corroded rebar. **See photo 5.**

Photo 5: East end of the slab.

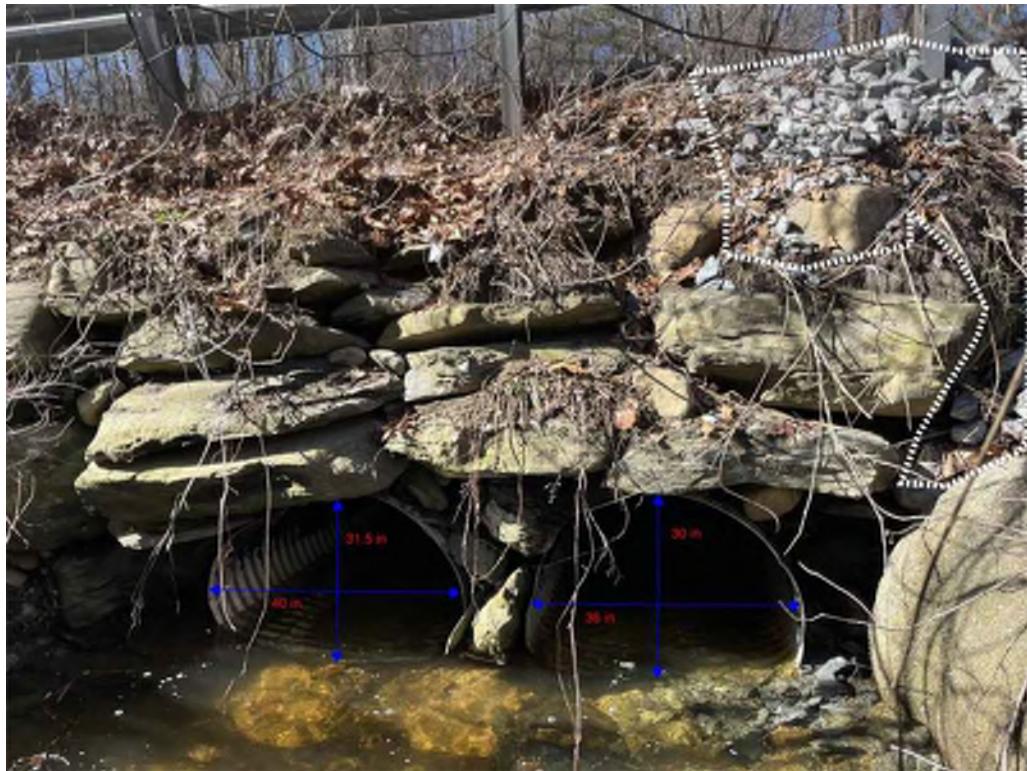
Photo 2: East elevation displaying deformed barrels and added embankment.

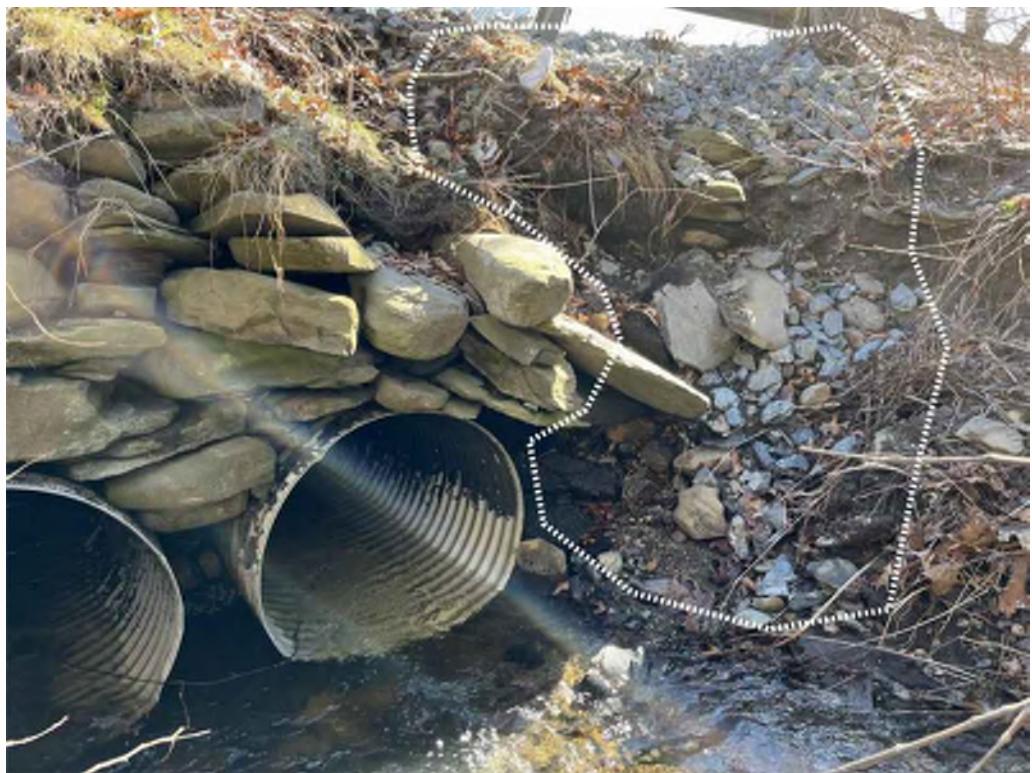
Photo 3: West elevation, South embankment displaying added riprap and erosion.

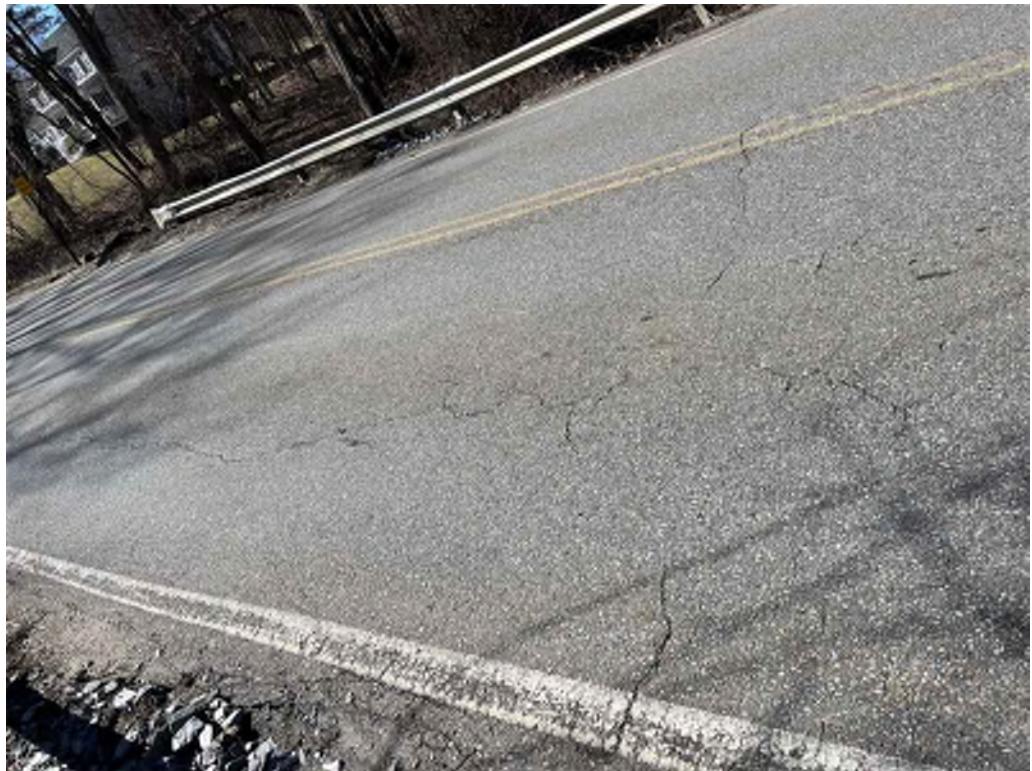
Photo 4: Wearing surface typical cracking.

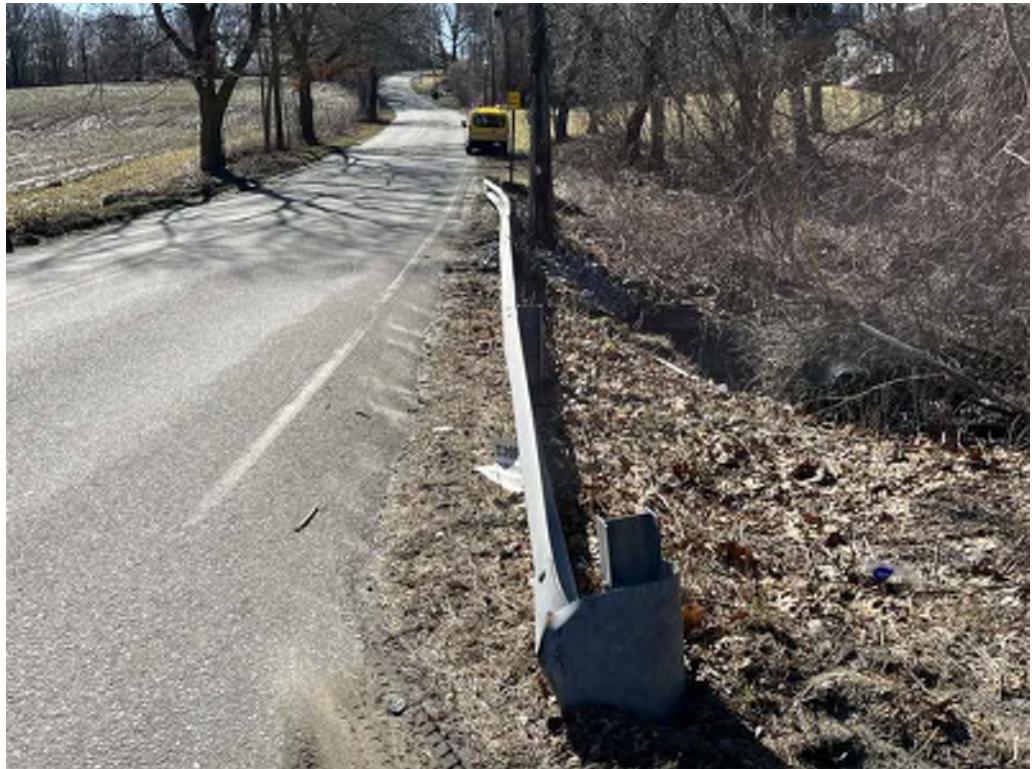
Photo 5: West rail collision damage.

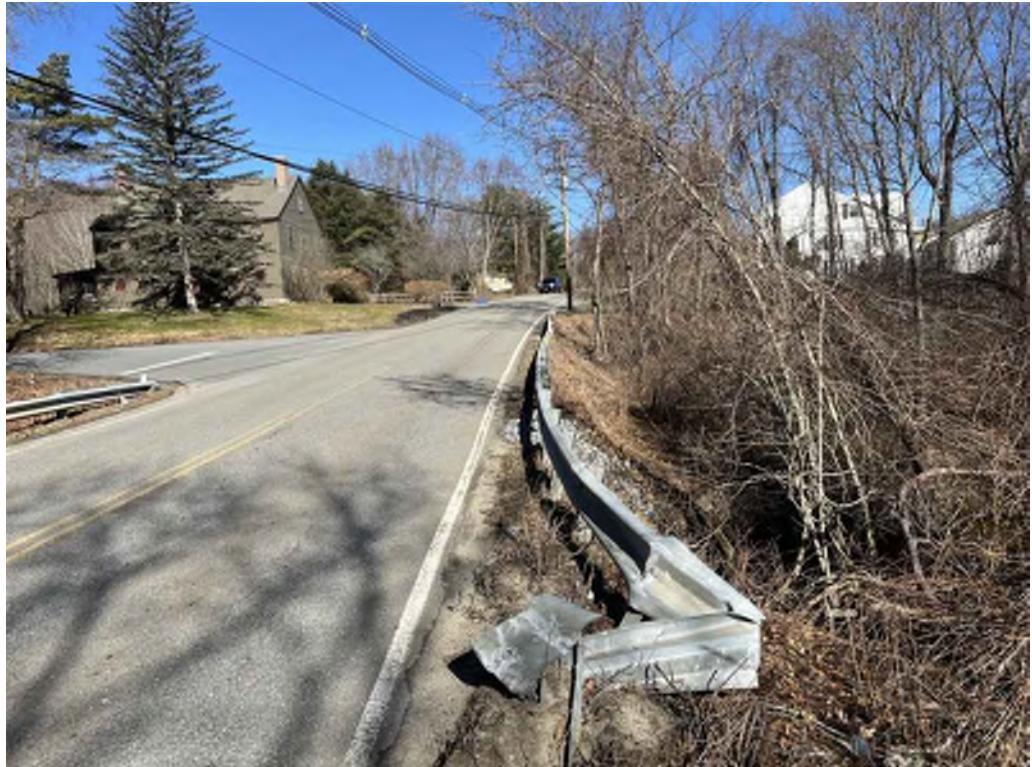
Photo 6: East rail collision damage.

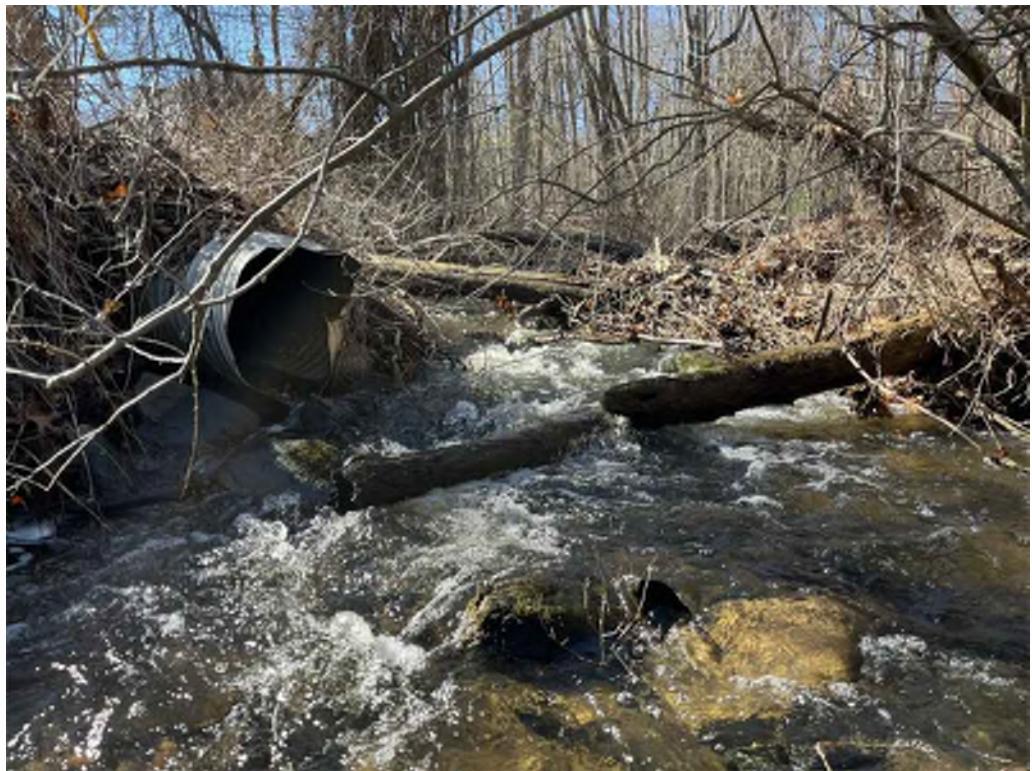
Photo 7: Upstream debris.
