**Brooks House**

1033 Massachusetts Avenue  
Lunenburg, MA 01462

## Property Condition Assessment

**February 6, 2018**

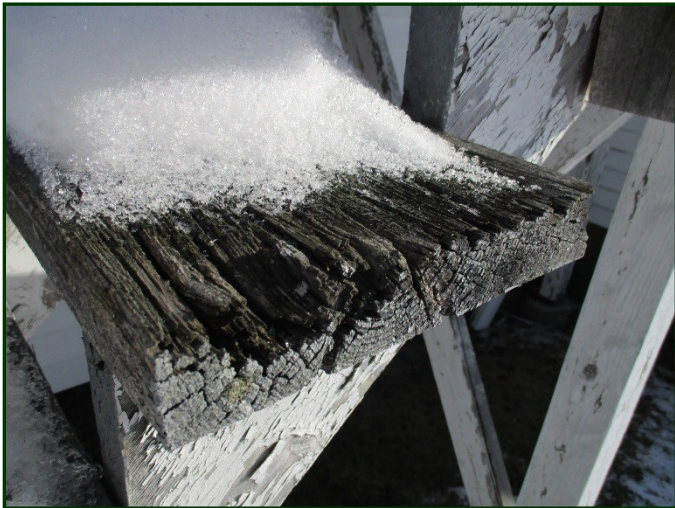
**Photo #5:** View of deteriorated wood at fire escape

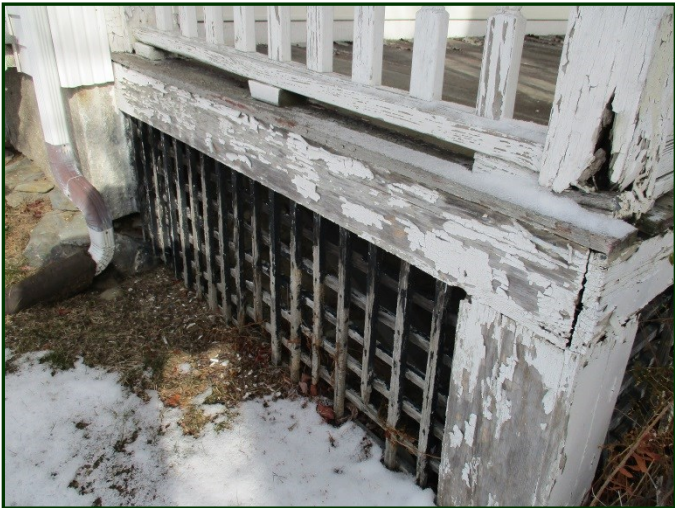
**Photo #6:** View of deteriorated wood at front porch

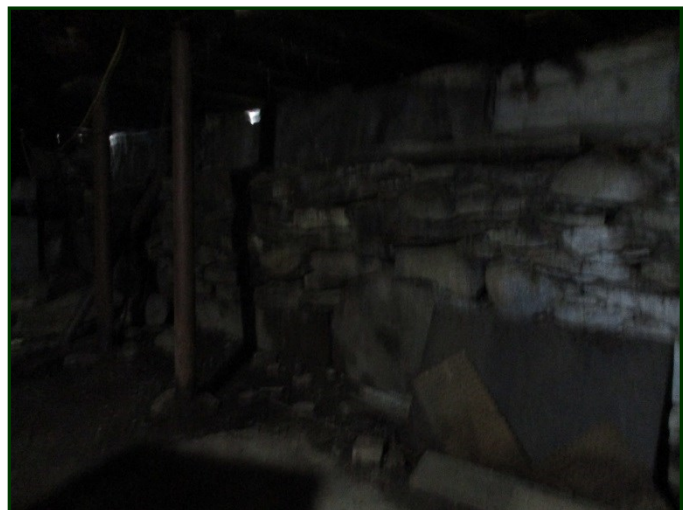
**Photo #30:** Stacked stone foundation. Note daylight at top of foundation wall

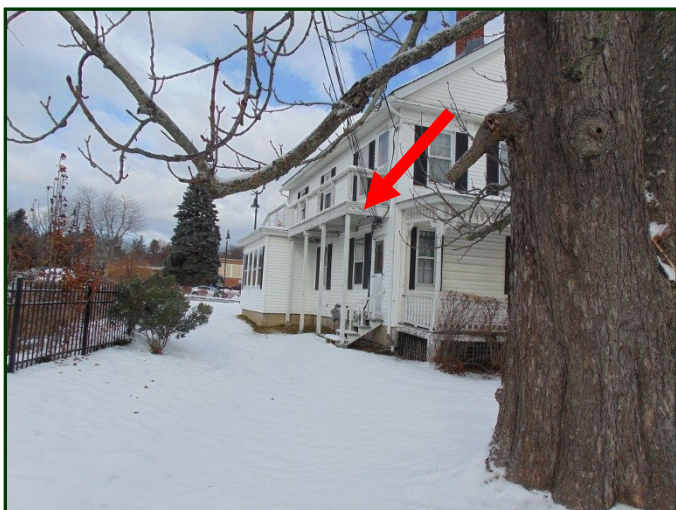
**Photo #39:** West (side) elevation of Brooks House. Note 2nd floor fire escape (indicated by arrow).

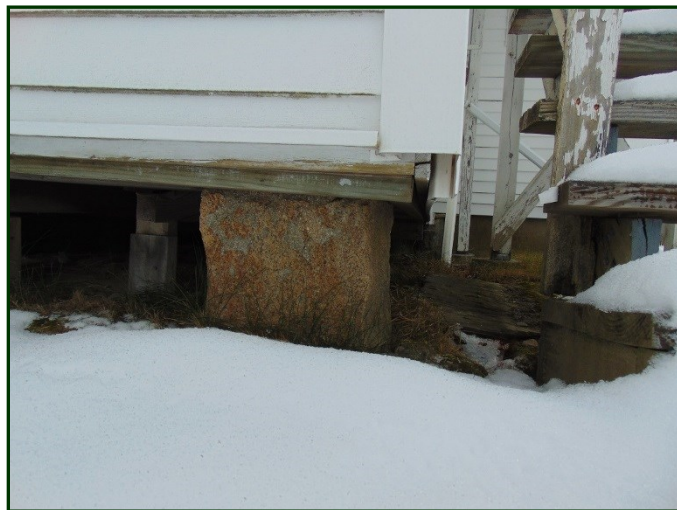
**Photo #44:** View of foundation block below northwest corner storage room. Floor in storage room was observed sloped toward west.

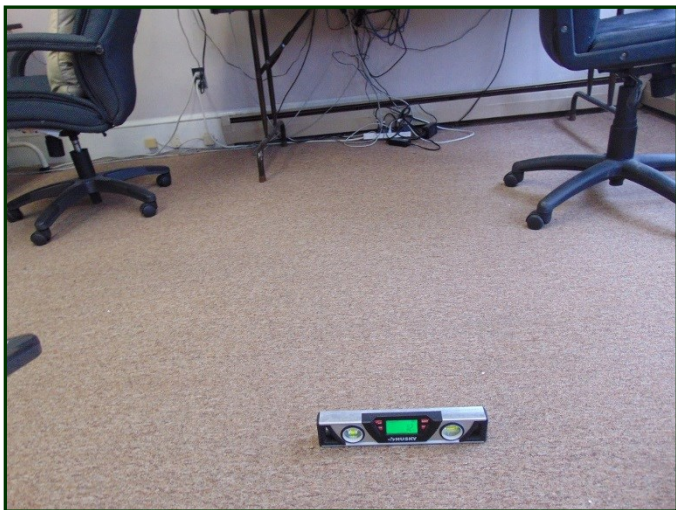
**Photo #45:** Measurement of sloped ground floor near northwest corner. The floor was sloped toward the west. Note digital level reads 1/2-inch per foot slope

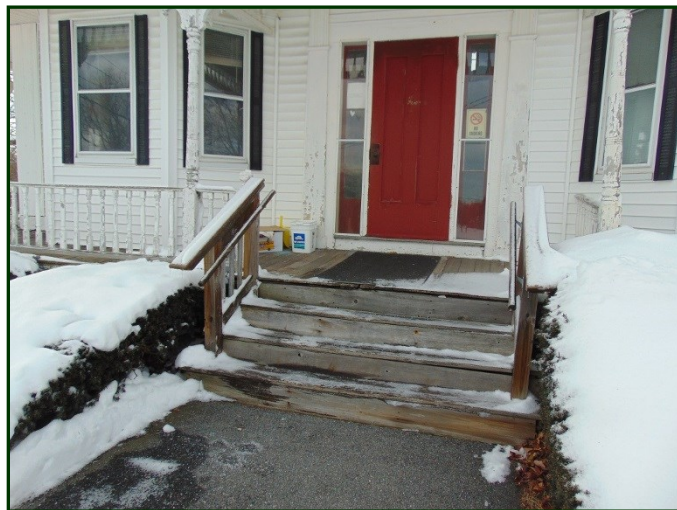
**Photo #46:** View of entrance steps on east elevation. Note porch is sloped away from the entrance.

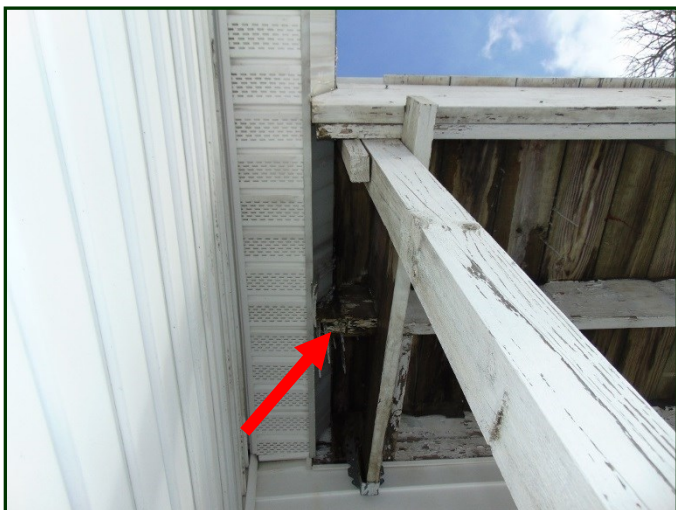
**Photo #47:** View of deteriorated fire escape framing on the west elevation.

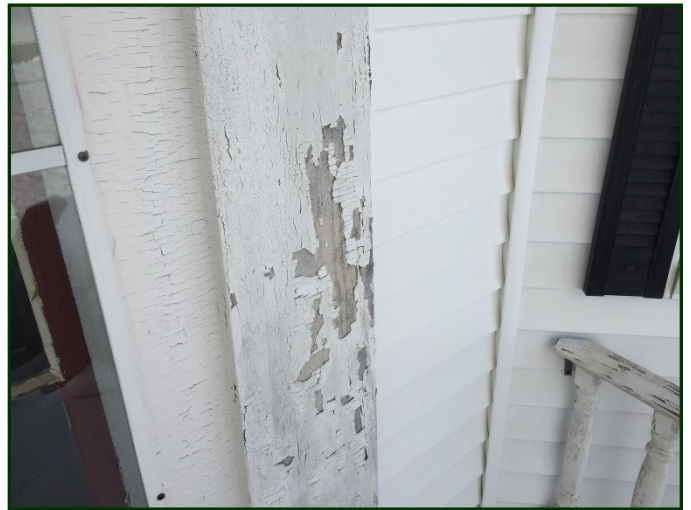
**Photo #52:** Photograph depicts general view of peeling/flaking paint on exterior trim

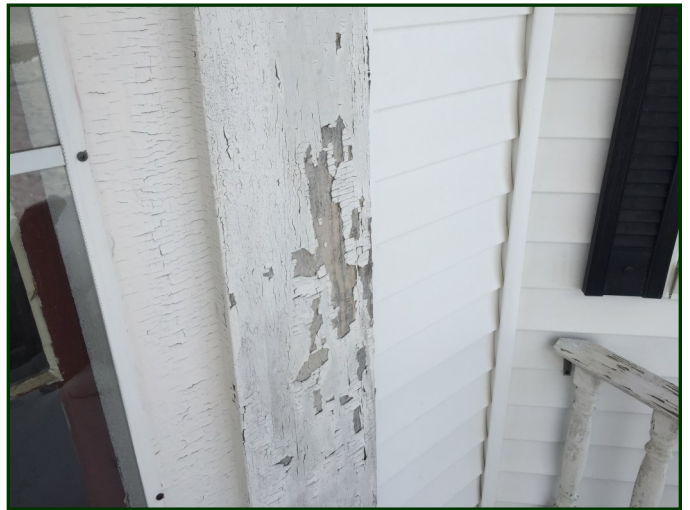
**Photo #4:** Photograph depicts general view of peeling/flaking paint on exterior trim
