**Brooks House**

1033 Massachusetts Avenue
Lunenburg, MA 01462

Property Condition Assessment**February 6, 2018****PREPARED FOR:**

VERTEX Project No: 48237

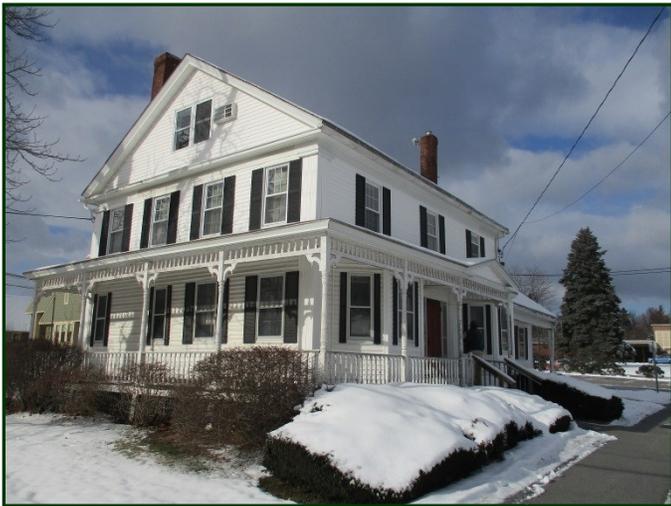
Photo #1: Overview from southeast corner of building

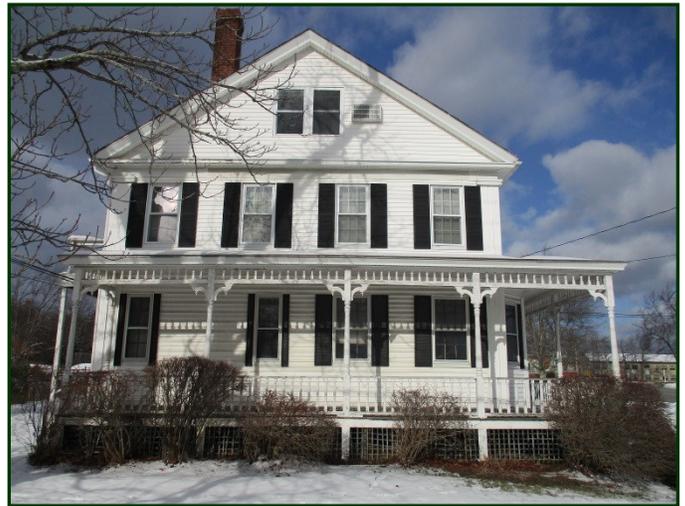
Photo #2: South elevation (front of building)

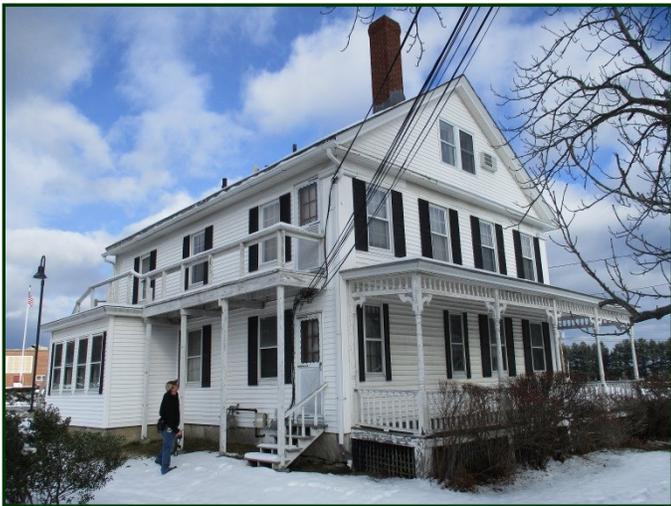
Photo #3: View from southwest corner of building

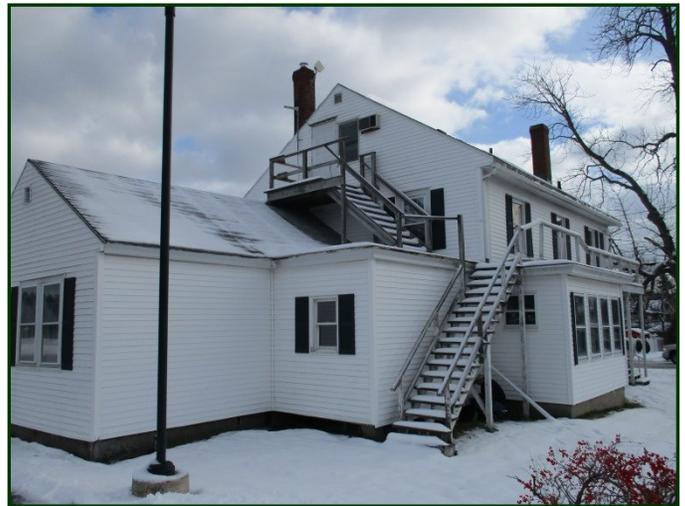
Photo #4: View from northwest corner of building. Note wooden fire escape

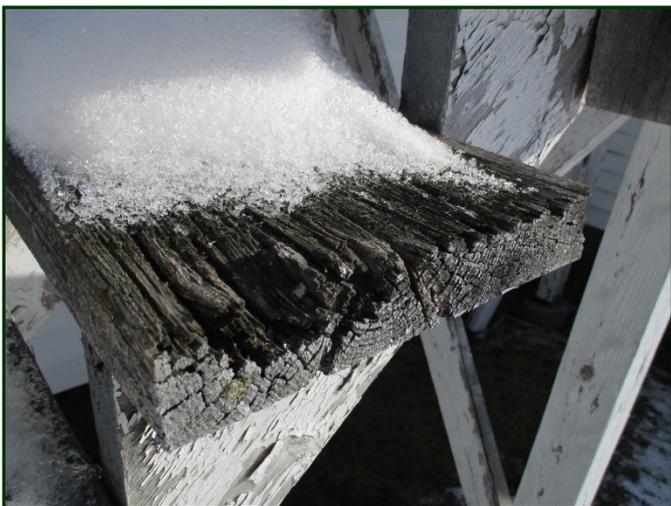
Photo #5: View of deteriorated wood at fire escape

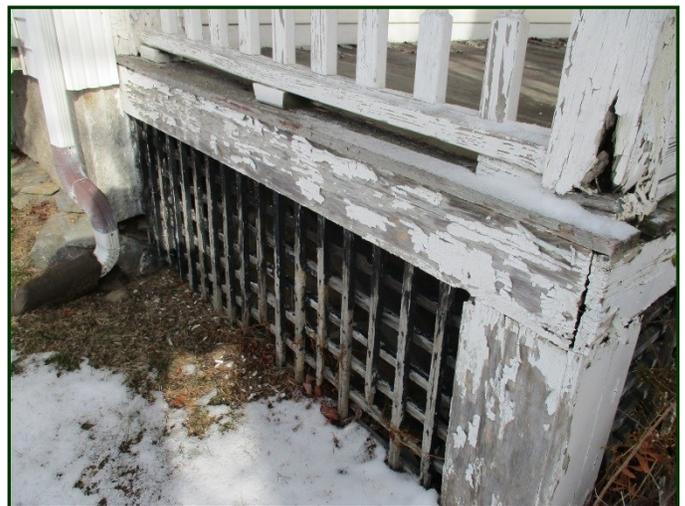
Photo #6: View of deteriorated wood at front porch

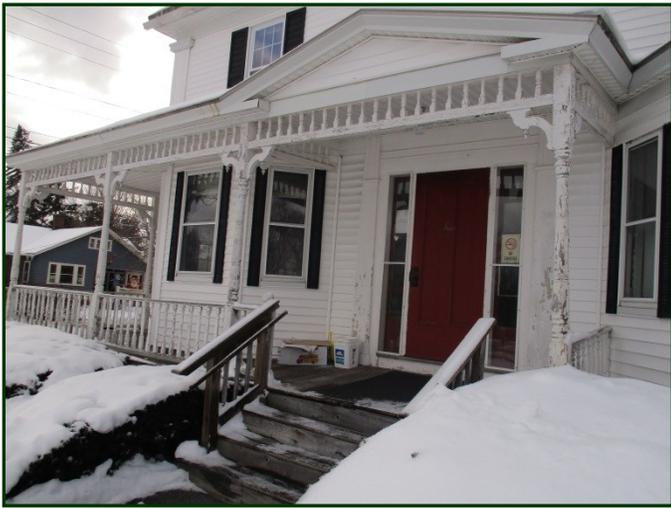
Photo #7: Main front entrance at east elevation

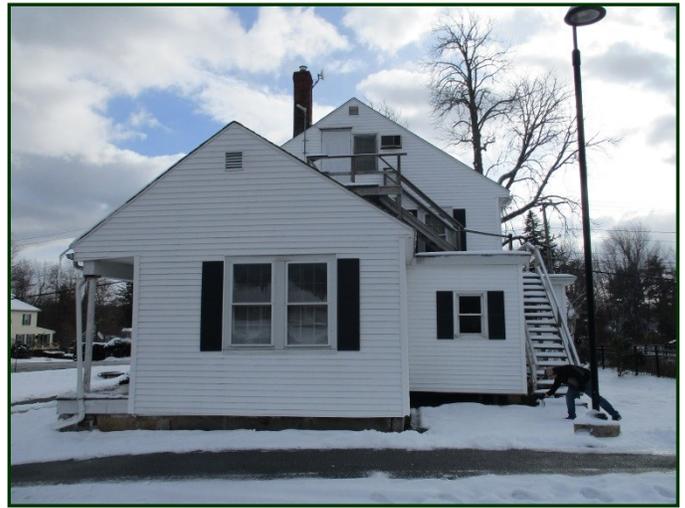
Photo #8: North elevation

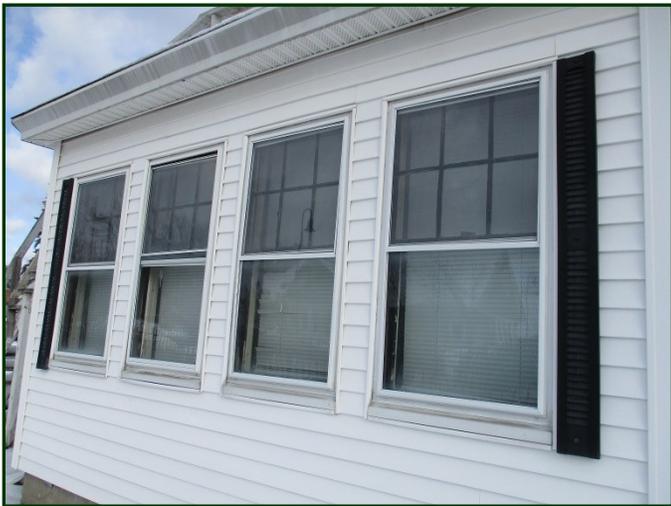
Photo #9: Vinyl clapboard siding and double hung wood windows

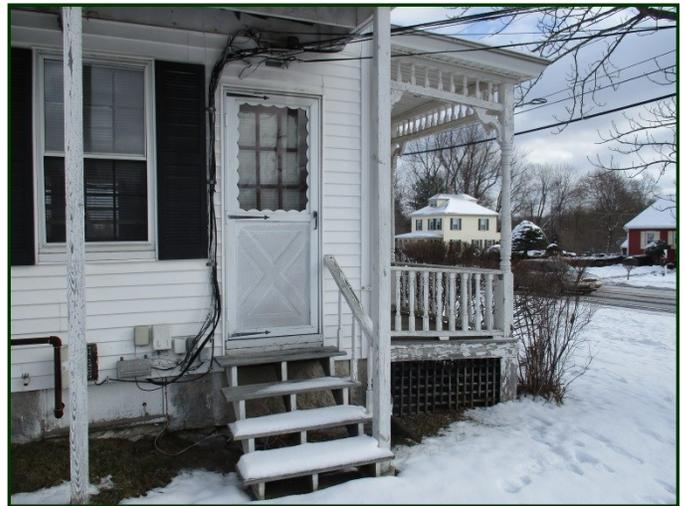
Photo #10: Secondary entrance at southwest corner of building

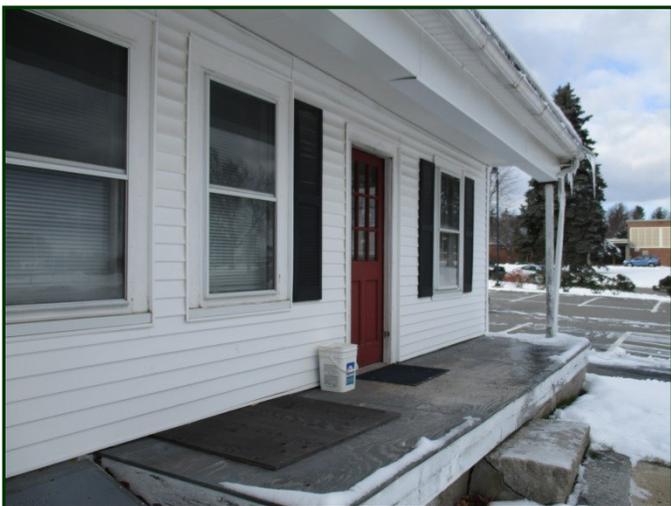
Photo #11: Secondary entrance at northeast corner of building

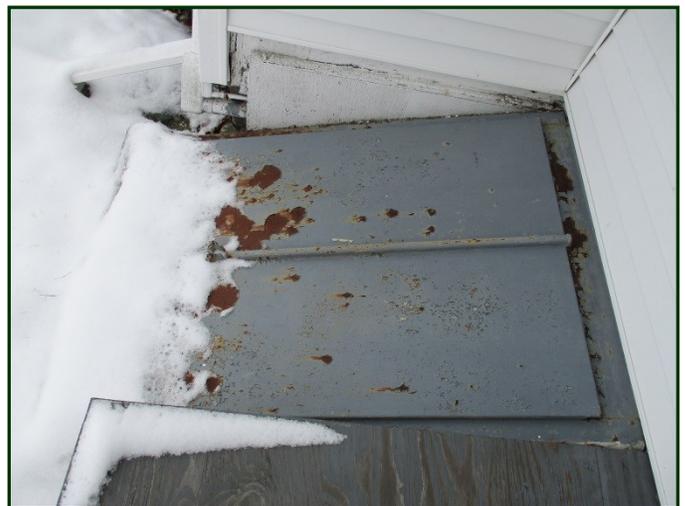
Photo #12: Painted steel bulkhead at east elevation

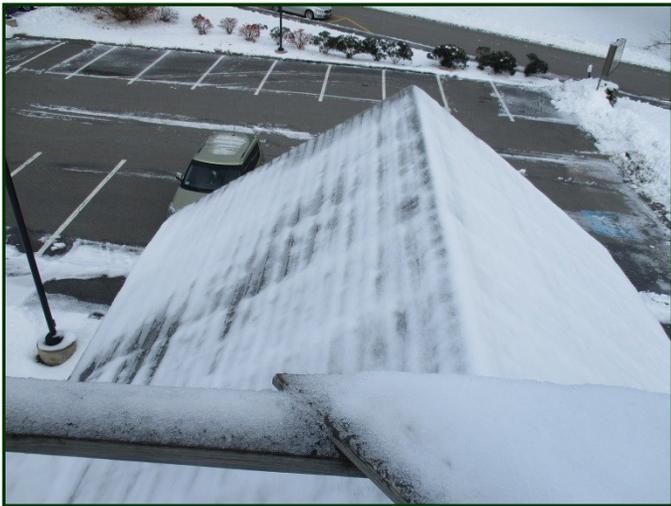
Photo #13: Asphalt composition roofing shingles. Note asphalt-paved parking lot beyond (north side of site)

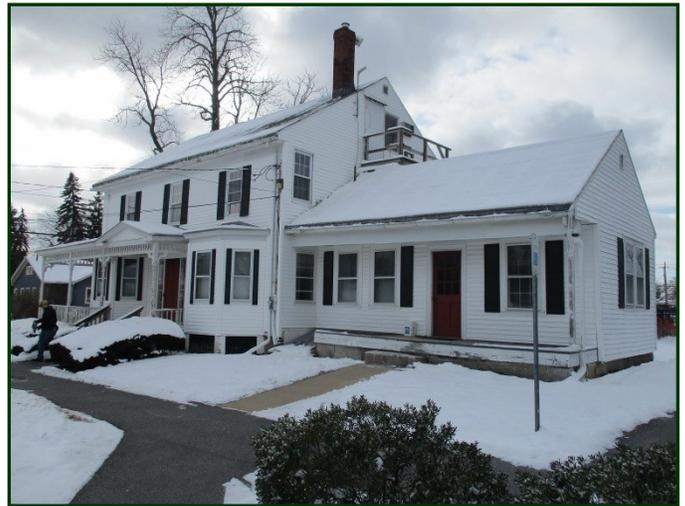
Photo #14: View from northeast corner of building

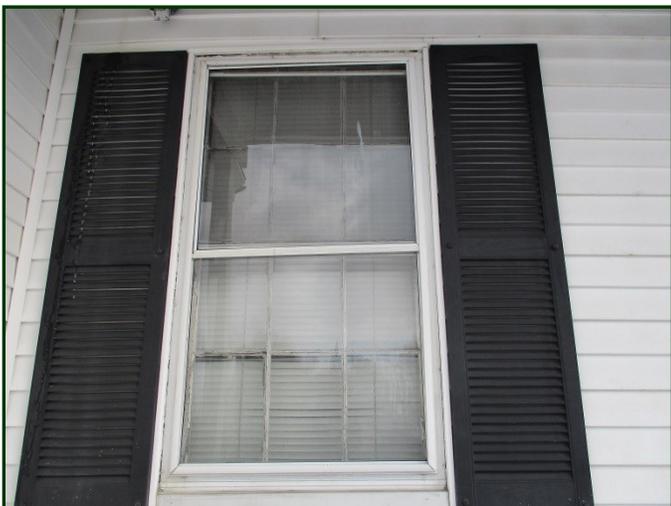
Photo #15: Original (circa 1935) double hung wood windows with non-insulated glazing on the first floor level

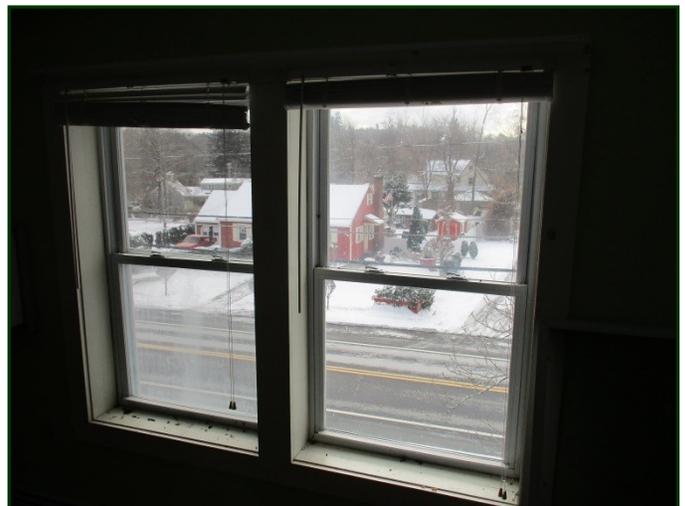
Photo #16: Newer (circa 1998) double hung vinyl windows with insulated glazing at upper floor level

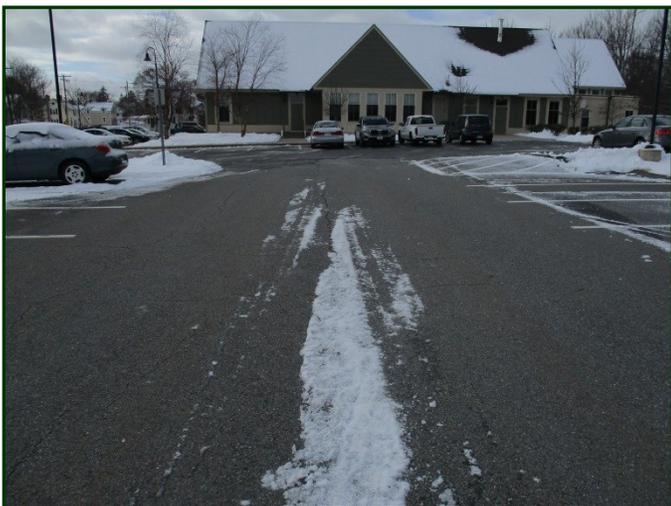
Photo #17: Asphalt-paved parking lot on north side of site

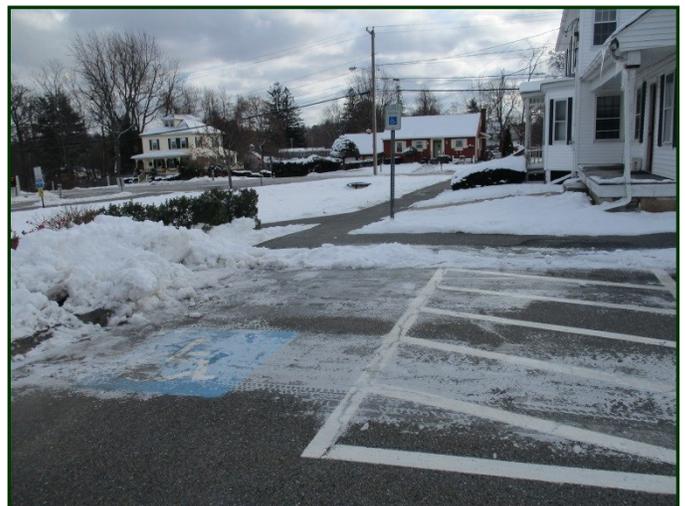
Photo #18: Accessible parking space adjacent to building entrance

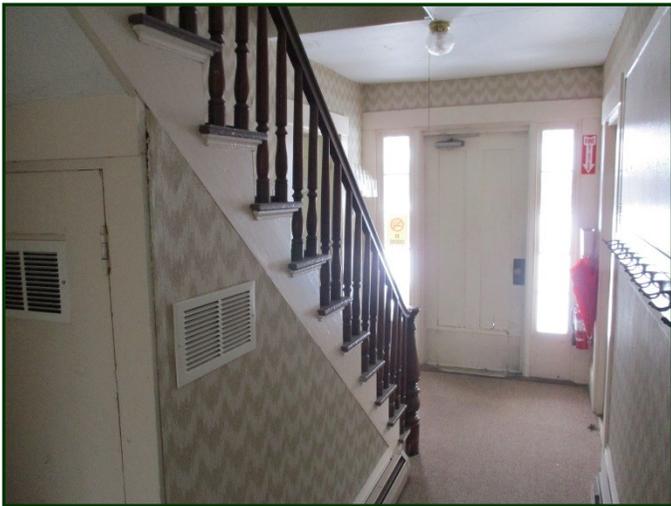
Photo #19: Main front entrance. Note carpet floor, wall covering and painted plaster ceiling and wood trim

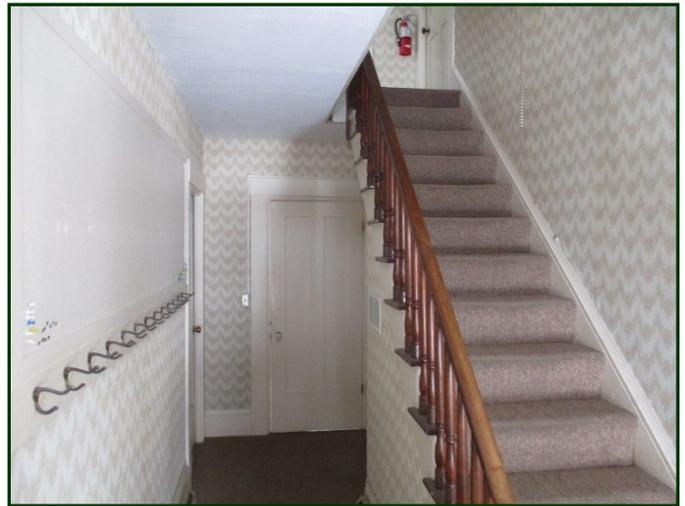
Photo #20: Wooden staircase with carpet and stained wood handrail and balusters (first to second floor level)

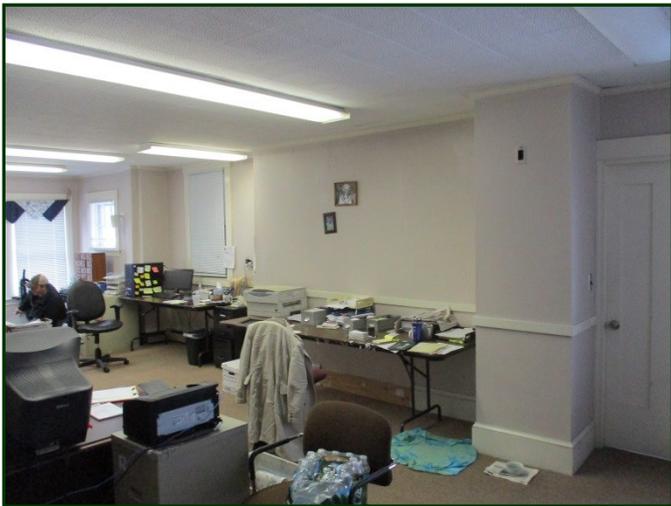
Photo #21: Office space with carpet flooring and surface-mounted fluorescent lighting fixtures

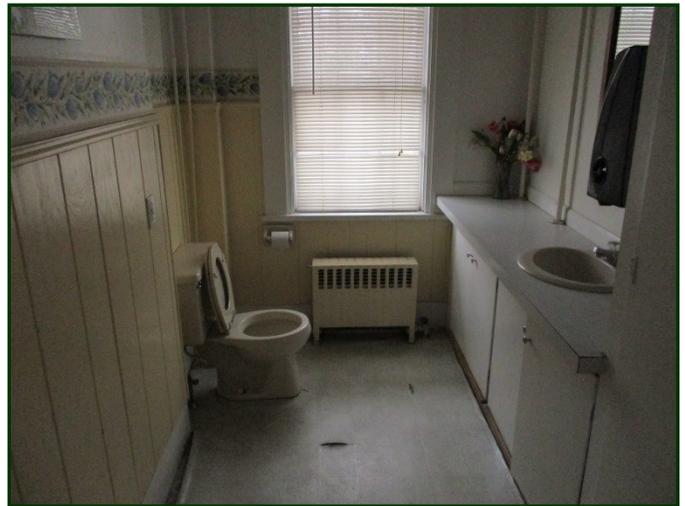
Photo #22: First floor level bathroom with resilient floor tiles

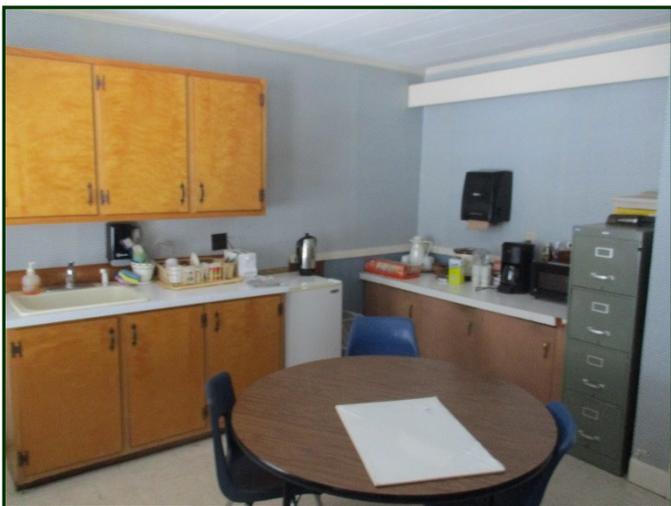
Photo #23: Wood cabinetry with laminate countertops

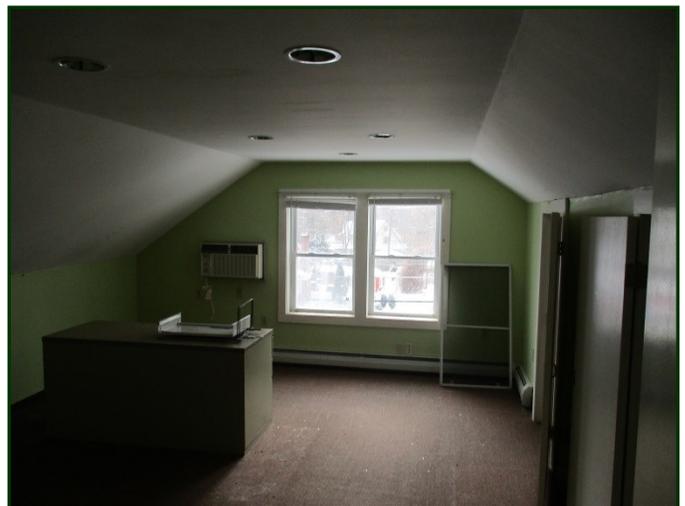
Photo #24: Finished attic level with carpet floor and painted gypsum board ceiling and walls

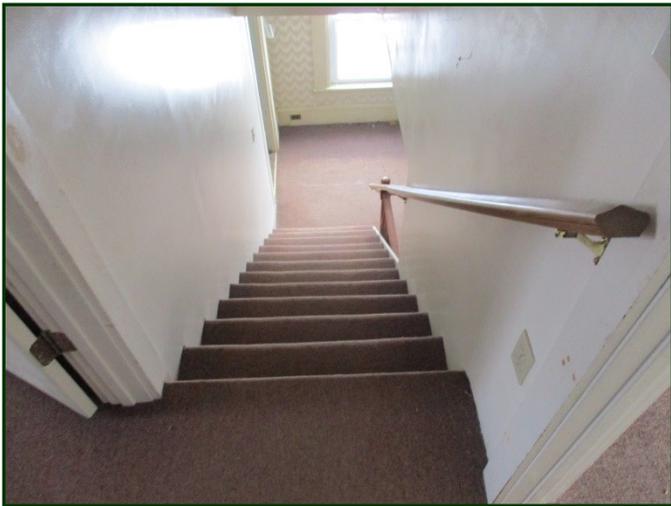
Photo #25: Wooden staircase with carpet and stained wood handrail (viewed from attic level to second floor)

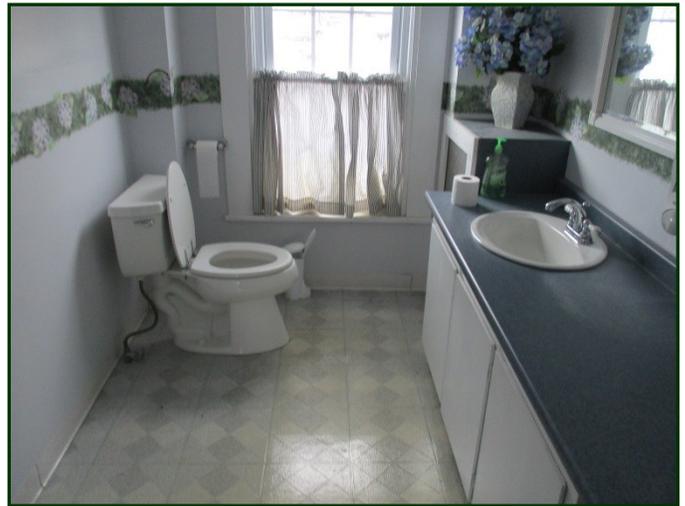
Photo #26: Second floor level bathroom

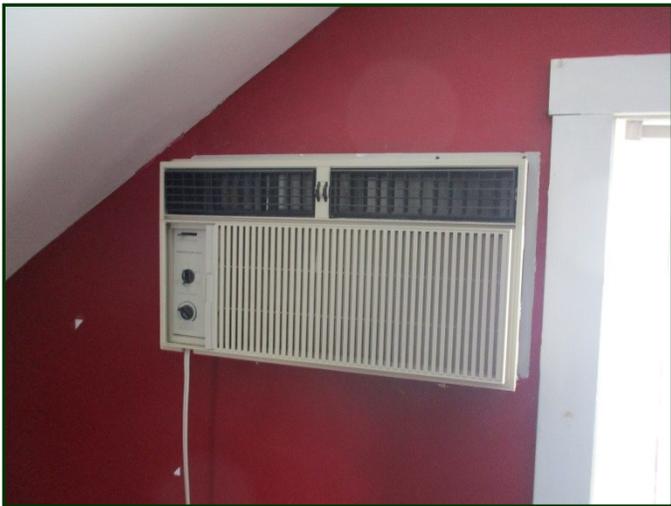
Photo #27: Through-wall air conditioning unit

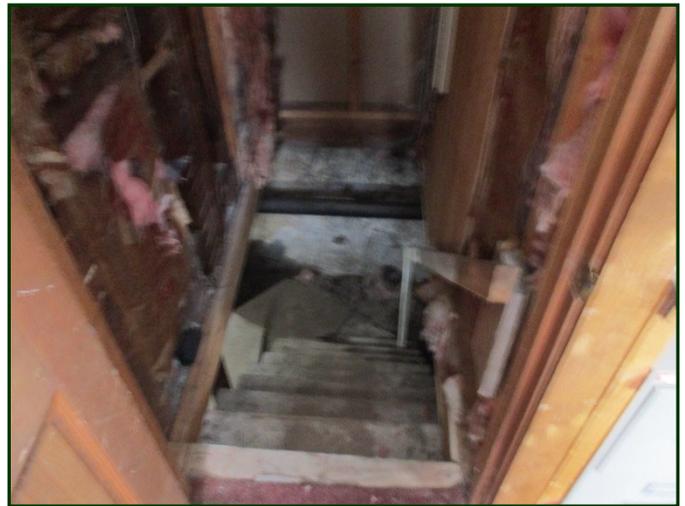
Photo #28: Stairway from first floor to basement

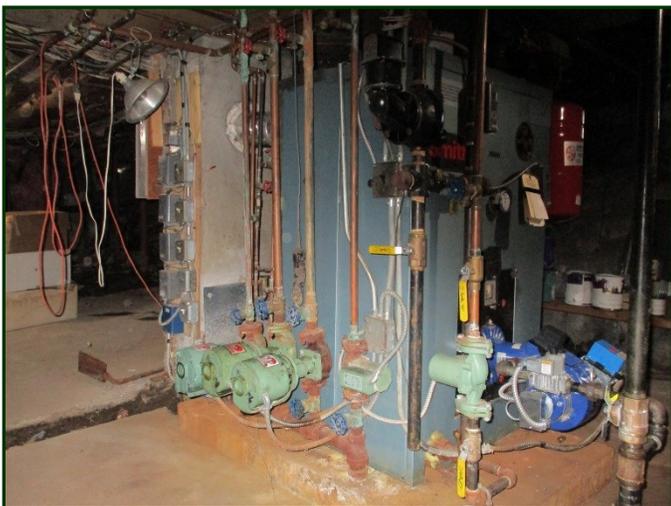
Photo #29: Gas-fired boiler in basement level

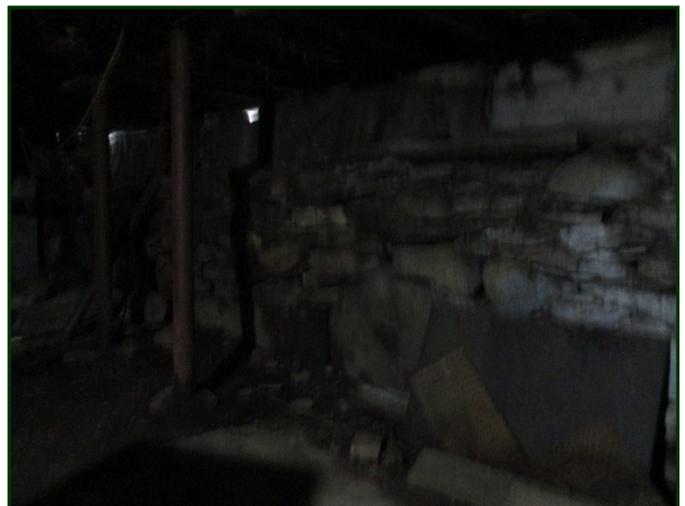
Photo #30: Stacked stone foundation. Note daylight at top of foundation wall

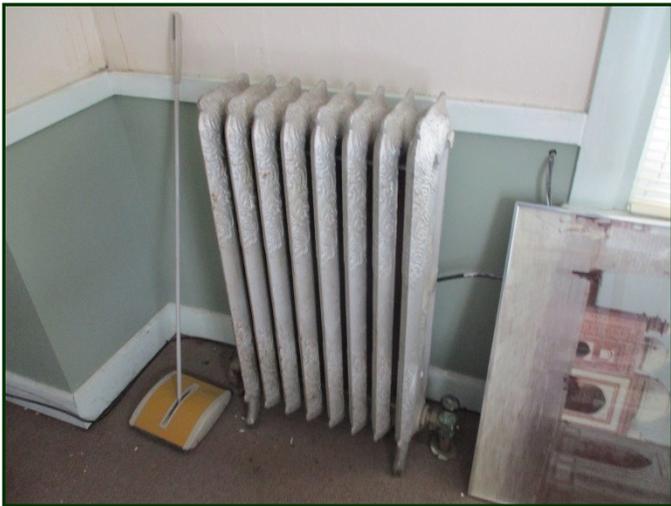
Photo #31: Cast iron radiator

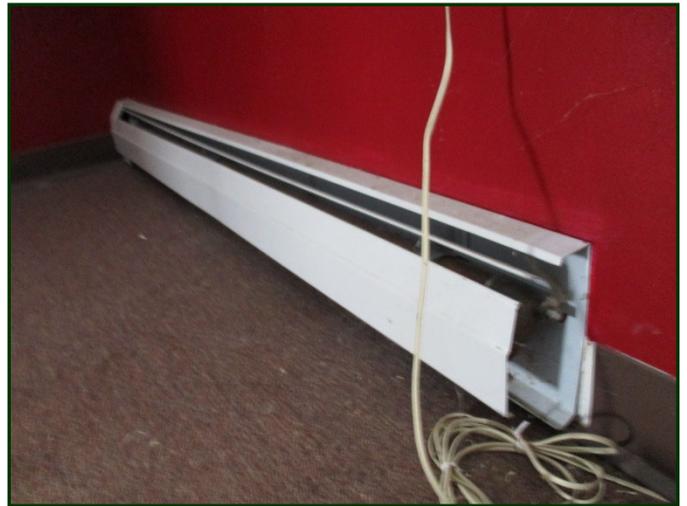
Photo #32: Fin tube baseboard radiator at attic level

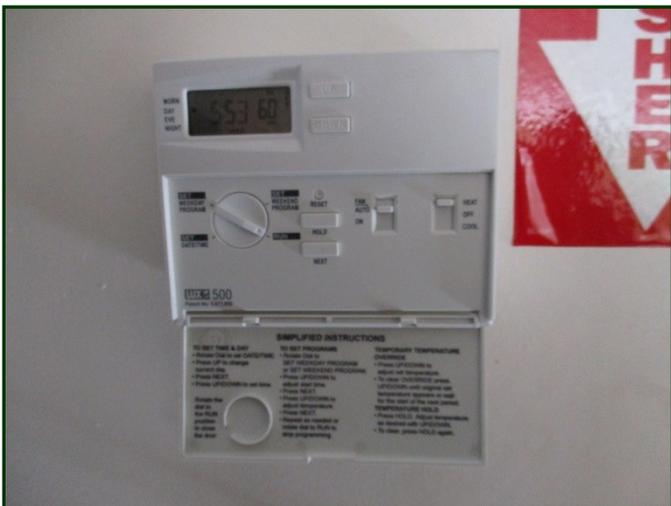
Photo #33: Programable thermostat

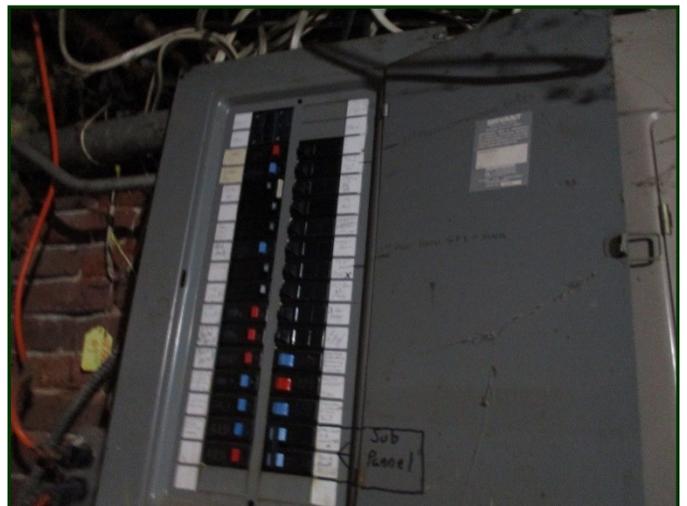
Photo #34: Main electrical service panel with circuit breakers in basement level

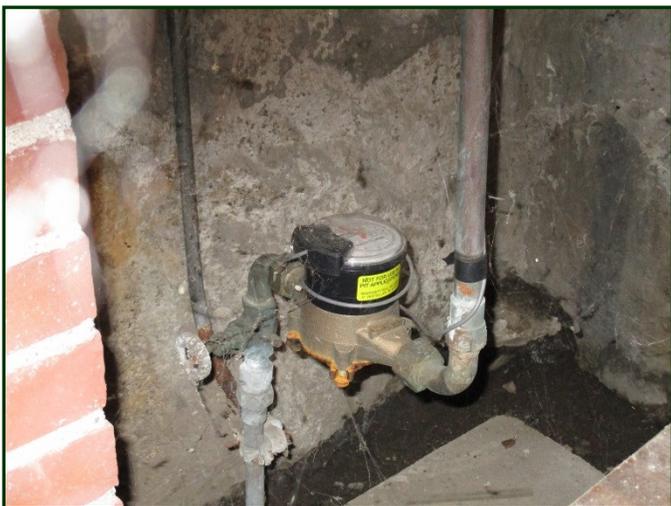
Photo #35: Domestic water service and meter in southwest corner of basement

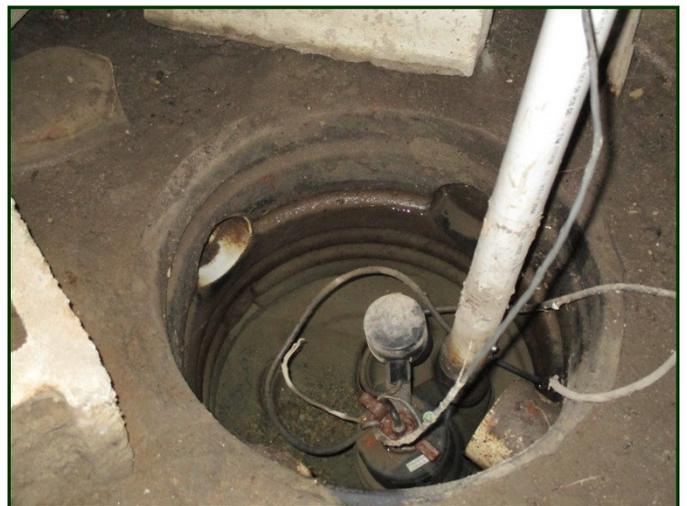
Photo #36: Sump pit with pump in southeast corner of basement

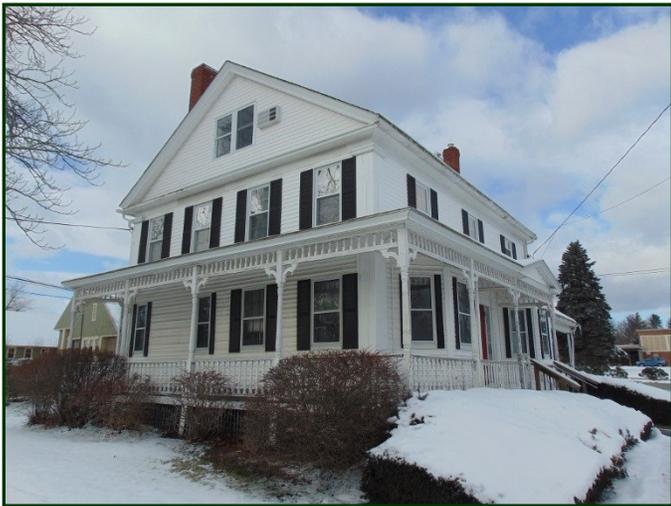
Photo #37: South (front) elevation of Brooks House. Note wrap-around porch.

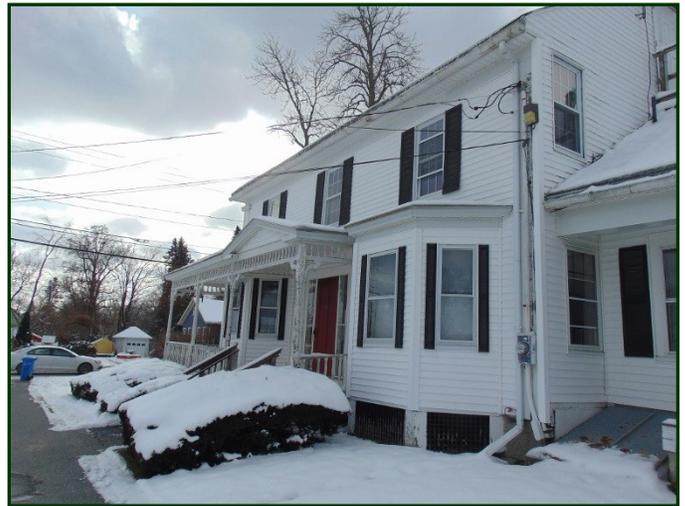
Photo #38: East (side) elevation of Brooks House.

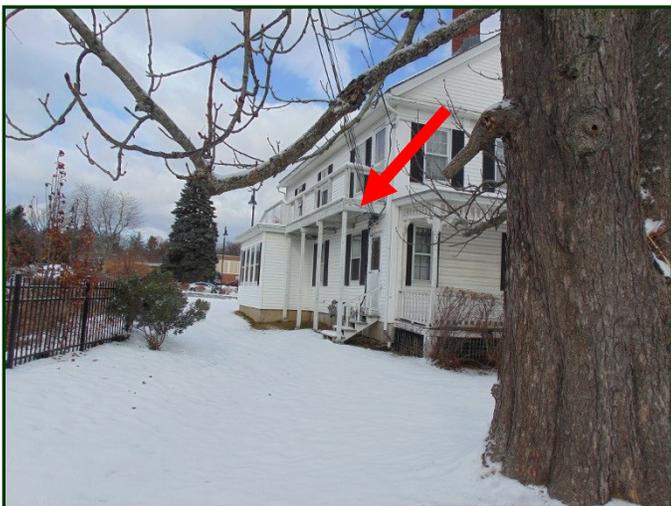
Photo #39: West (side) elevation of Brooks House. Note 2nd floor fire escape (indicated by arrow).

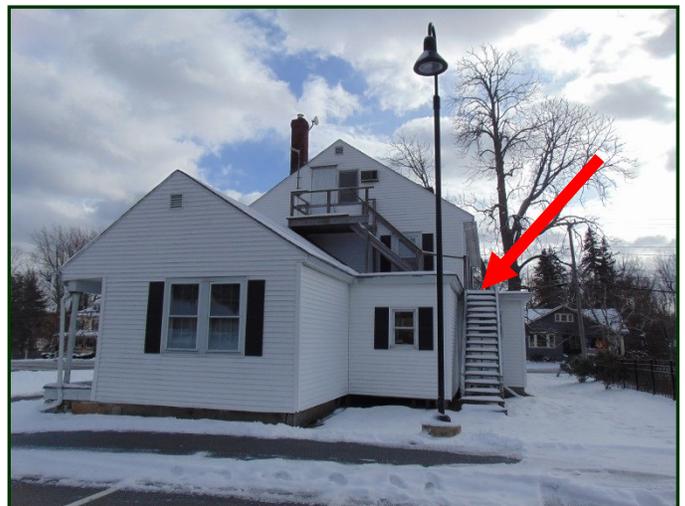
Photo #40: North (rear) elevation of Brooks House. Note 2nd floor fire escape.

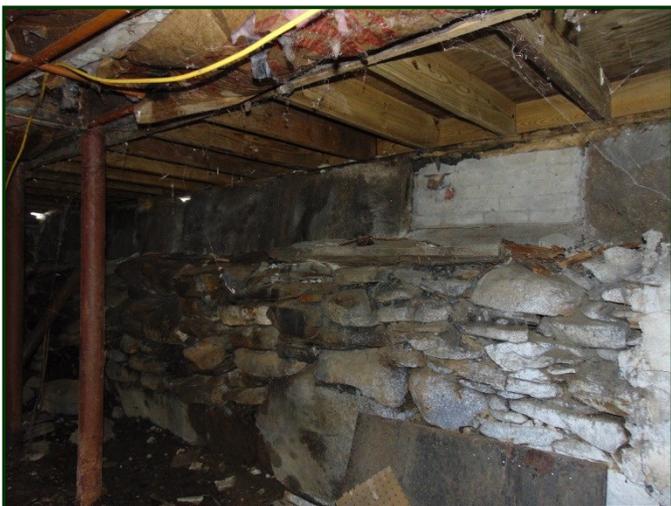
Photo #41: Stone foundation exposed in the basement.

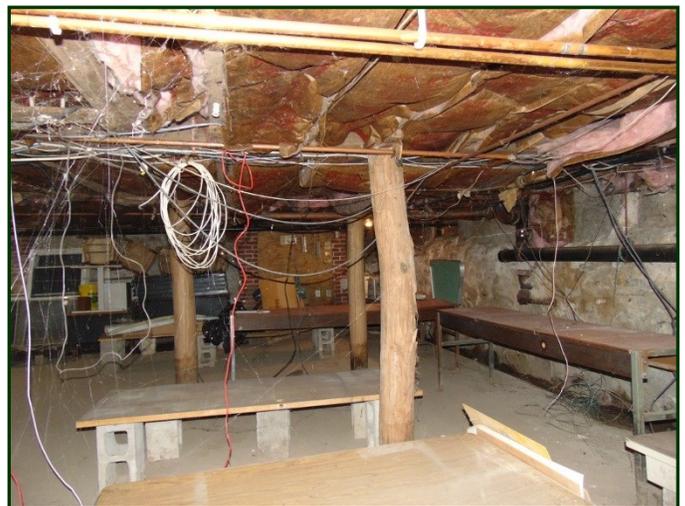
Photo #42: Typical round wood post supporting ground floor.

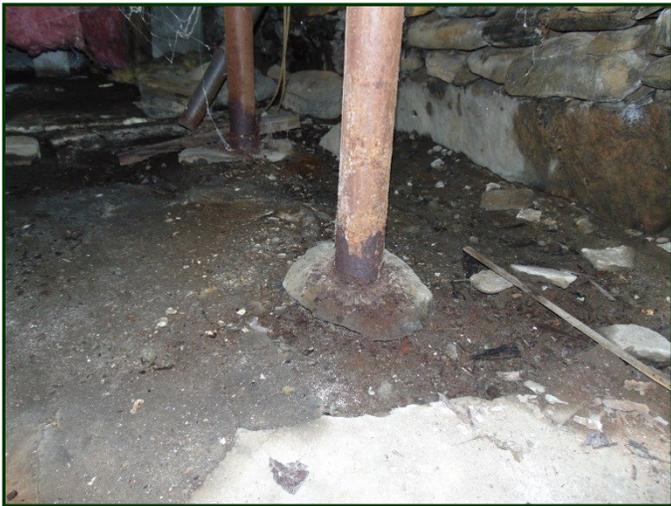
Photo #43: Steel posts supporting the north one-story wing of the Brooks House.

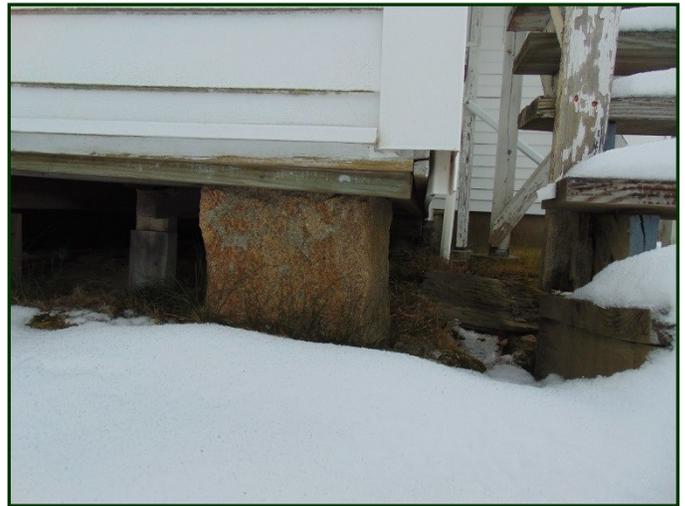
Photo #44: View of foundation block below northwest corner storage room. Floor in storage room was observed sloped toward west.

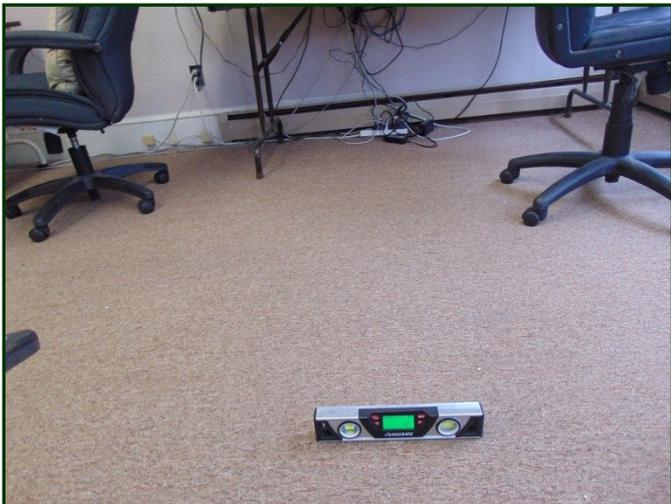
Photo #45: Measurement of sloped ground floor near northwest corner. The floor was sloped toward the west. Note digital level reads 1/2-inch per foot slope

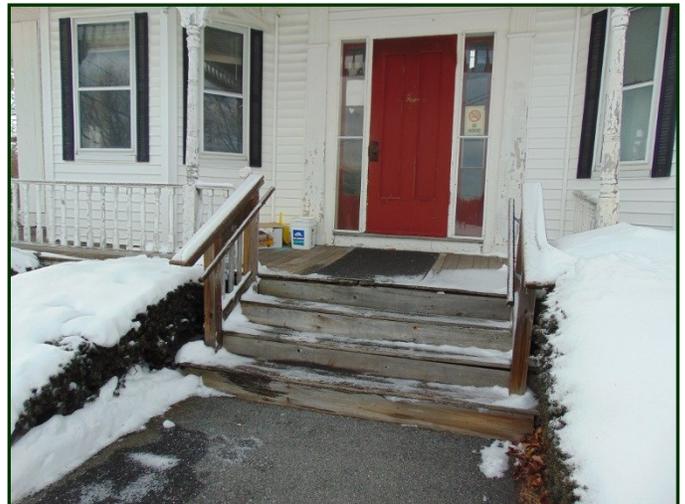
Photo #46: View of entrance steps on east elevation. Note porch is sloped away from the entrance.

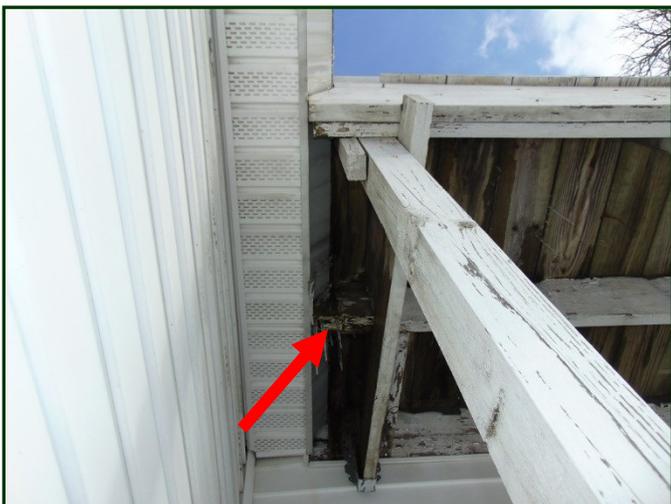
Photo #47: View of deteriorated fire escape framing on the west elevation.

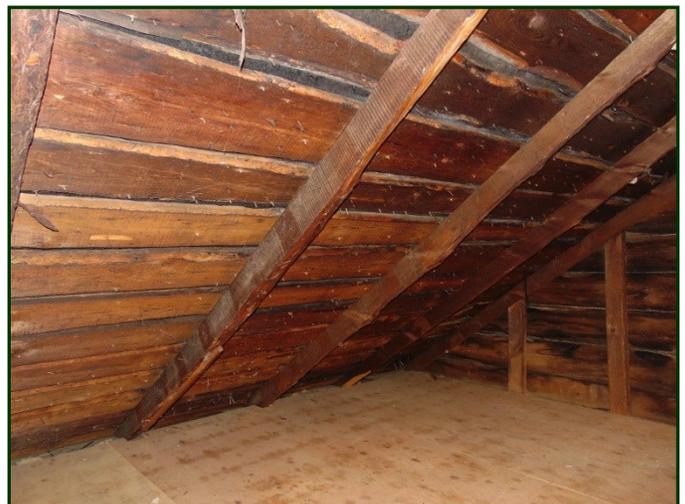
Photo #48: View of typical roof framing.

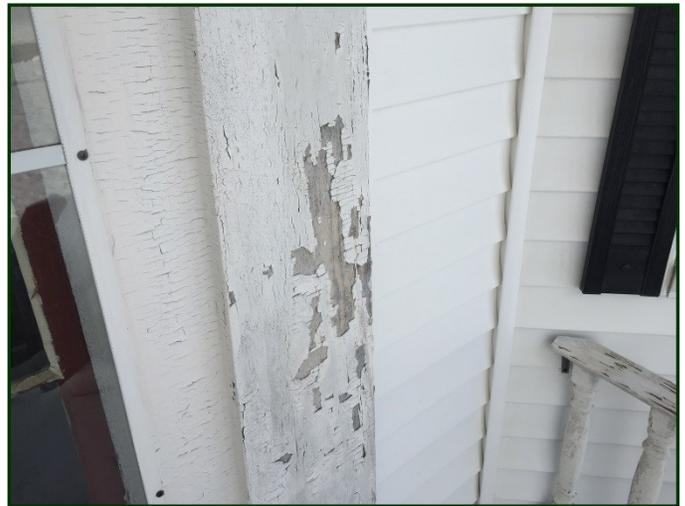
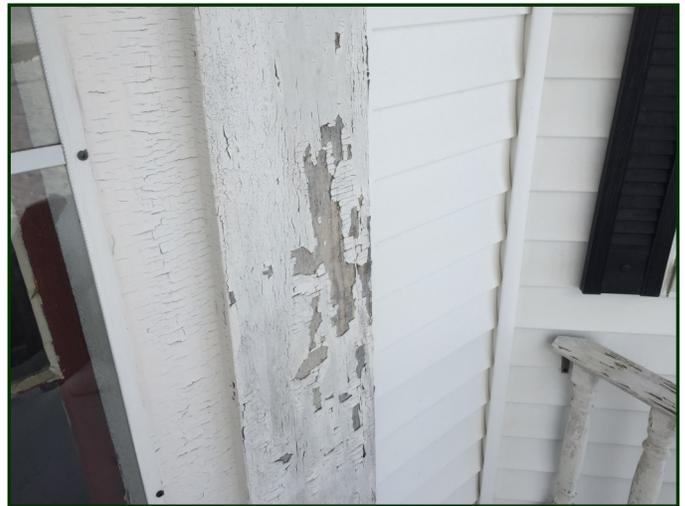
Photo #52: Photograph depicts general view of peeling/flaking paint on exterior trim

Photo #4: Photograph depicts general view of peeling/flaking paint on exterior trim

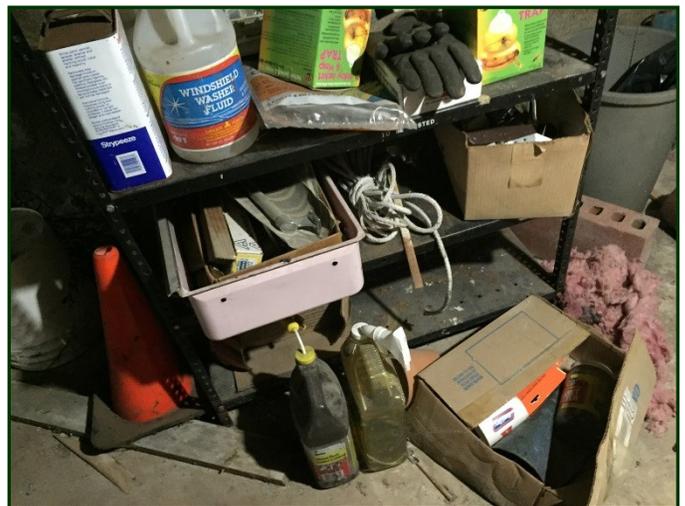
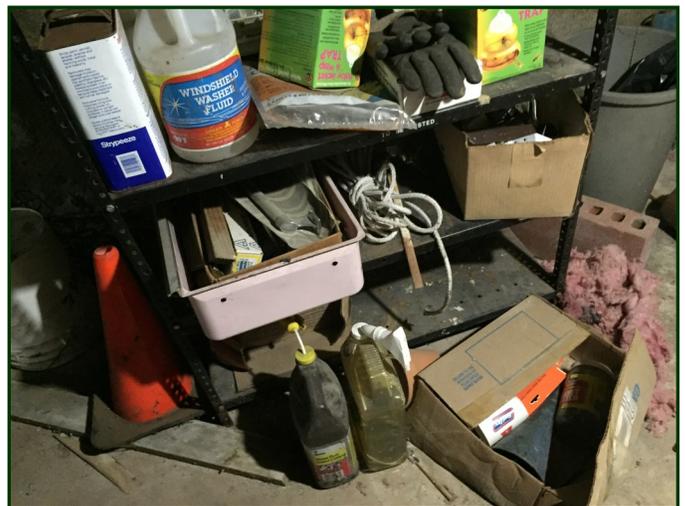
Photo #60: Photograph depicts general view of Chemical Storage within Basement Area

Photo #12: Photograph depicts general view of Chemical Storage within Basement Area
