Turkey Hill Elementary School

Property Condition Assessment

March 9, 2018

VERTEX Project No: 48237

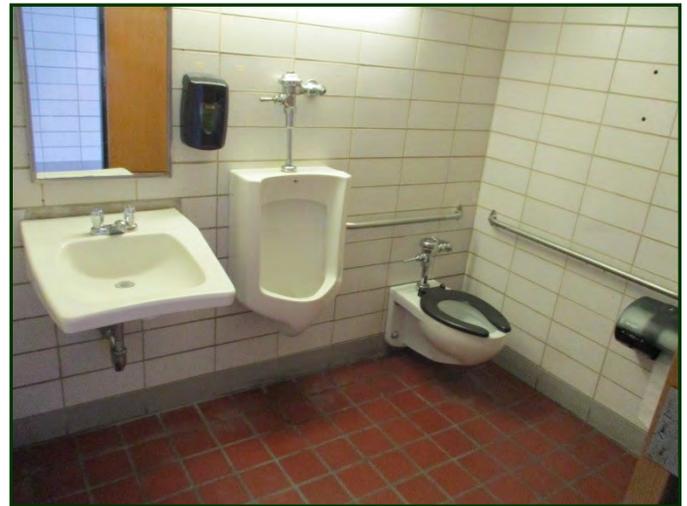
Photo #46: Men's accessible toilet room. Note lack of compliant rear grab bar and un-insulated piping under sink

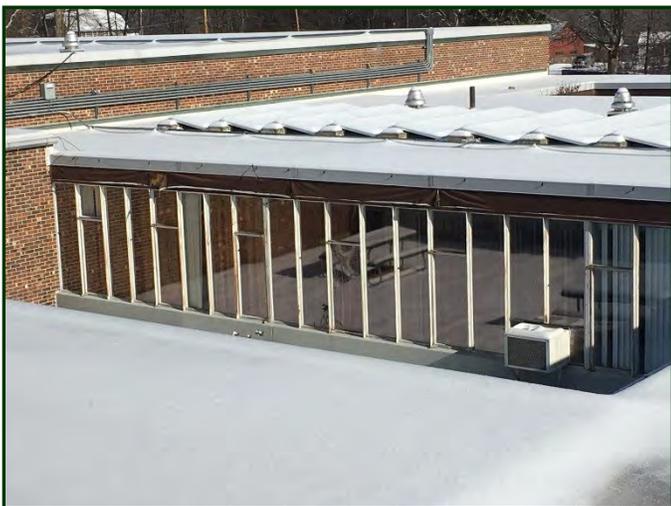
Photo #170: Detail of the fascia from Photo 27. Note the damaged fascia at center.

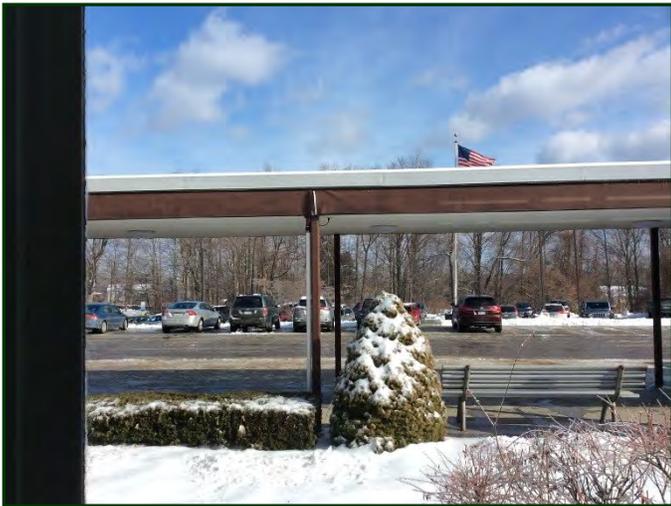
Photo #172: Detail of Photo 29. Note the damaged fascia at center.

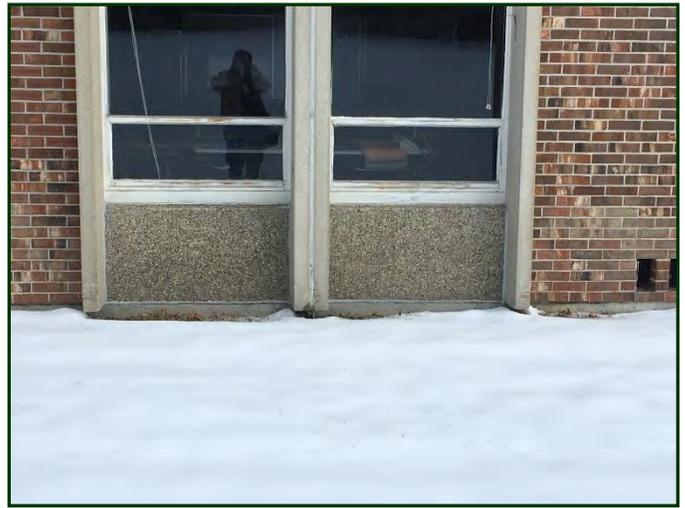
Photo #179: Rusting and a vent at one of the Classroom windows.

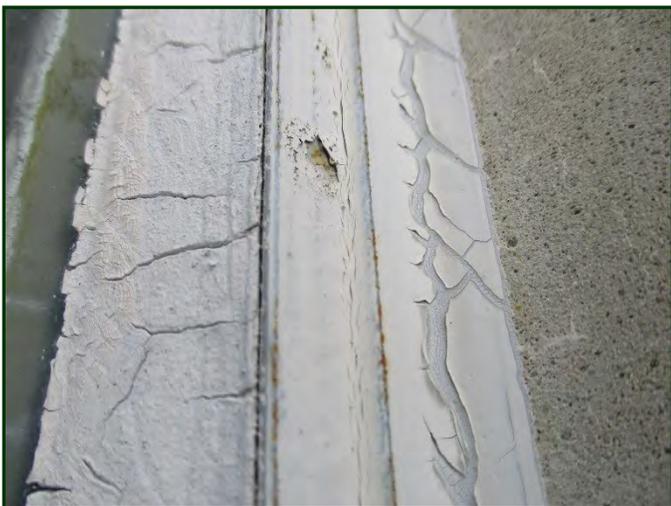
Photo #182: Detail of a Classroom window illustrating the deteriorated glazing sealant.

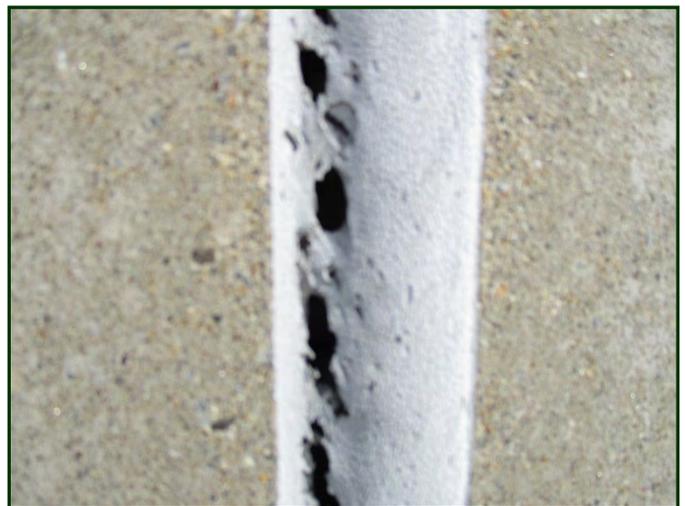
Photo #183: Perimeter sealant at a window bay. Note the cracking of the sealant.
