Town Hall
17 Main Street
Lunenburg, MA 01462

Property Condition Assessment

February 6, 2018

VERTEX Project No: 48237

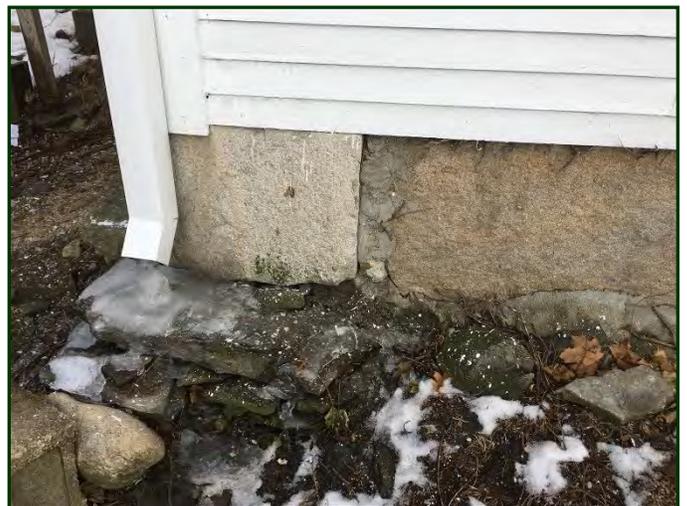
Photo #24: Detail of the downspout outflow at the north-west corner. Note the build up of ice on grade at the foundation .

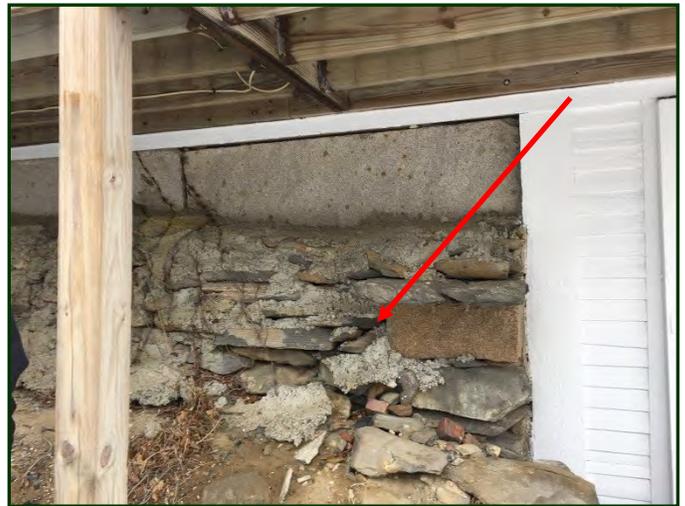
Photo #28: The stone foundation on the north side. Note the deteriorated mortar.

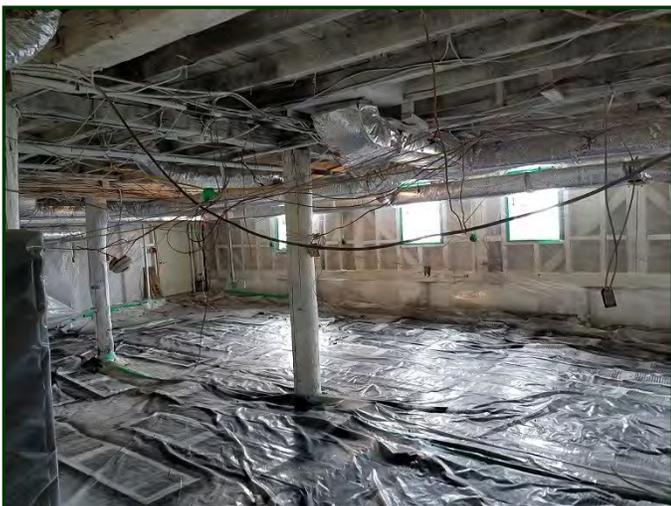
Photo #100: Loose wiring observed around main water meter and associated piping
