Lunenburg Primary School

30 School Street
Lunenburg, MA 01462

Property Condition Assessment

February 6, 2018

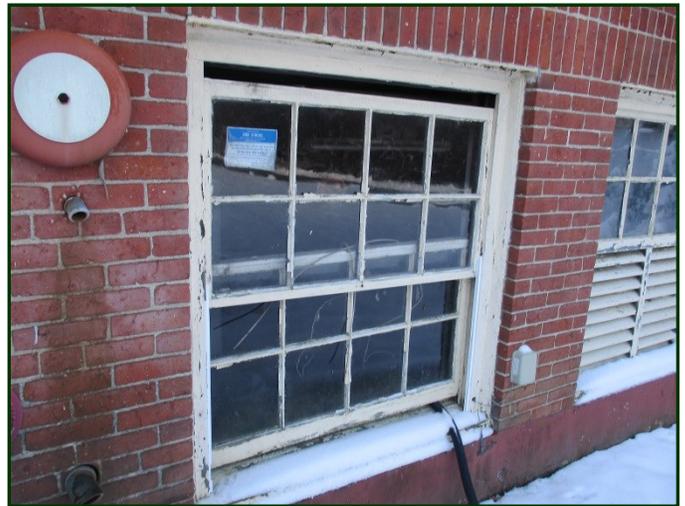
Photo #4: Original double hung wood windows with non-insulated glazing

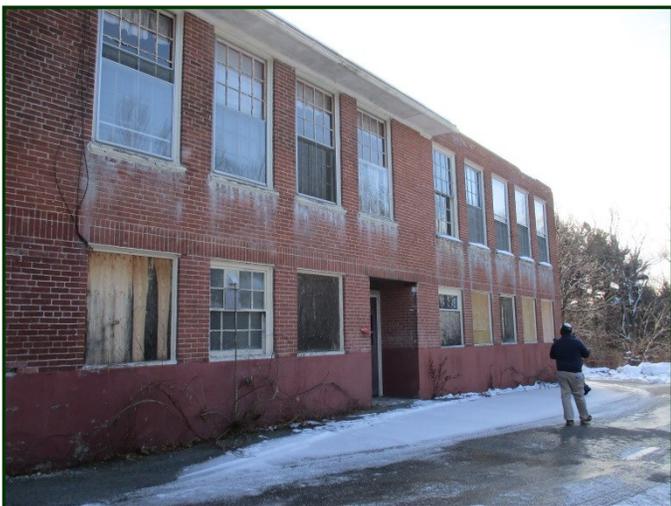
Photo #5: West elevation. Note boarded-up windows

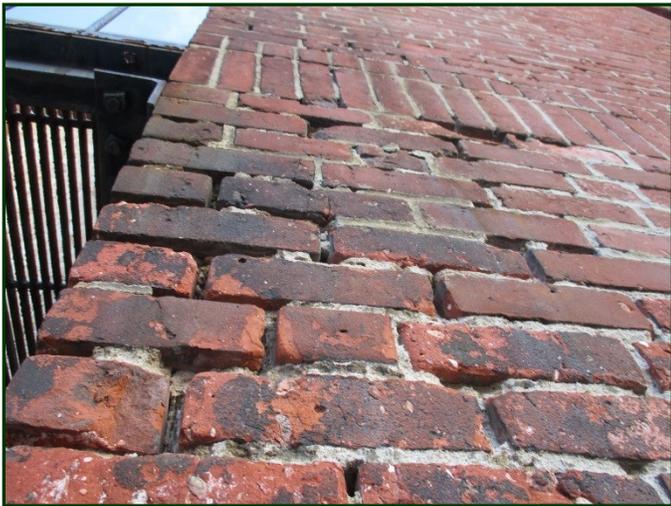
Photo #7: Deteriorated condition of mortar joints and brickwork (south elevation)

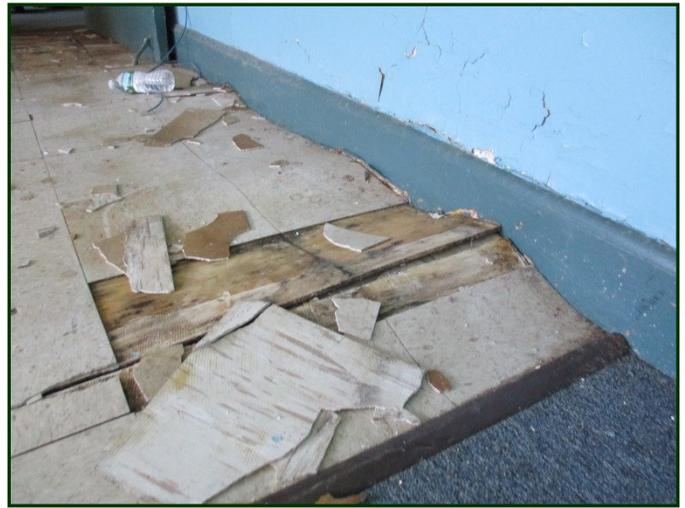
Photo #20: Buckled floor in classroom (west side of upper level)

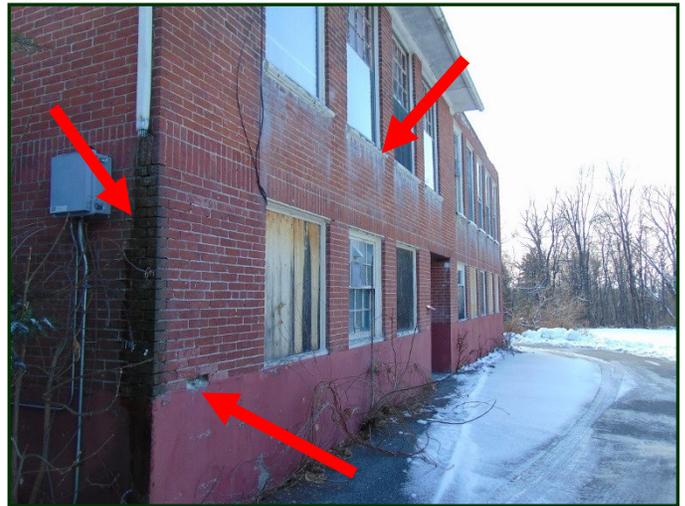
Photo #38: West elevation of the Primary School. Note staining on masonry below windows, below downspout and missing brick unit.

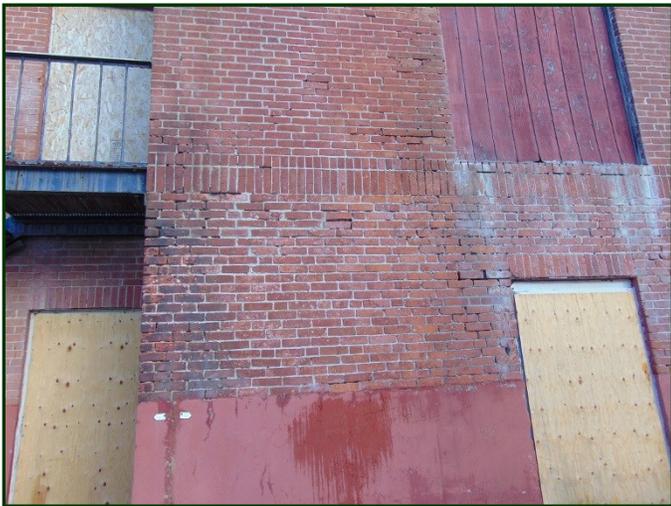
Photo #39: Deteriorated mortar joints on the rear (south) elevation of the primary school.

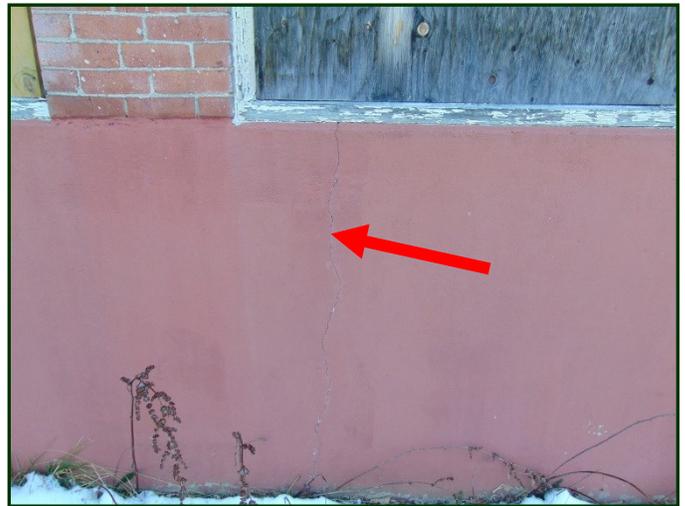
Photo #40: View of a hairline crack in the foundation of the Primary School.

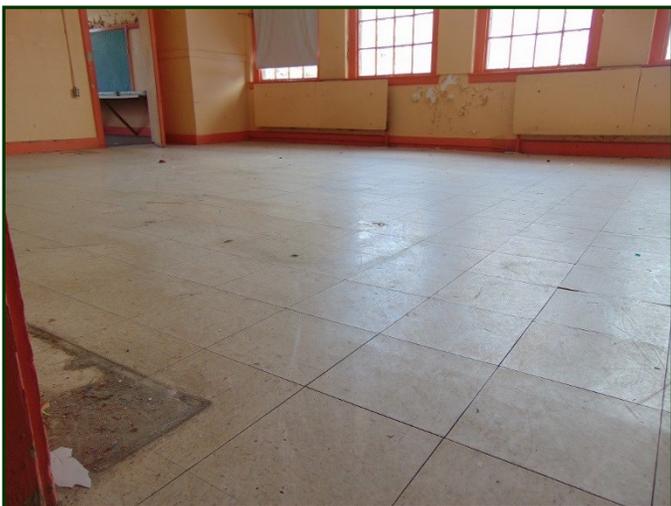
Photo #41: View of a 2nd floor classroom floor. Note bulge in floor near the center of the room.

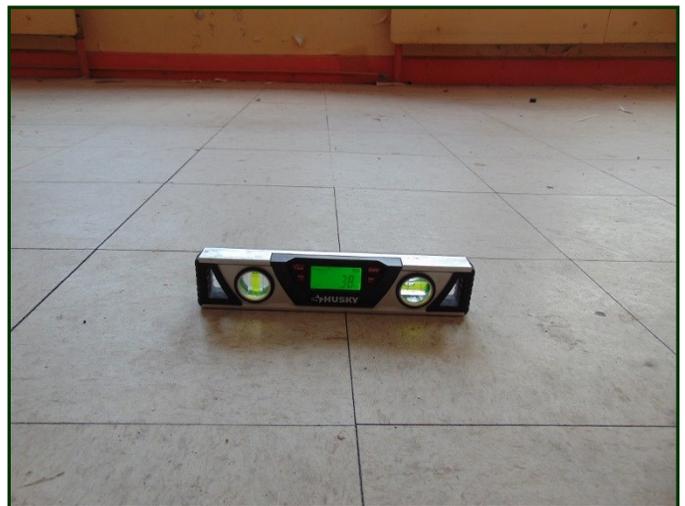
Photo #42: Measurement of the floor slope adjacent to the bulge. Note digital level reads 3/8-inch per foot.

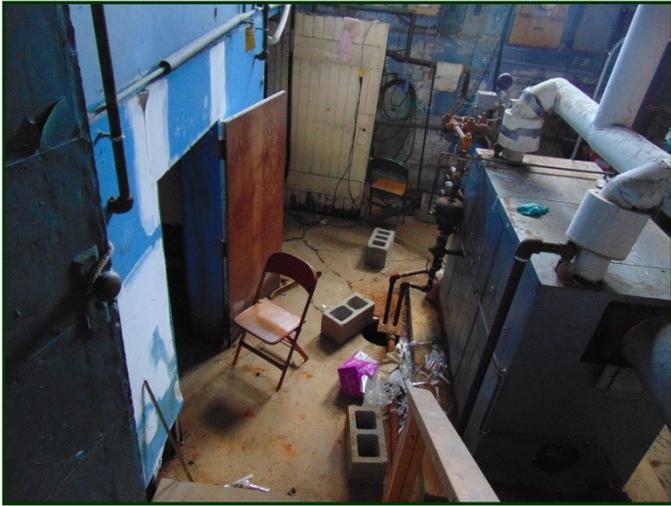
Photo #43: Boiler room located in the lower level of the Primary School. Note cracks in concrete slab.

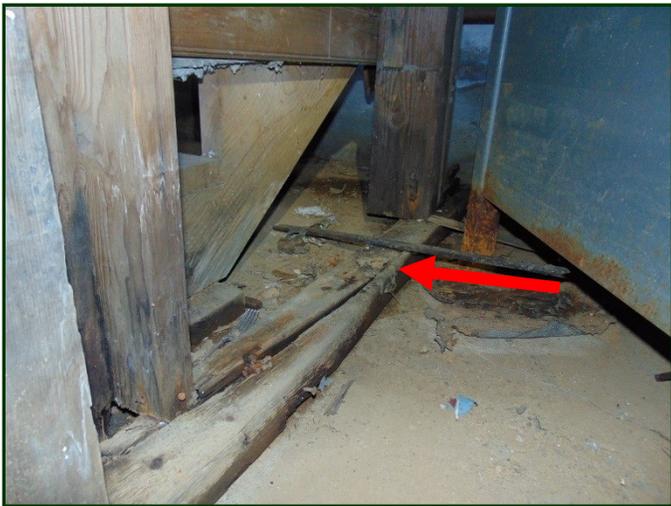
Photo #45: Sill plate below a 1st floor load bearing wall. Note deterioration of sill plate.

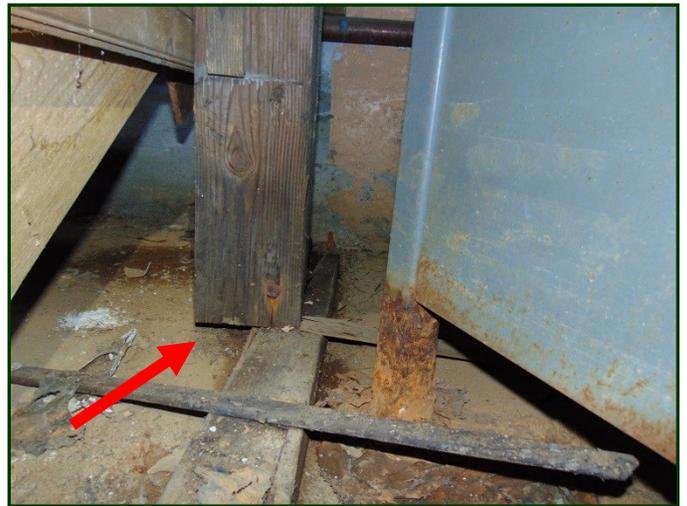
Photo #46: Limited bearing of wood stud on sill plate.

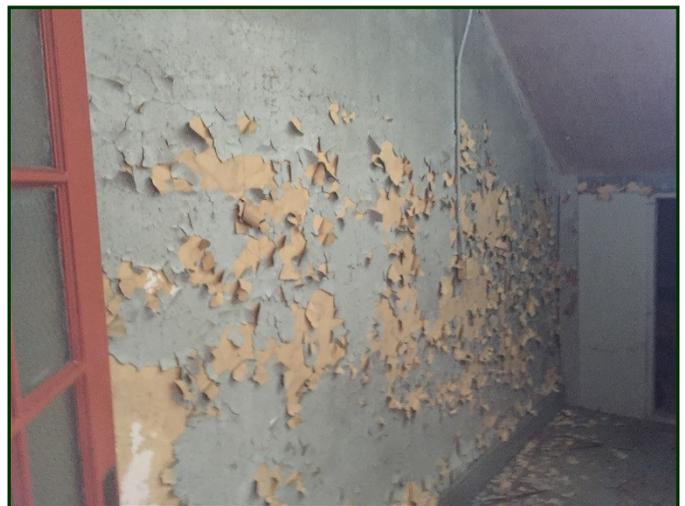
Photo #60: Photograph depicts general view of peeling/flaking paint within the lower level corridor
