**Ritter Memorial Building**

960 Massachusetts Avenue
Lunenburg, MA 01462

Property Condition Assessment

February 6, 2018

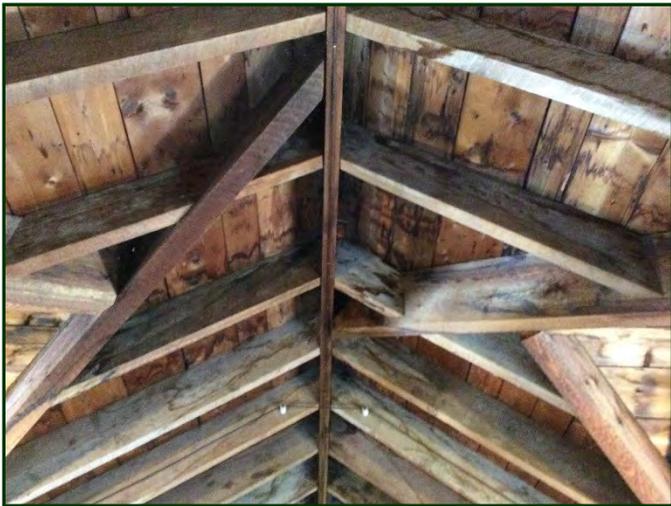
Photo #13: The underside of the roof deck showed evidence of historical water infiltration.

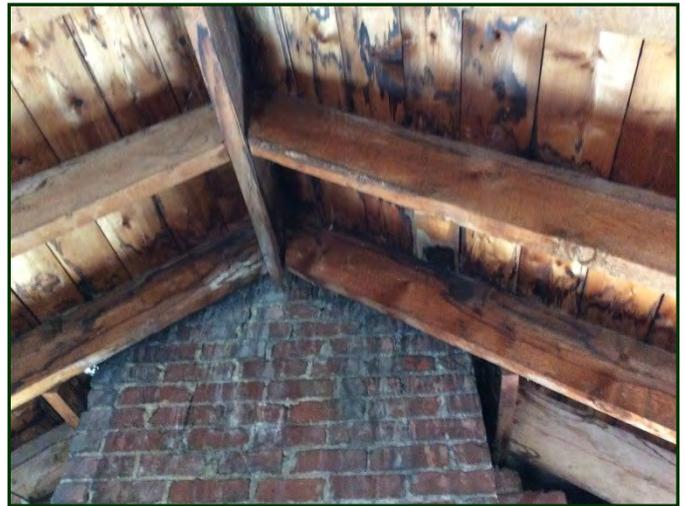
Photo #14: Detail of the masonry chimney which showed evidence of historical water infiltration.

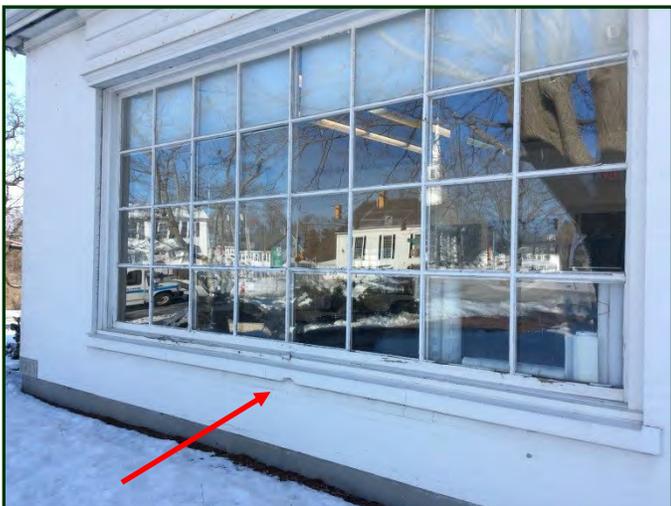
Photo #15: 32 Window at the north façade of the addition. Note the damaged precast concrete sill.

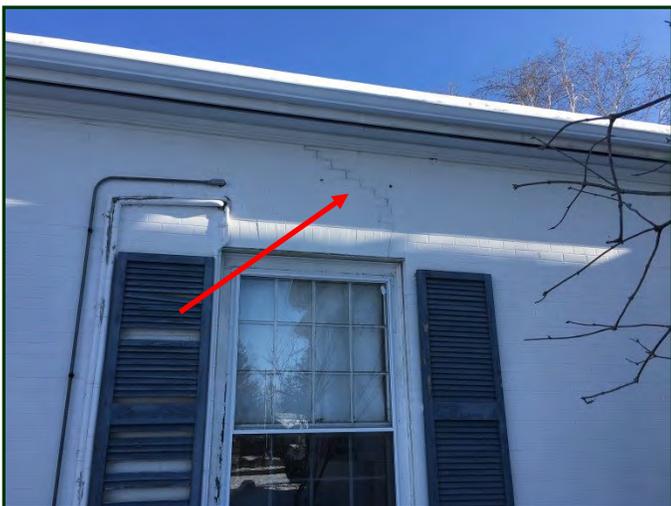
Photo #17: The window in the west side of the addition adjacent to the accessible entry. Note the crack at the window head.

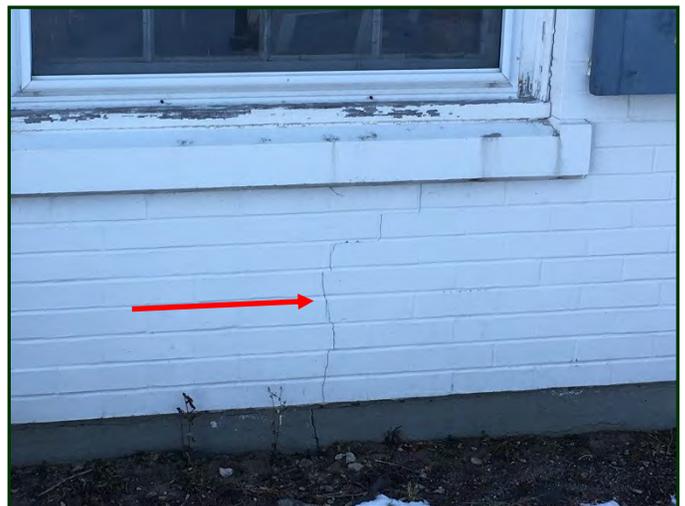
Photo #18: The same window showed the crack originating at the foundation travelling up to the top of wall.

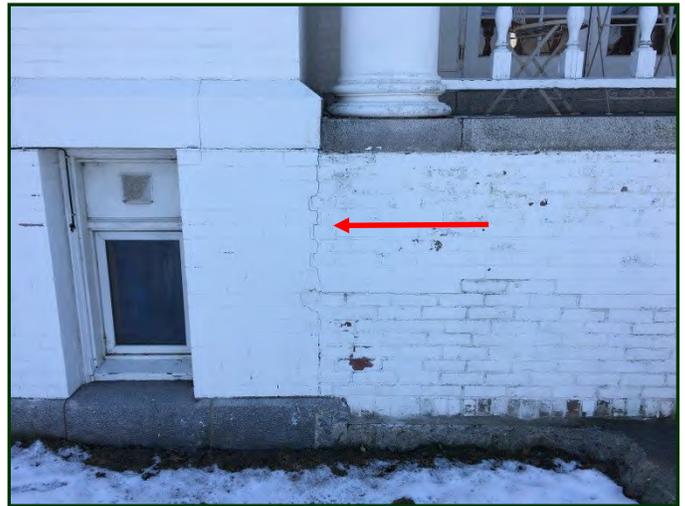
Photo #20: Detail of the east end of where it appeared that the original stair was removed previously. Note the crack along the mortar joints.

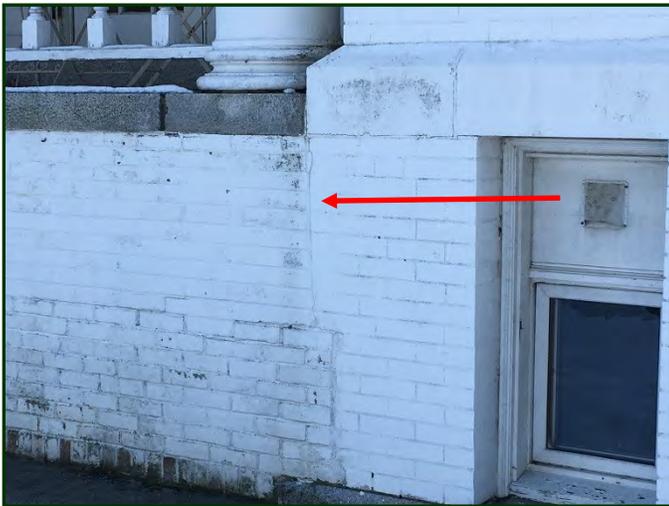
Photo #21: The west end of where the original stair was removed. Note the crack below the column.

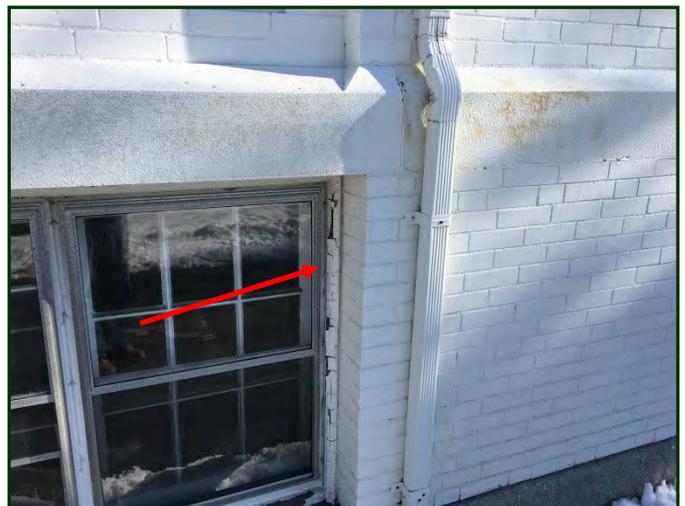
Photo #24: The basement window located at the west end of the north façade. Note the damaged brickmould.

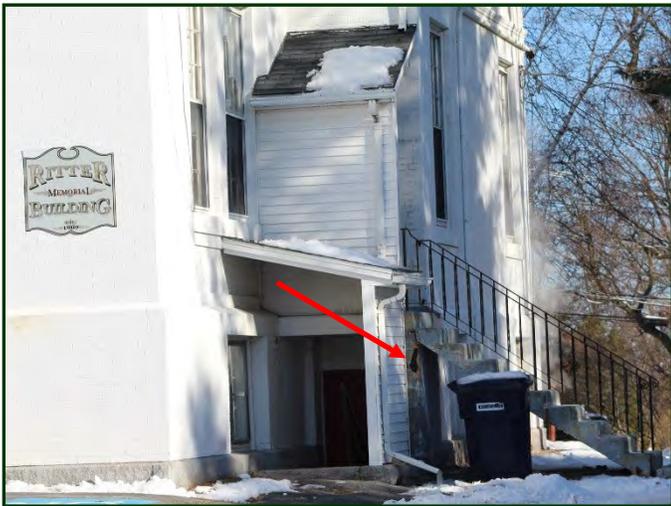
Photo #27: The rear stair at the south façade exhibited cracking and damage at the masonry pier below.

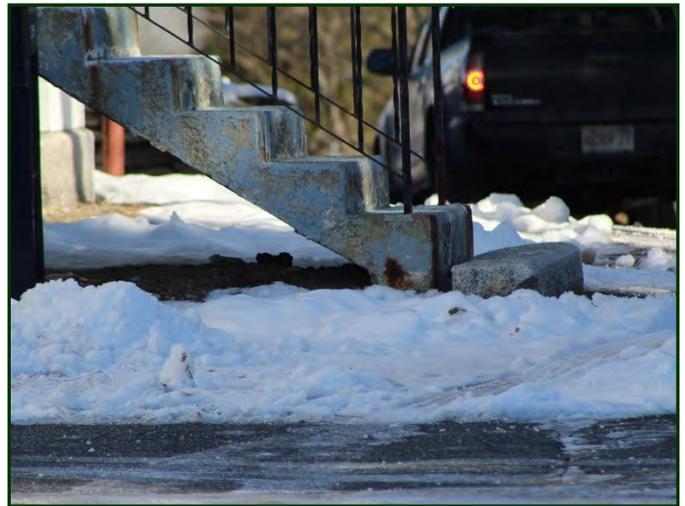
Photo #28: Detail of the concrete stair exhibited rust in the area of the handrail embed.

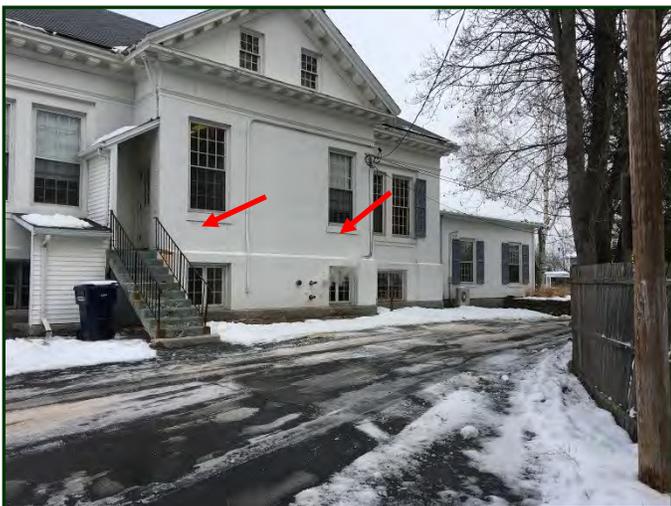
Photo #29: The south façade masonry was observed to be in good condition generally, with minor mortar cracks observed below the first floor window sills.

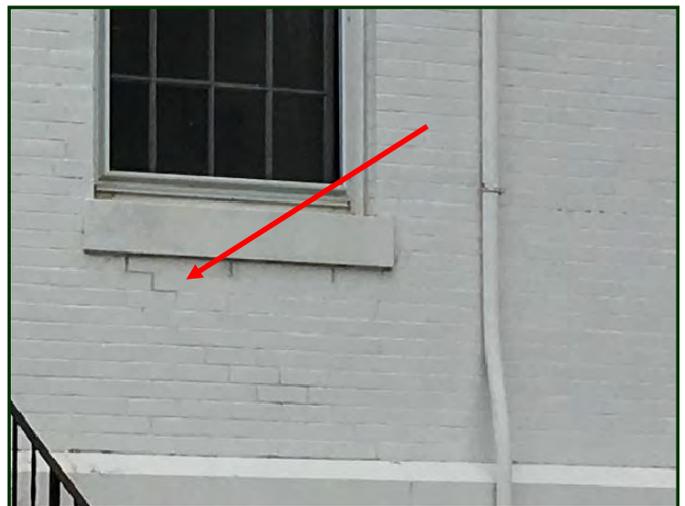
Photo #30: Detail of one of the mortar cracks below the first floor windows.

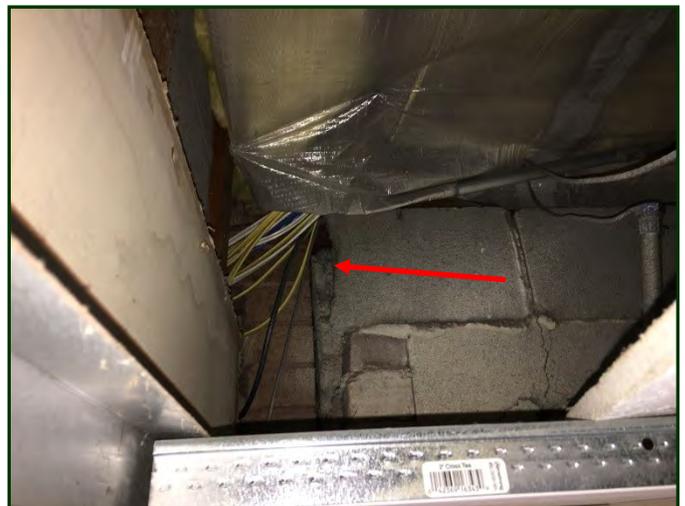
Photo #34: The arrow indicates where daylight was observed at the intersection.

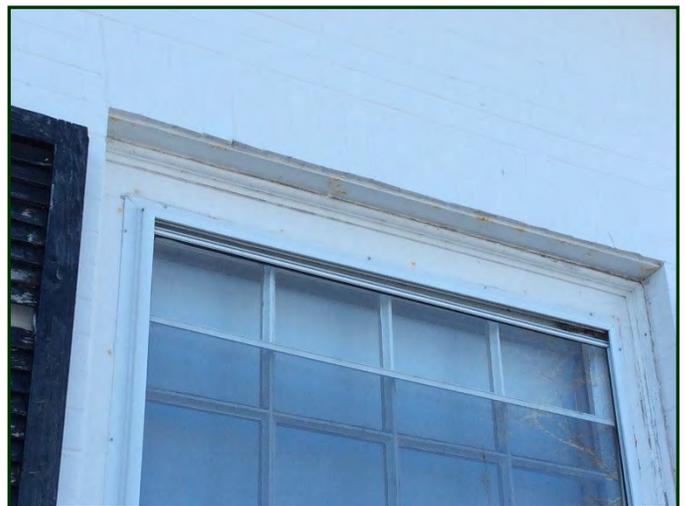
Photo #36: Minor rusting was observed at the addition window heads. This window was located just north of the

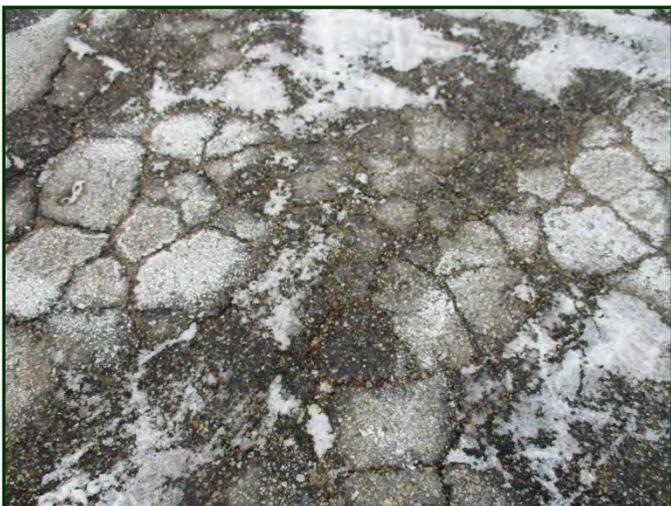
Photo #41: Close-up view of map cracking in asphalt paving (east side of site)

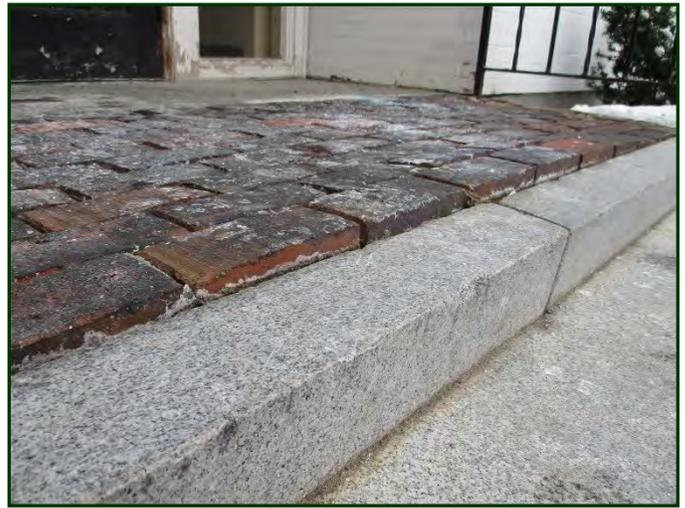
Photo #44: Close-up view of uneven bricks and granite pieces with open brick joints creating a tripping hazard

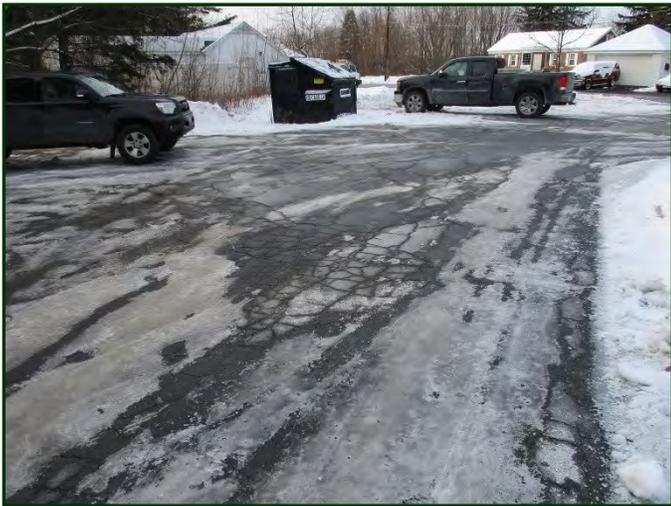
Photo #49: Asphalt-paved parking area at southwest corner of site. Note map cracking in asphalt paving

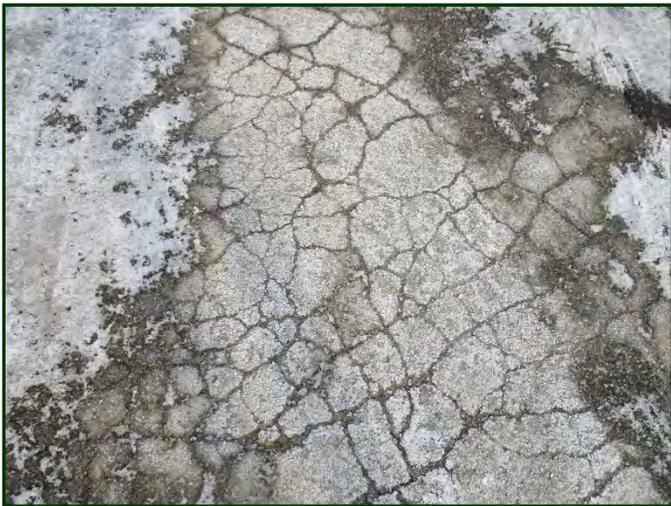
Photo #51: Close-up view of map cracking in asphalt paving

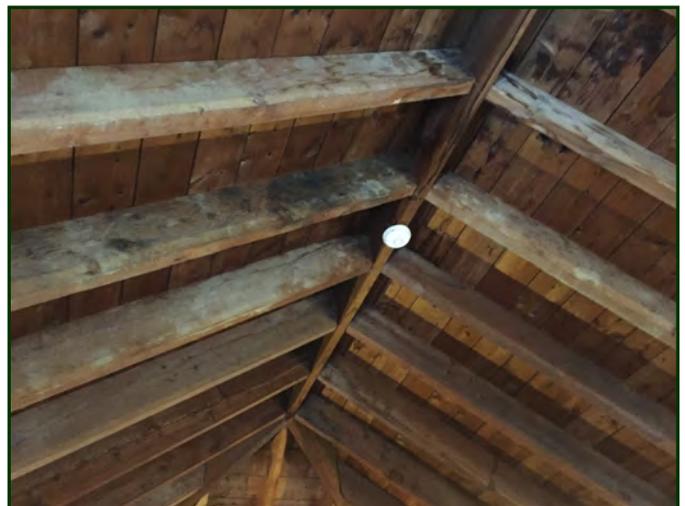
Photo #84: Photograph depicts general view of water staining and suspect growth within the Original Section attic area

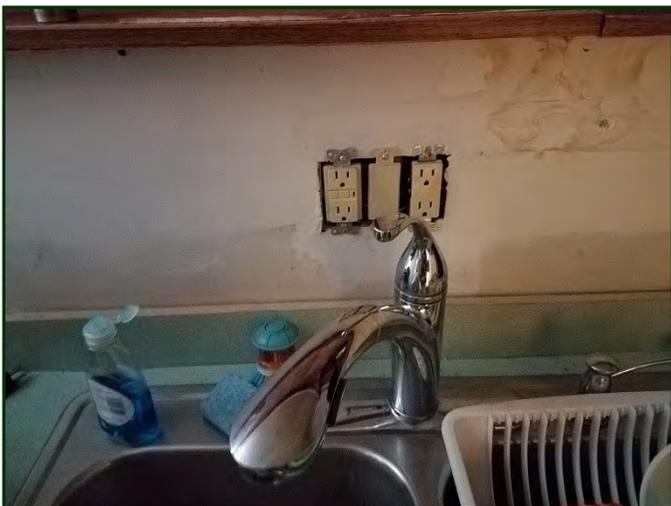
Photo #95: Missing outlet cover near breakroom sink

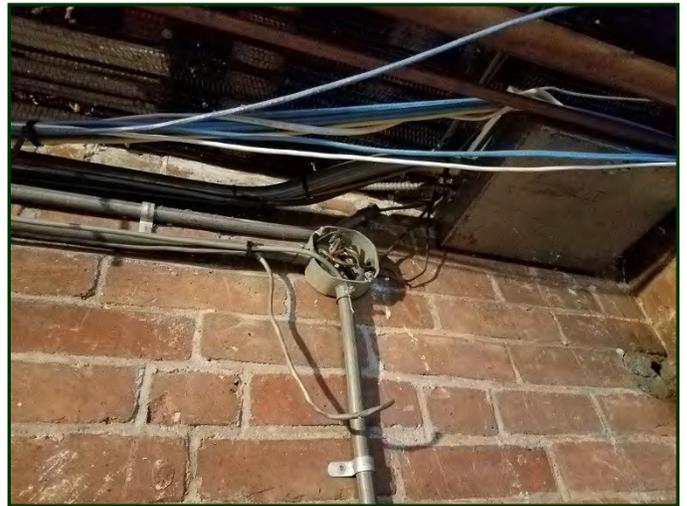
Photo #98: Open junction box in boiler room

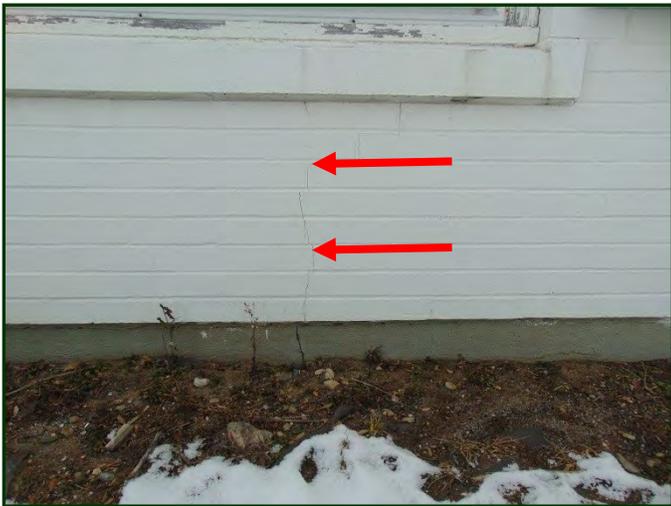
Photo #109: View of a crack in the masonry on the west elevation of the addition.

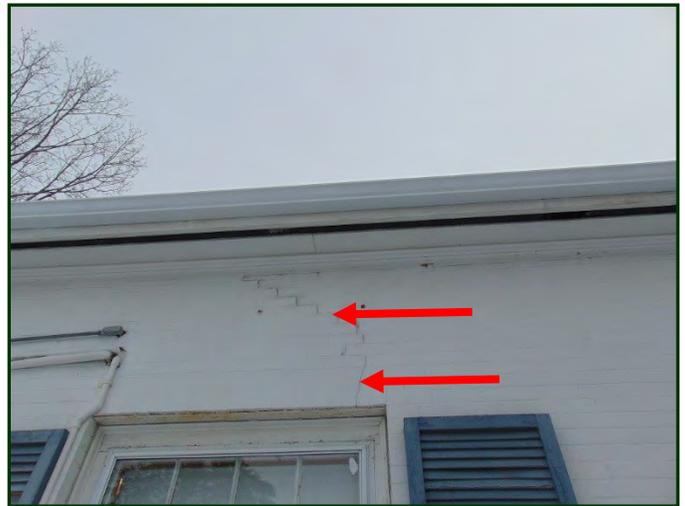
Photo #110: Continuation of the crack in the west elevation of the addition shown in the previous photo.

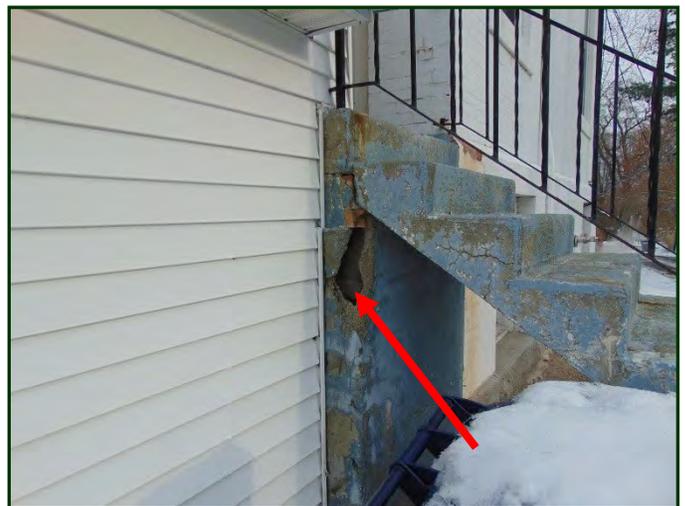
Photo #112: View of the south stairs. Note the cracked CMU block.

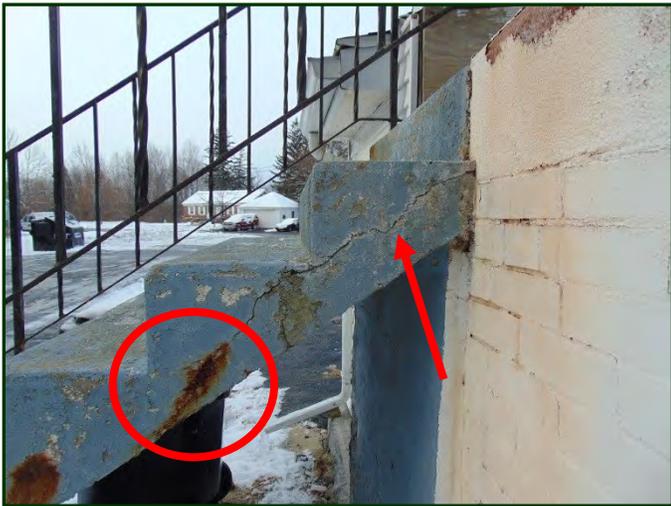
Photo #113: View of a crack and rust staining at the south stairs.
