Bridge Assessment and Ranking

Town of Lunenburg, MA

May 2024

BSC GROUP

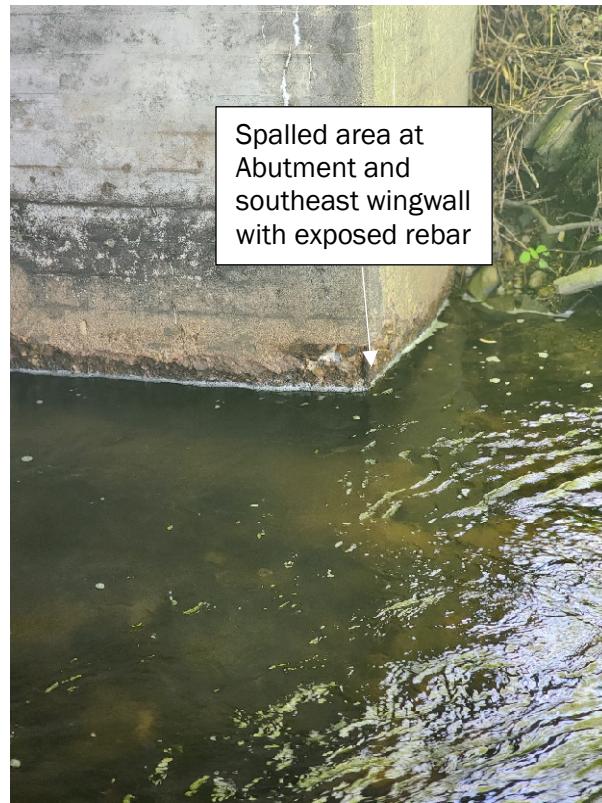
Figure 1-6 L-17-025 Upstream

There is a 30' long x 20" high x 2" deep spall on the South Abutment and Southeast Wingwall at the water line (Figure 1-5). Efflorescence and hairline cracks are present and continue for the full height of the abutment. The structure is undersized for the current volume of water that passes through. According to Streamstats, an online water resources tool maintained by the USGS, the bankfull width at the location of the crossing is 23.2-feet. Debris can be seen both in the upstream and downstream directions, with the upstream debris greatly restricting flow due to large branches and other buildup (Figure 1-6).

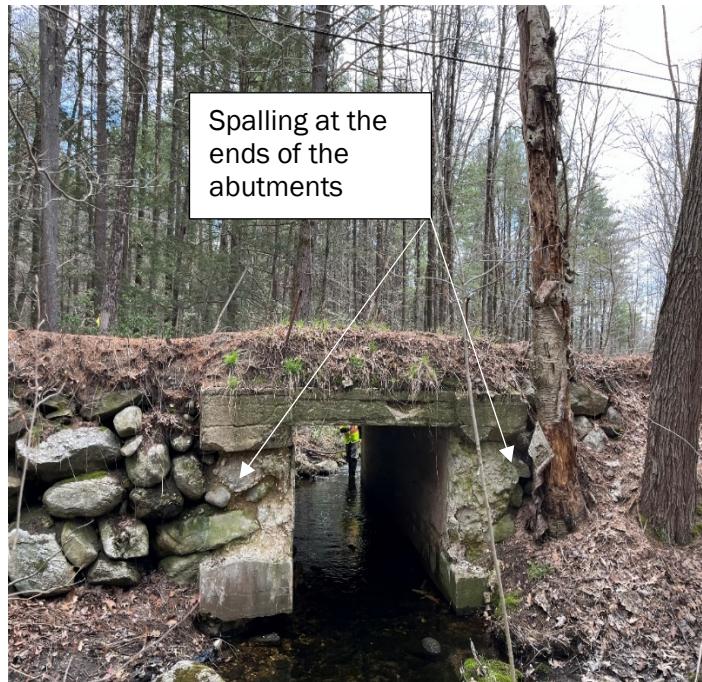
Figure 2-1 L-17-029 West Elevation

There is heavy deterioration of the concrete throughout the structure. The cast-in-place concrete abutments are approximately 3'-0" thick and appear to be unreinforced. The outside edges of each of the abutments are severely spalled at both the East and West elevations, with spalls up to 6'-0" long by 3'-0" wide and up to 10" deep (Figure 2-1). These spalls have exposed some of the larger stones (18" \pm diameter) used as aggregate. Both abutments have undermining for the entire length, up to 24" deep in some locations, exposing boulders which are sitting below the abutment (Figure 2-2). Inside the culvert both abutment walls are deteriorated with spalling and delaminated concrete. At the North abutment there are a series of horizontal and vertical cracks, close to the east elevation, which start beneath the beam seat and extend down to the bottom of the abutment and are up to $\frac{1}{2}$ " wide. There are several full-length horizontal cracks on both the North and South abutments up to 1" wide with moderate amounts of efflorescence (Figure 2-3). In between the encased beams on the South abutment wall there are several areas of honeycombing. The concrete around some of the encased beams has spalled, exposing the bottom flange. The exposed portions of the steel beams exhibit heavy rust and possible section loss (Figure 2-4). The underside of the deck exhibits typical cracking, spalling and honeycombing similar to the abutment walls. The exterior of the deck slab shows various spalls, and multiple full length cracks up to $\frac{1}{2}$ " wide (Figure 2-5). There are presently no guardrails at the crossing, causing safety concerns due to the substantial drop.

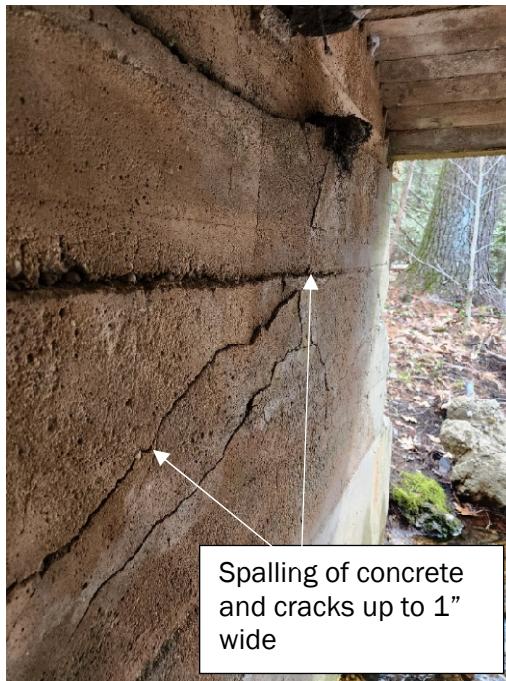
Figure 2-3 L-17-029 North Abutment

The culvert is undersized for the volume of water present, which has led to the significant scour and undermining of the abutments. According to Streamstats, the bankfull width at this location is 12.9-feet.

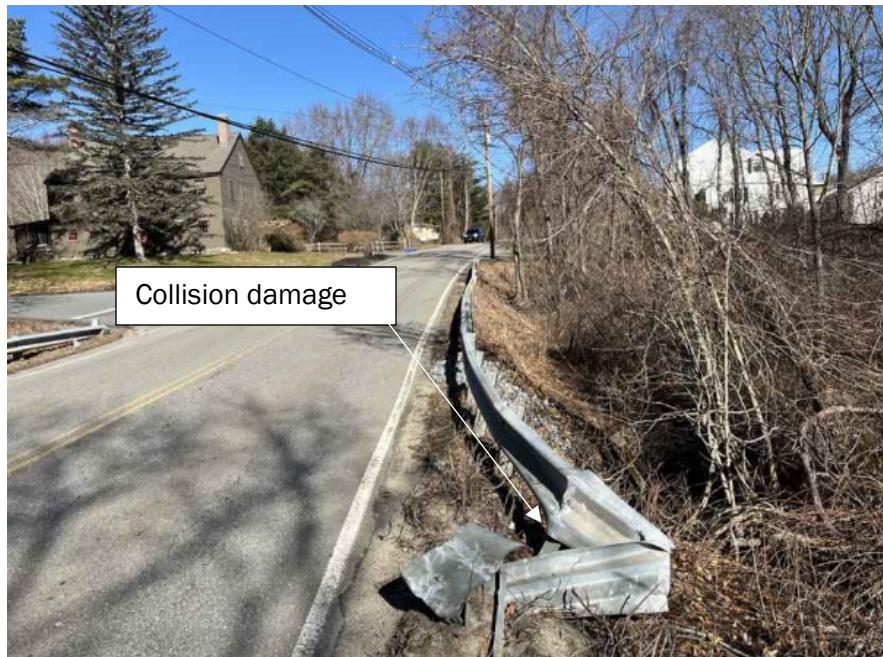
Figure 3-3 L-17-014 East Rail

The wearing surface can be seen to have several cracks. There is a 10' longitudinal crack in the northbound lane and a 9' long transverse crack above pipe #3 (Figure 3-1). The west guardrail has collision damage and two bent posts (Figure 3-2). The east guardrail has moderate collision damage at the north end and is bent towards the slope (Figure 3-3). There is an area of erosion measuring the full slope height x 4' wide x 2' deep, present in the west embankment next to pipe #1 and minor erosion of the east embankment near pipe #3. Stone has been added to prevent further erosion. The headwalls on both the east and west elevations have voids up to 2' x 2' with a penetration depth of 2'. The east headwall has evidence of deformation over pipes #1 and #2 (Figure 3-4). Debris is visible in the upstream direction restricting water flow (Figure 3-5).

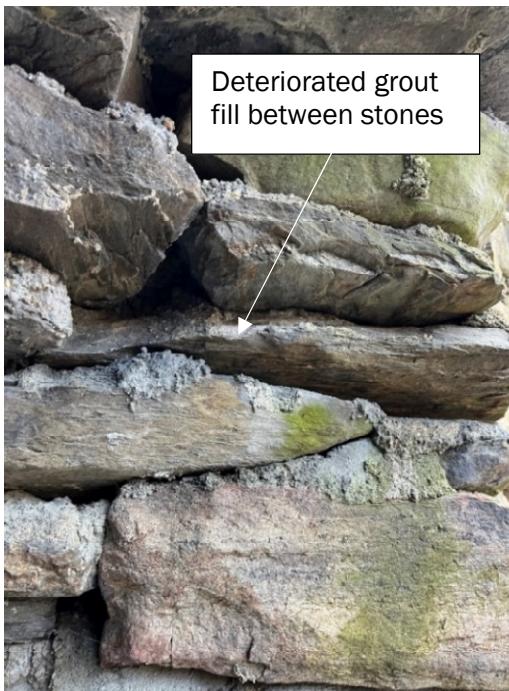
Figure 4-2 L-17-031 South Abutment

The wearing surface over the structure has some minor cracking but otherwise appears to be in good condition. The east elevation wingwalls show several voids up to 12" wide along with loose stones (Figure 4-1). The abutment walls in the stone section of the culvert have additional voids, up to 6" in diameter, due to deteriorated grout between the stones (Figure 4-2). The stone deck beams do not have a consistent shape or width. There are large gaps and deteriorating grout at the location where the stone culvert meets the pipe culvert (Figure 4-3).

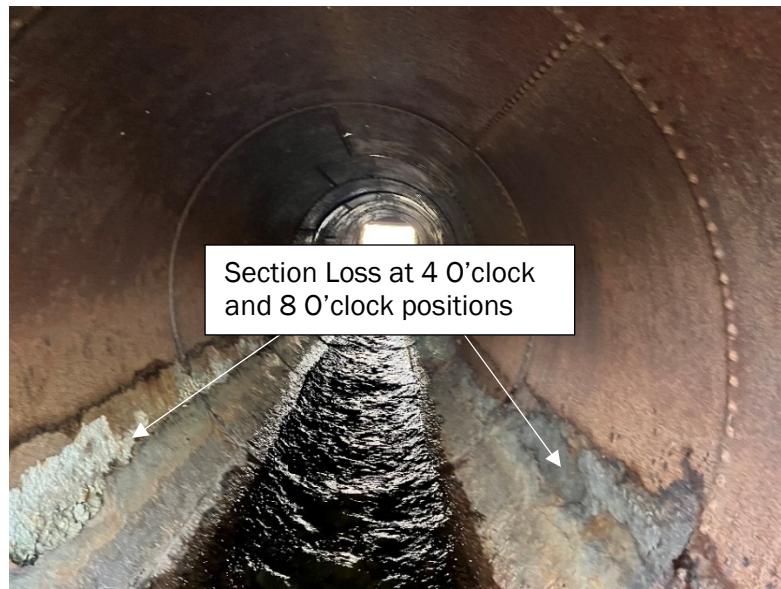
Figure 4-4 L-17-031 Steel Pipe

The west elevation masonry headwall and wingwalls have failing grout and show several voids up to 12" wide between the stones. There is heavy corrosion throughout the pipe and large areas of section loss at the 4 o'clock and 8 o'clock positions for most of the length of the pipe (Figure 4-4). There are several large holes throughout the pipe at other locations which measure up to 10' in length. Holes towards the bottom of the pipe show honeycombed concrete due to water intrusion (Figure 4-5). There are gaps between segments up to 3", causing sections to be misaligned. Several of the rivets have fallen out, leading to further corrosion (Figure 4-5). Streamstats list the bankfull width at this location at 18.3', with a span of 7'-6" this culvert is significantly undersized.

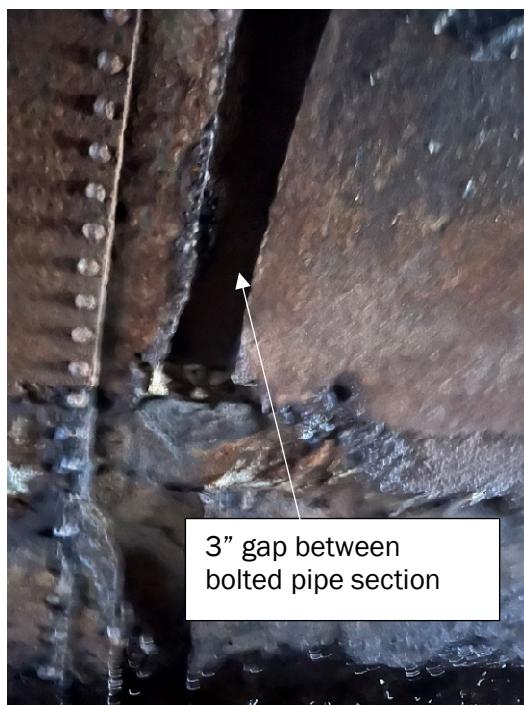
Figure 4-8 L-17-031 Steel pipe section gap

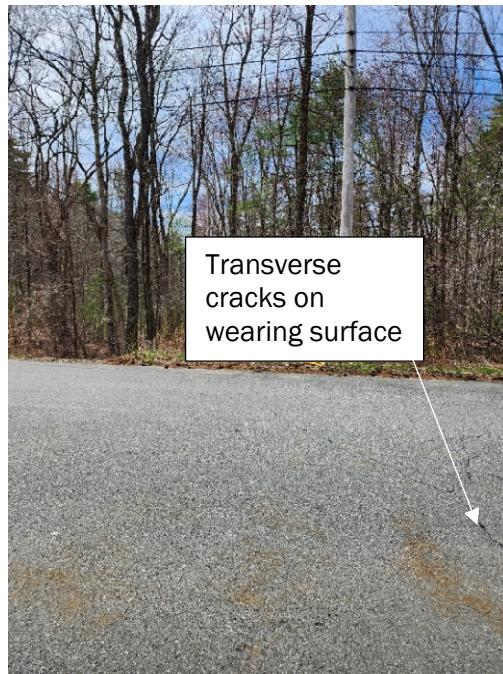
Figure 5-1 L-17-030 Wearing Surface

The culvert has no guardrail present, which can be a danger to vehicular traffic due to poor visibility of the structure and close proximity of the pavement to the edge of the culvert. The wearing surface over the culvert has several transverse cracks along the east approach (Figure 5-1). Close to the north elevation there is a 12" diameter pothole approximately 12" deep which is filled with debris. The hole is located directly above the wingwall and at the edge of the pavement (Figure 5-2).

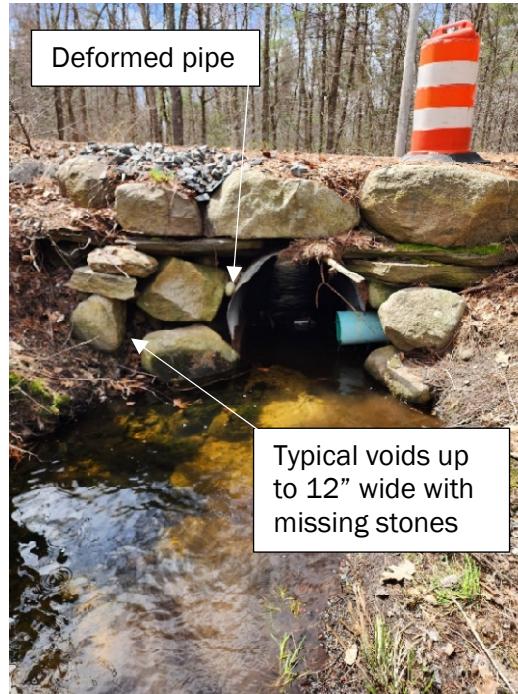
Figure 5-3 L-17-030 North Elevation

Both the south and north elevations have headwalls with missing stones and large voids up to 8" wide. The large gaps and encroaching vegetation are causing debris to accumulate between the stones (Figure 5-3 & 5-4). The pipe south elevation can be seen with full section loss towards the waterline (Figures 5-5). The wingwalls have similar issues, with several loose stones as well. The pipes have heavy rust towards the bottom, with the north and south elevations both experiencing areas of section loss up to 5' long. The pipe at the north elevation has moderate deformation and has a large amount of debris, restricting flow downstream (Figure 5-5). Streamstats list the bankfull width at this location at 12.2' making the current 4'-0" diameter pipe significantly undersized for this crossing.

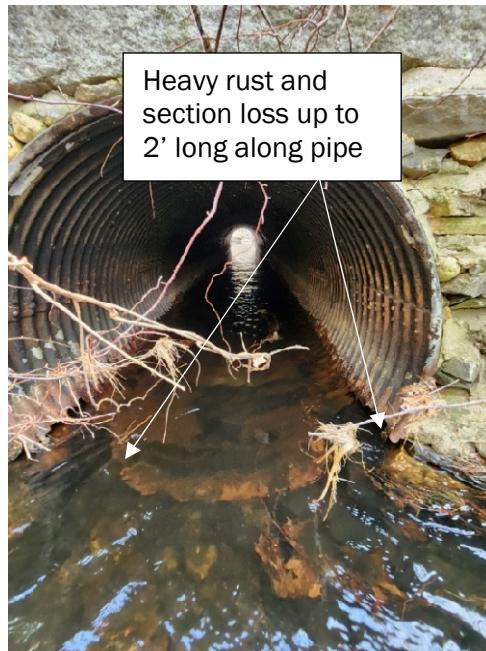
Figure 6-3 L-17-001 North Elevation Pipe 1

There are no guardrails on either side of the road over the structure, which can pose a major hazard to oncoming vehicles (Figure 6-1). The steel pipes both have section loss up to 2' long and 3' wide below the water line (Figure 6-2). Heavy rust is present along the full length of the pipes below the water line and smaller areas of rust appear throughout the pipes (Figure 6-3). The pipes at the north elevation have debris and vegetation severely restricting flow downstream (Figure 6-4). The current will cause further blocking of the water flow by pushing small branches and leaves downstream.

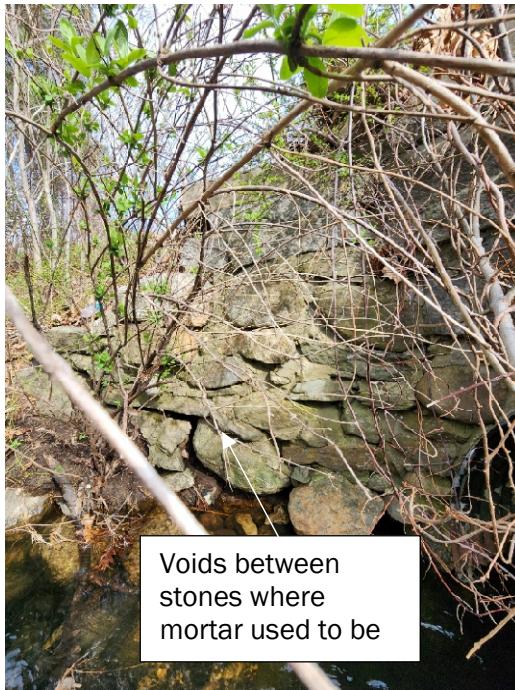
Figure 6-5 L-17-001 Northeast Wingwall

Originally the structure had been fully mortared, but weathering has deteriorated much of the mortar. The headwall on the north elevation has multiple voids up to 6" long x 2" high (Figure 6-5). Several of the longer stones on the headwall show vertical cracks up to 1" wide. The wingwalls on the north elevation also show large voids between the stones where the mortar has eroded, and many stones are loose due to the lack of bonding material (Figure 6-6). Similar deficiencies with the mortar and stones are repeated on the South elevation. Streamstats list the bankfull width at this location at 21', with the span being 10'-11", this culvert is significantly undersized.

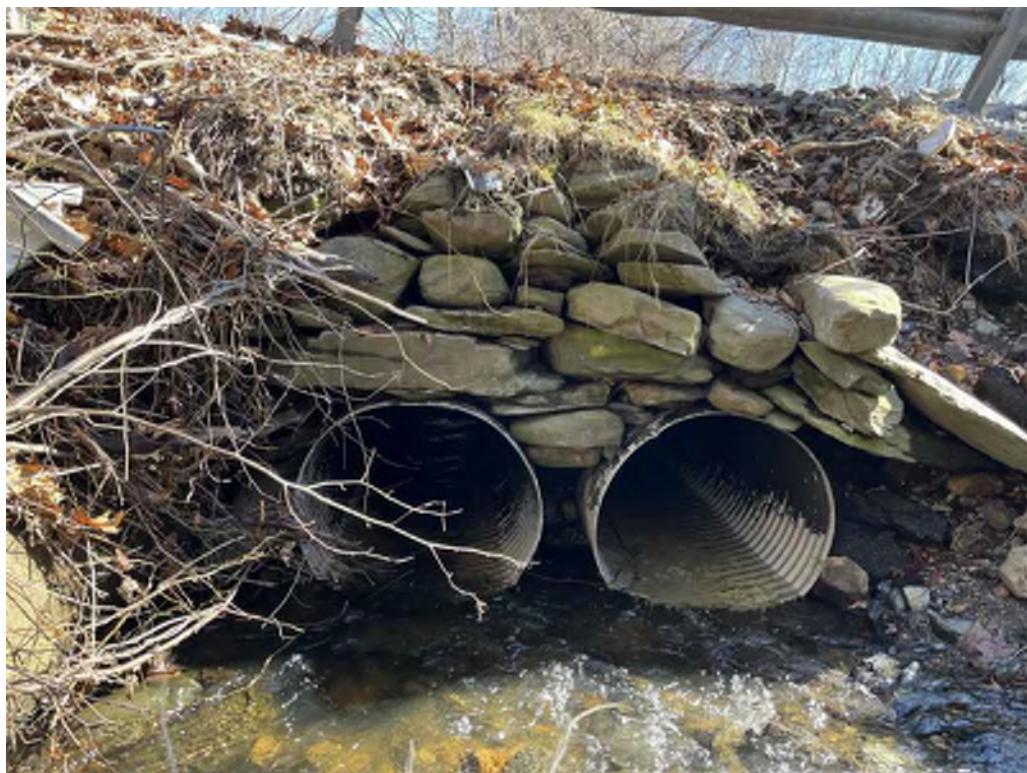
Photo 1: West elevation displaying masonry headwall and barrels #1 and #2.
