**Brooks House**

1033 Massachusetts Avenue  
Lunenburg, MA 01462

## Property Condition Assessment

**February 6, 2018**

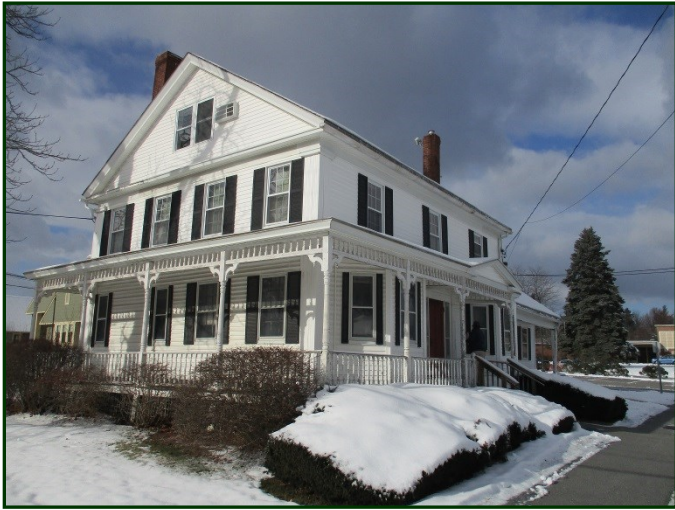
**Photo #1:** Overview from southeast corner of building

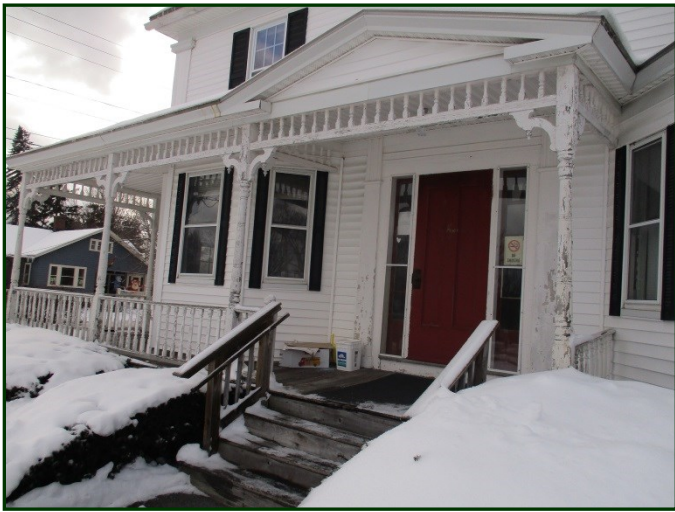
**Photo #7:** Main front entrance at east elevation

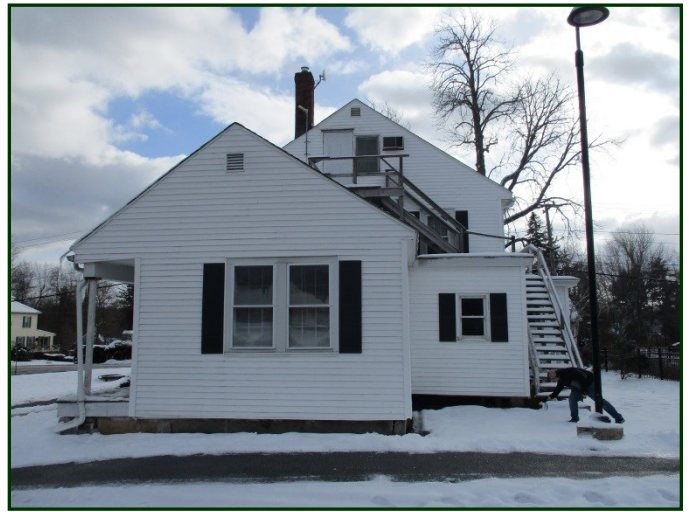
**Photo #8:** North elevation

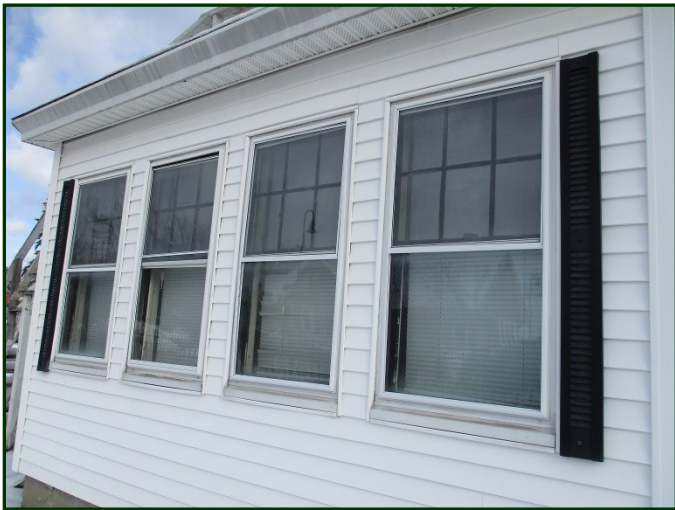
**Photo #9:** Vinyl clapboard siding and double hung wood windows

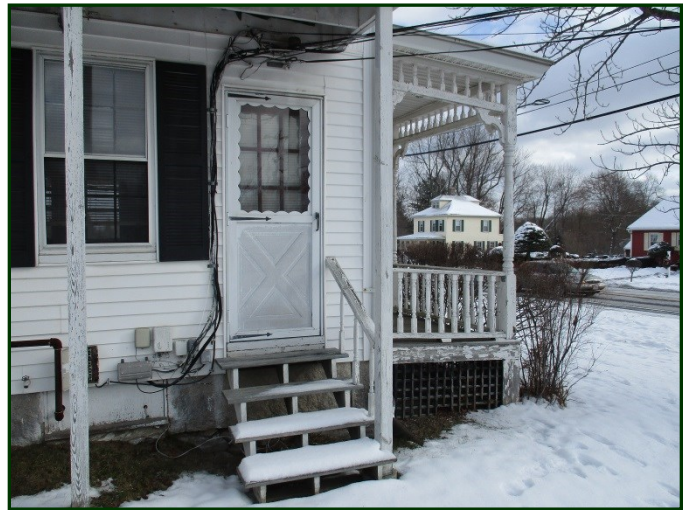
**Photo #10:** Secondary entrance at southwest corner of building

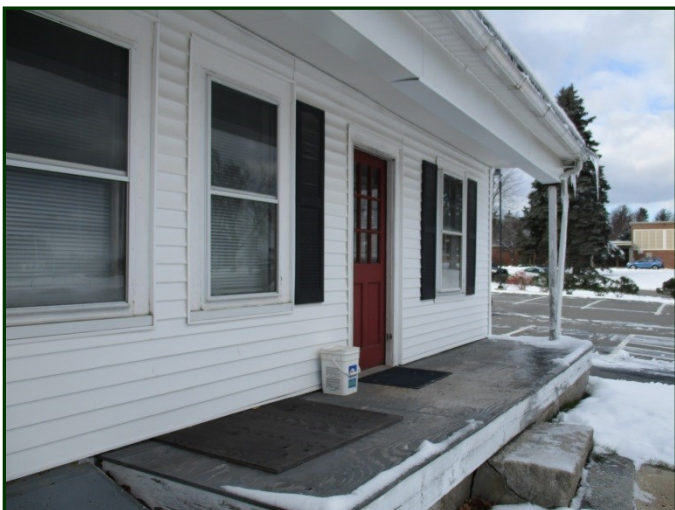
**Photo #11:** Secondary entrance at northeast corner of building

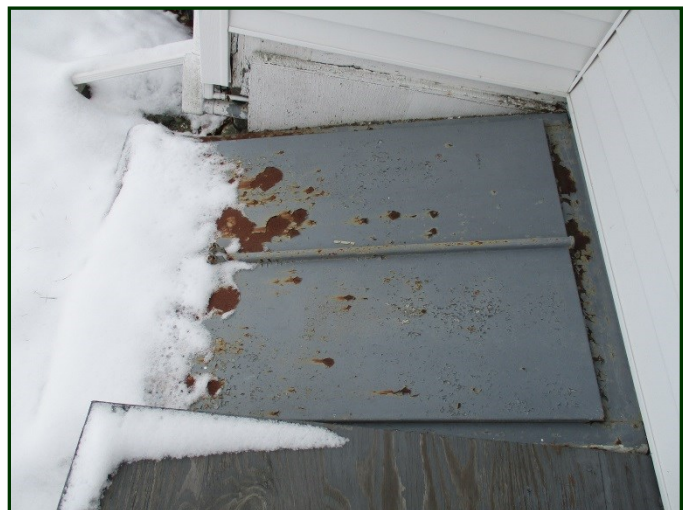
**Photo #12:** Painted steel bulkhead at east elevation

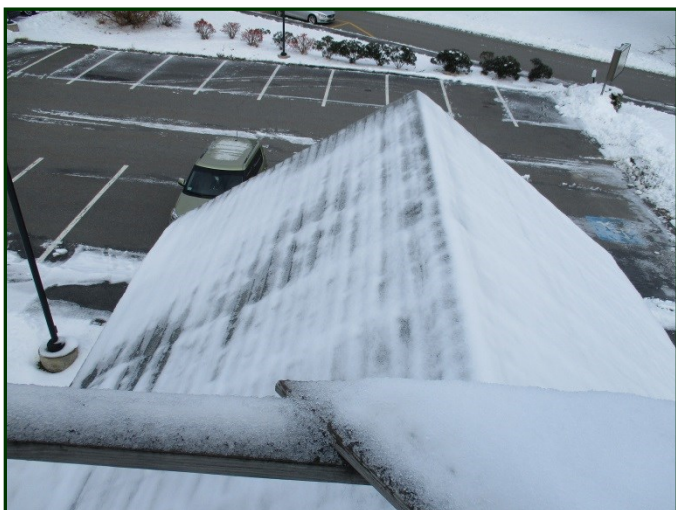
**Photo #13:** Asphalt composition roofing shingles. Note asphalt-paved parking lot beyond (north side of site)

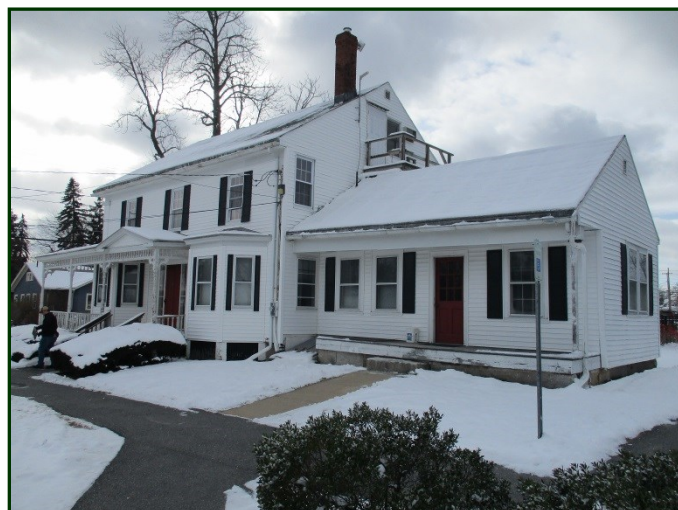
**Photo #14:** View from northeast corner of building

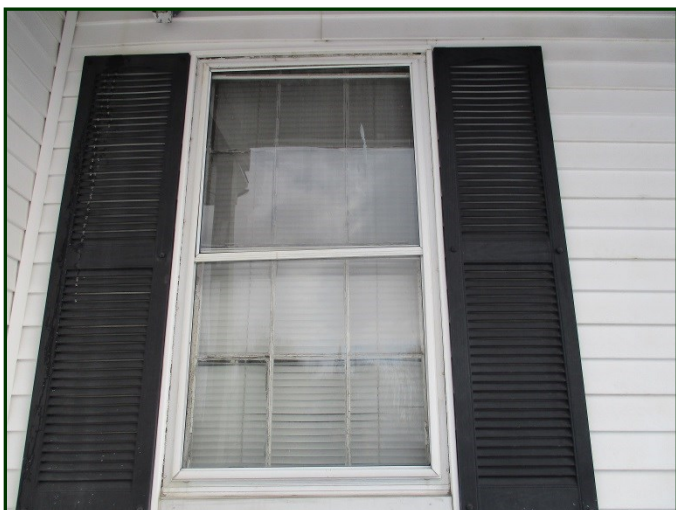
**Photo #15:** Original (circa 1935) double hung wood windows with non-insulated glazing on the first floor level

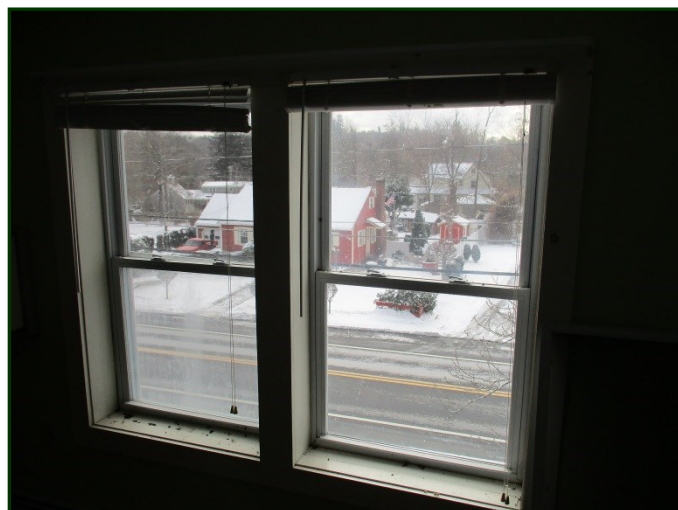
**Photo #16:** Newer (circa 1998) double hung vinyl windows with insulated glazing at upper floor level

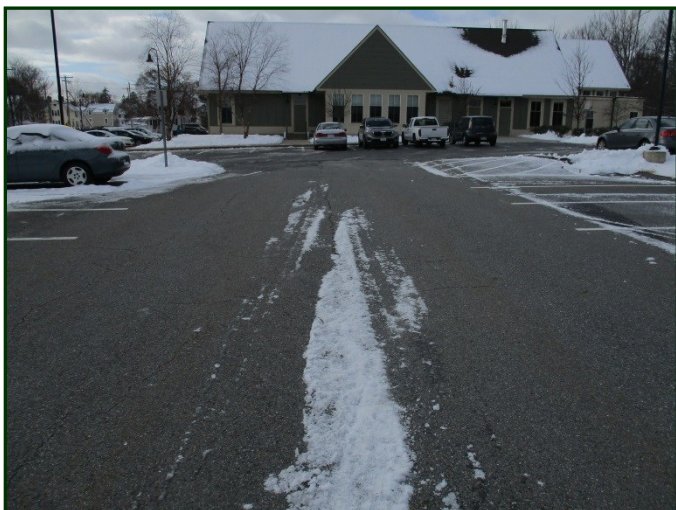
**Photo #17:** Asphalt-paved parking lot on north side of site

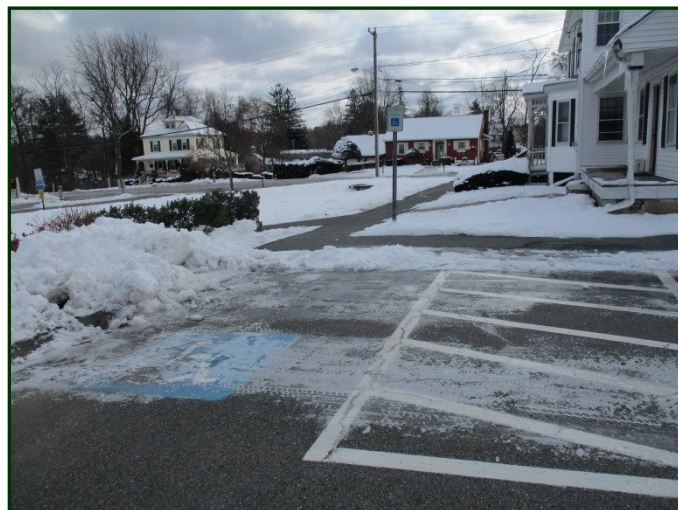
**Photo #18:** Accessible parking space adjacent to building entrance

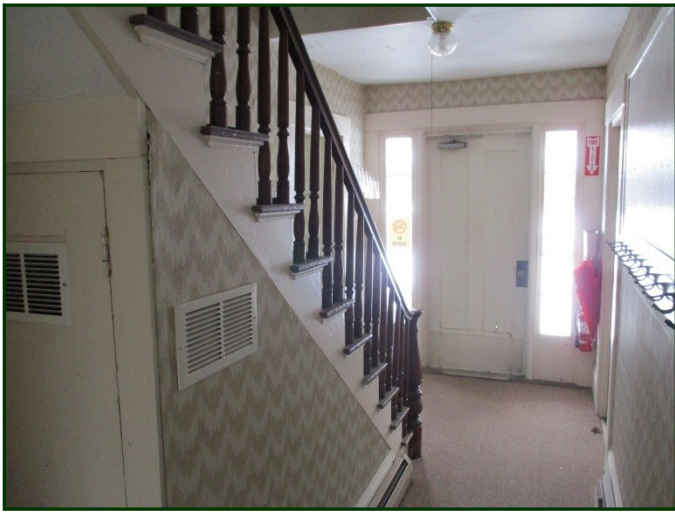
**Photo #19:** Main front entrance. Note carpet floor, wall covering and painted plaster ceiling and wood trim

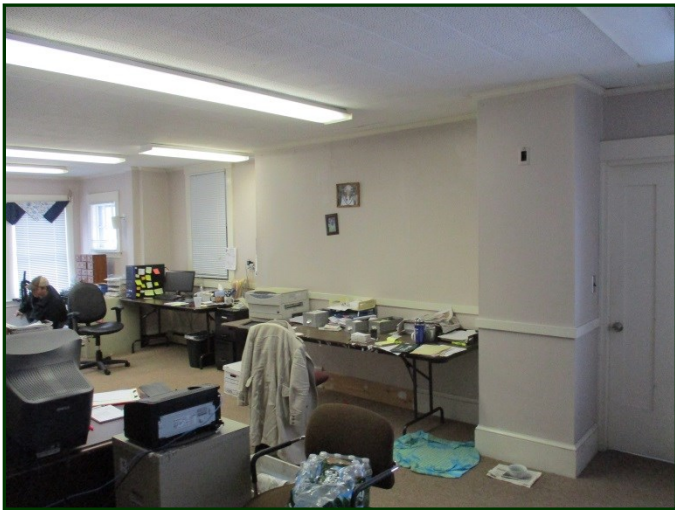
**Photo #21:** Office space with carpet flooring and surface-mounted fluorescent lighting fixtures

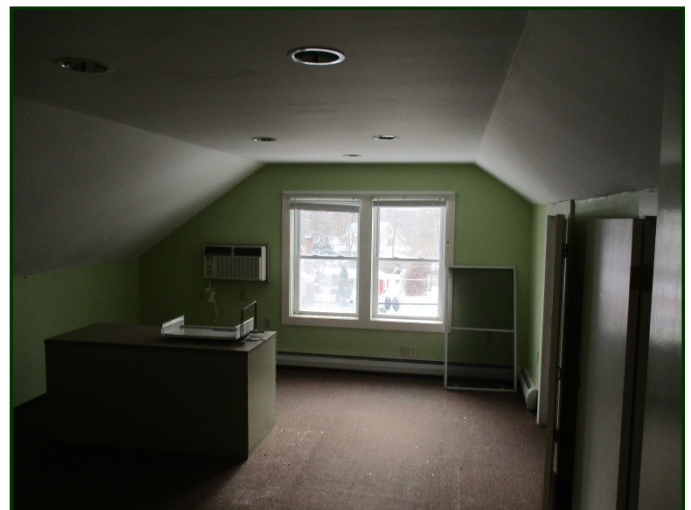
**Photo #24:** Finished attic level with carpet floor and painted gypsum board ceiling and walls

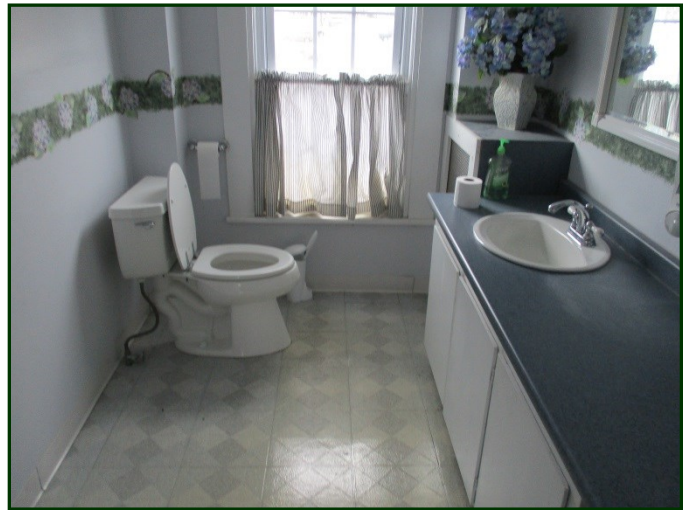
**Photo #26:** Second floor level bathroom

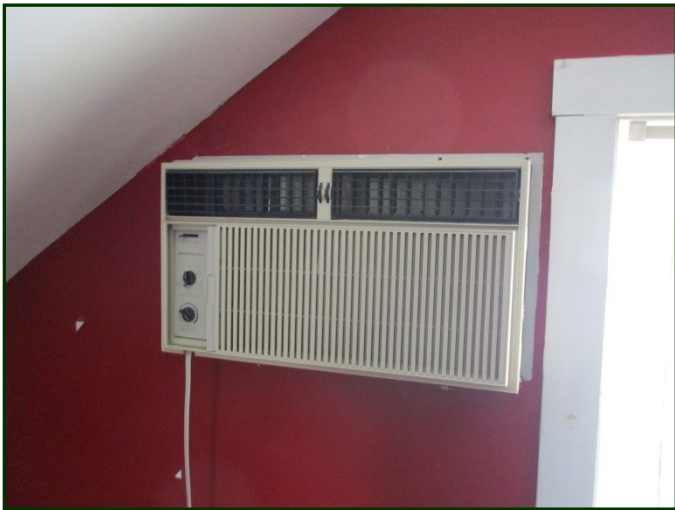
**Photo #27:** Through-wall air conditioning unit

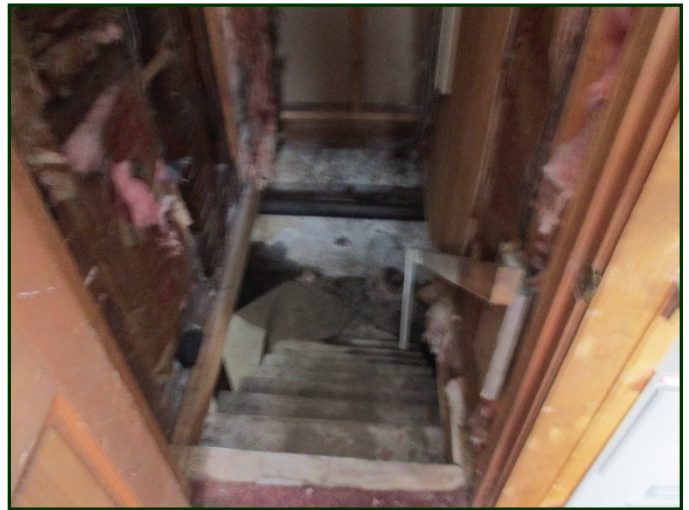
**Photo #28:** Stairway from first floor to basement

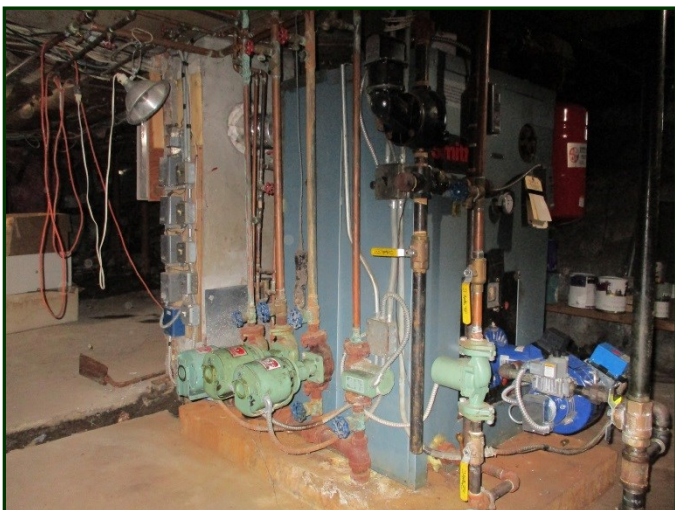
**Photo #29:** Gas-fired boiler in basement level

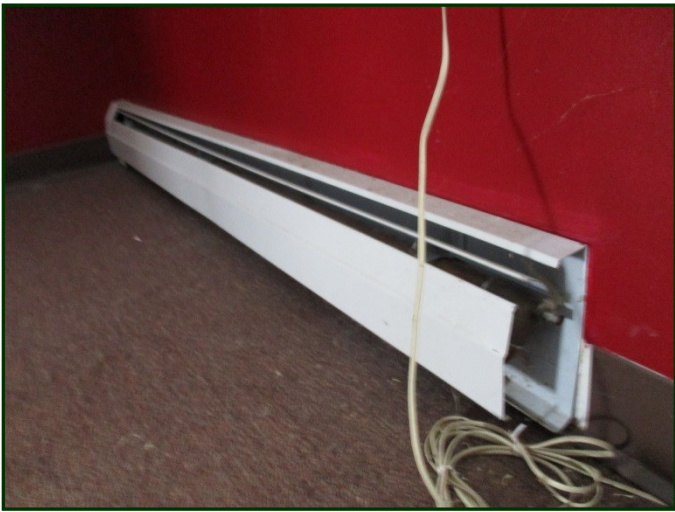
**Photo #32:** Fin tube baseboard radiator at attic level

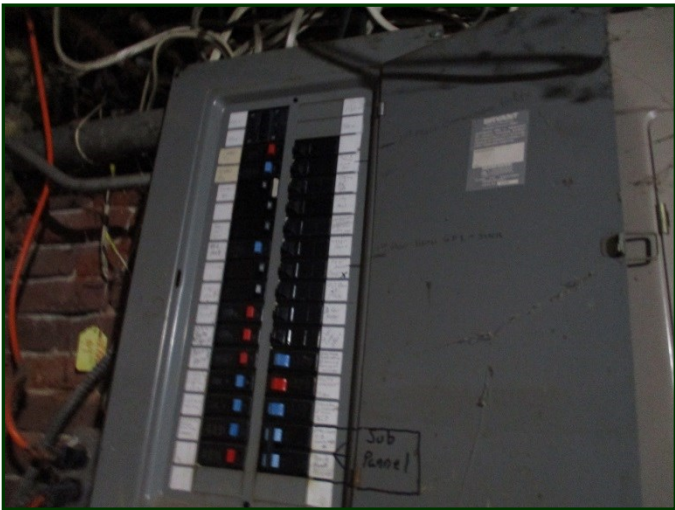
**Photo #34:** Main electrical service panel with circuit breakers in basement level

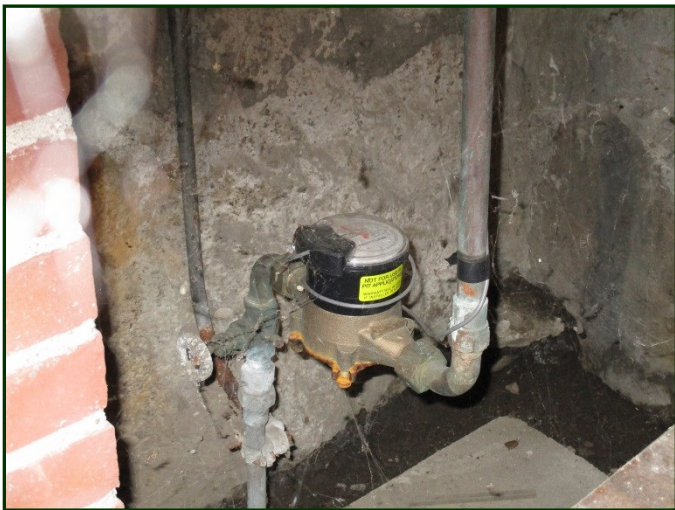
**Photo #35:** Domestic water service and meter in southwest corner of basement

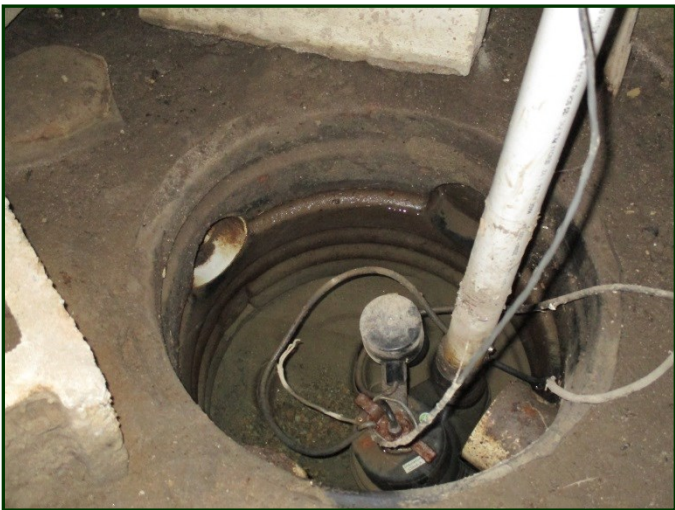
**Photo #36:** Sump pit with pump in southeast corner of basement

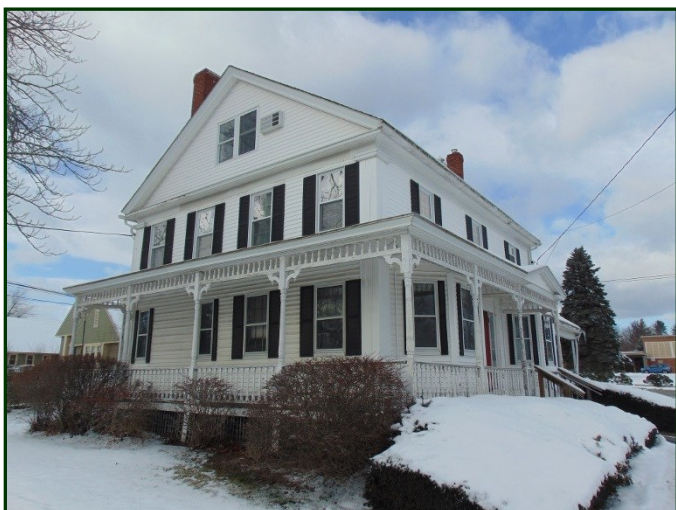
**Photo #37:** South (front) elevation of Brooks House. Note wrap-around porch.

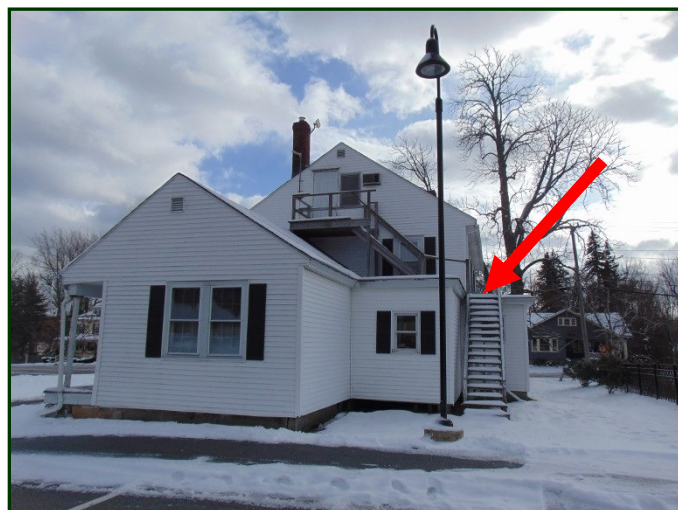
**Photo #40:** North (rear) elevation of Brooks House. Note 2nd floor fire escape.

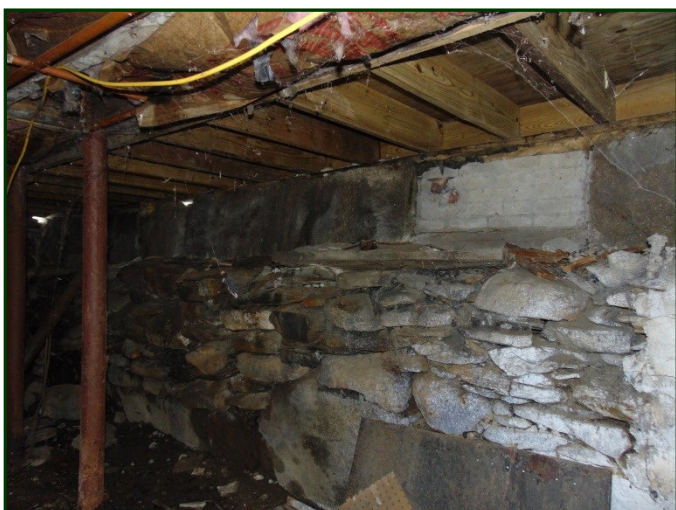
**Photo #41:** Stone foundation exposed in the basement.

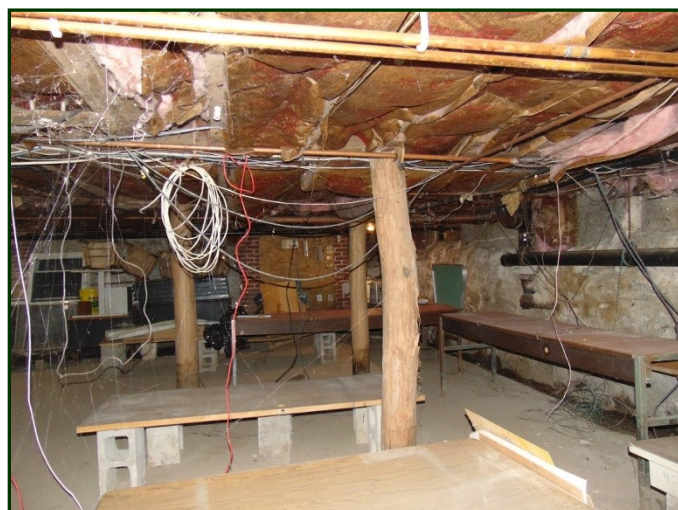
**Photo #42:** Typical round wood post supporting ground floor.

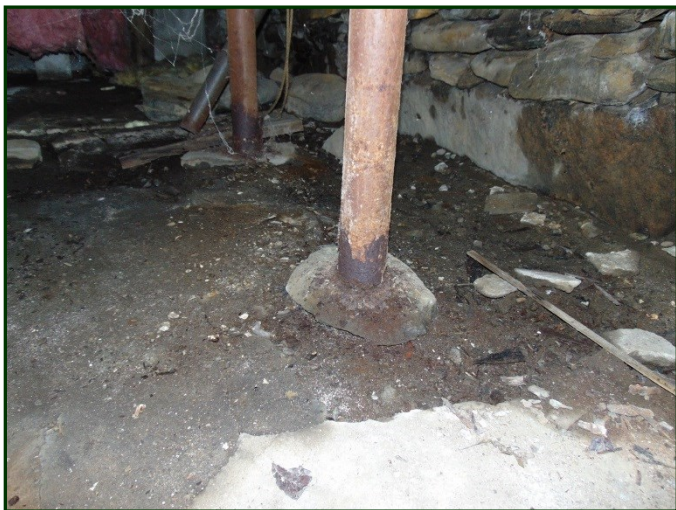
**Photo #43:** Steel posts supporting the north one-story wing of the Brooks House.

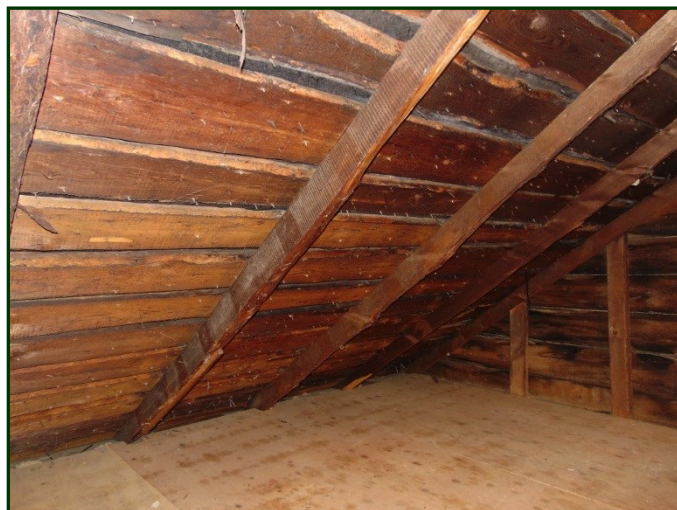
**Photo #48:** View of typical roof framing.

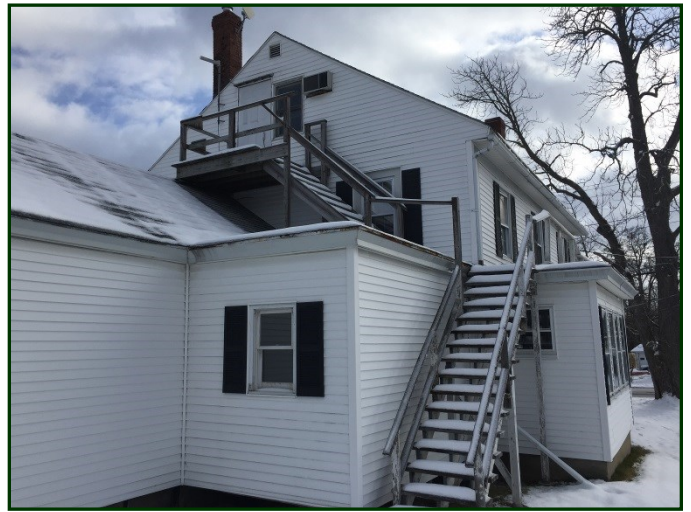
**Photo #50:** Photograph depicts general view of the backside of the Site Building

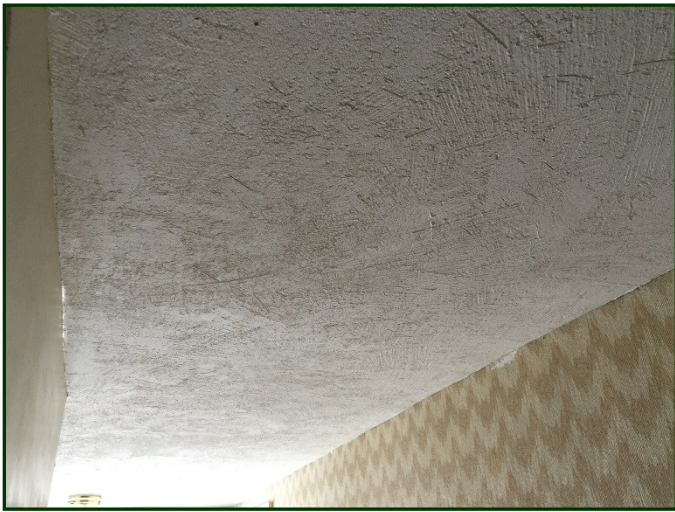
**Photo #55:** Photograph depicts general view of the Textured Ceiling with the 2nd Floor Hallway

At the time of the assessment, the suspect ACMs identified were observed to be in fair condition. Please refer to Attachment A which includes photographic documentation of the suspect ACMs identified during the assessment.

Prior to any renovation or demolition activities, sampling of suspect ACMs that may be disturbed would need to be conducted in applicable areas to determine asbestos content. A comprehensive ACM survey is required to be conducted to comply with the Environmental Protection Agency (EPA) National Emission Standard for Hazardous Air Pollutants (NESHAPs) 40 CFR Part 61. Until these materials have been sampled and determined to be non-asbestos containing, these materials should be managed in place as presumed asbestos-containing materials (PACMs).

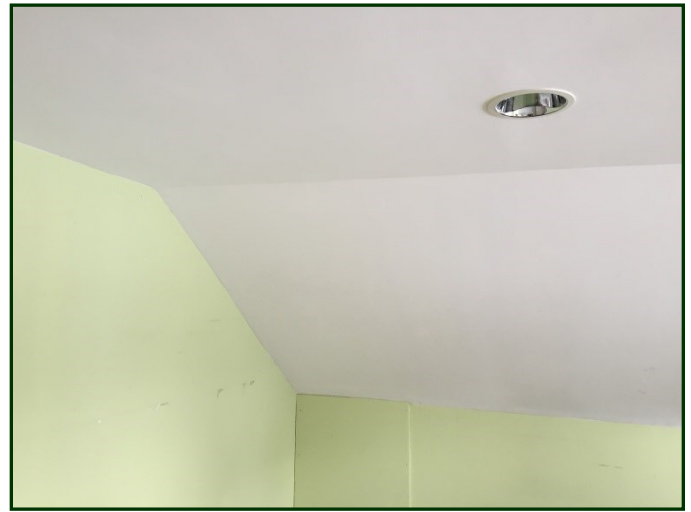
**Photo #56:** Photograph depicts general view of the Wall-board Walls and Ceiling within the 3rd Floor

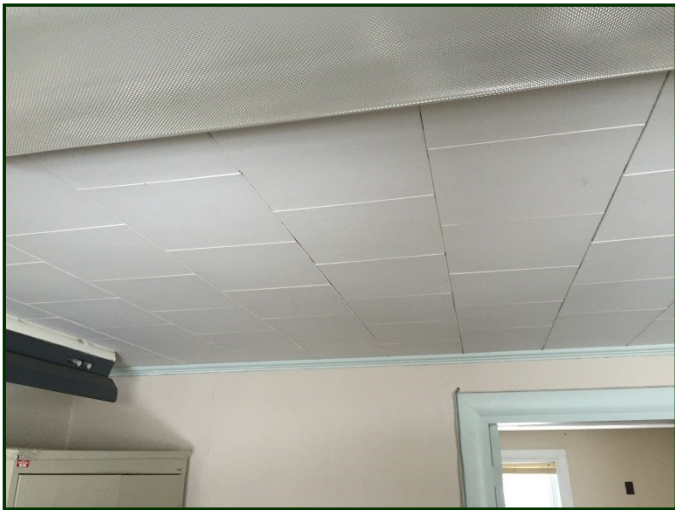
**Photo #57:** Photograph depicts general view of the 1'x 1' Ceiling Tile within the 2nd Floor Office Area

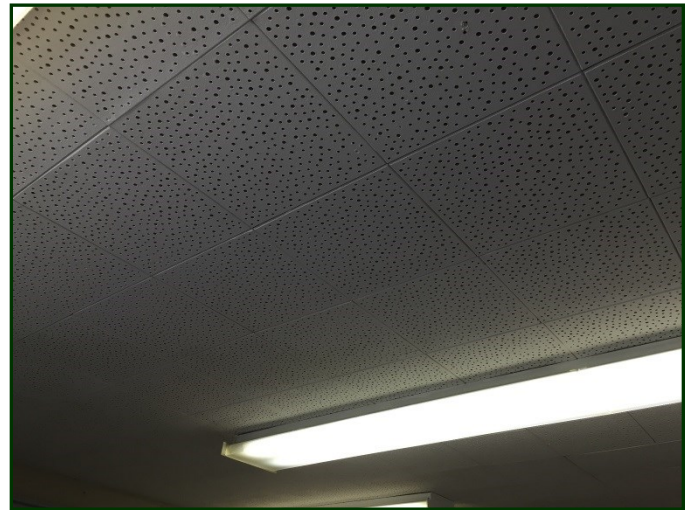
**Photo #58:** Photograph depicts general view of the 1'x 1' Ceiling Tile within the 1st Floor Office Area

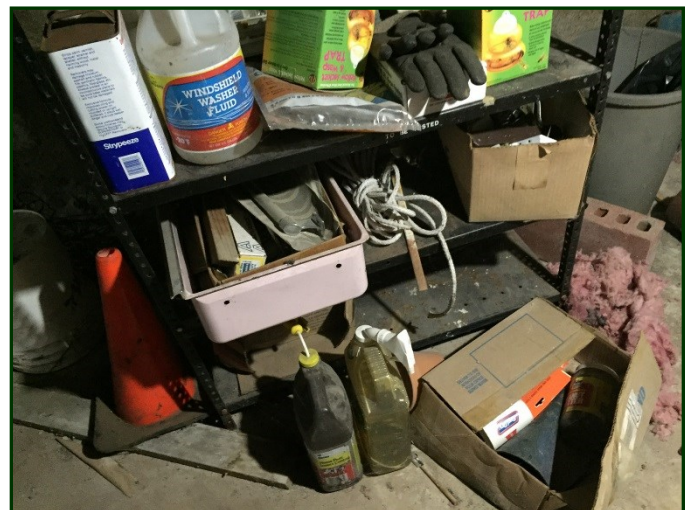
**Photo #60:** Photograph depicts general view of Chemical Storage within Basement Area
