TOWN OF LUNENBURG BUILDING ASSESSMENT & SPACE NEEDS STUDY

PASSIOS SCHOOL
TOWN HALL
OLD PRIMARY SCHOOL
RITTER MEMORIAL BUILDING

JANUARY 11, 2016

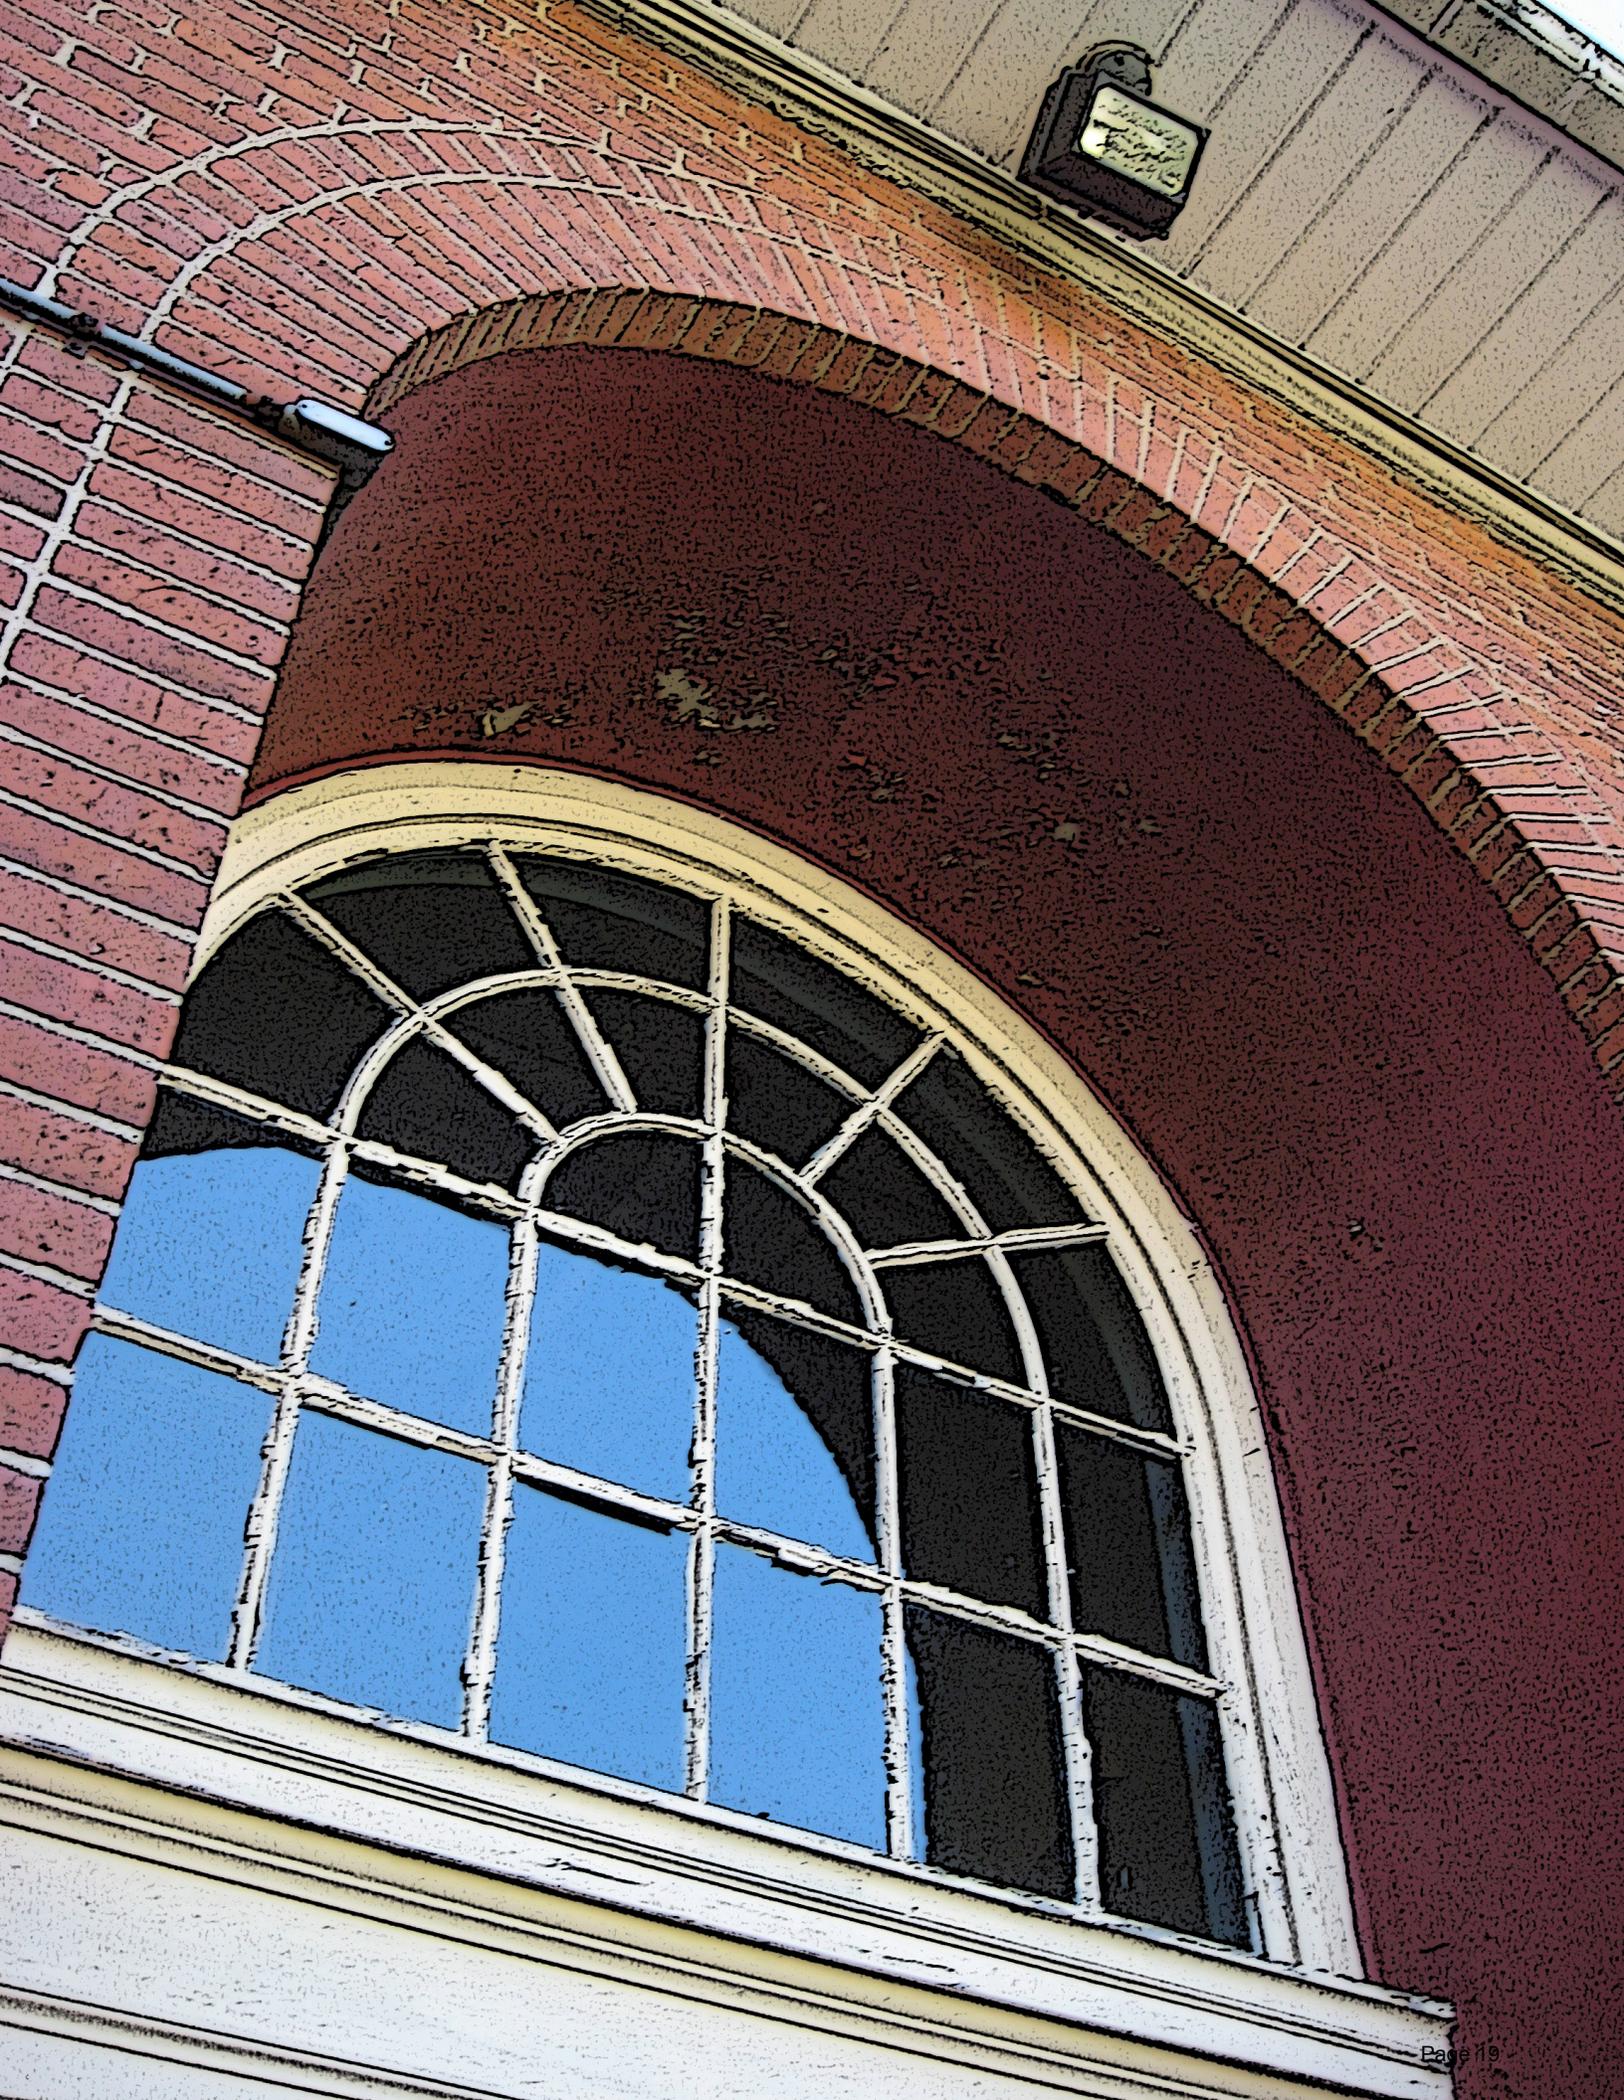
UPPER LEVEL

EXISTING CONDITIONS - OLD PRIMARY SCHOOL

The building has not been in active use for ten years and this condition has led to a general deterioration of the building. The structure is a combination of masonry exterior and bearing walls, concrete slabs and steel roof trusses. The exterior envelope is in need of repairs including lintel replacement, window and roof replacement and masonry restoration in various locations. Removal of interior walls would need to be carefully analyzed relative to structural integrity of the building.

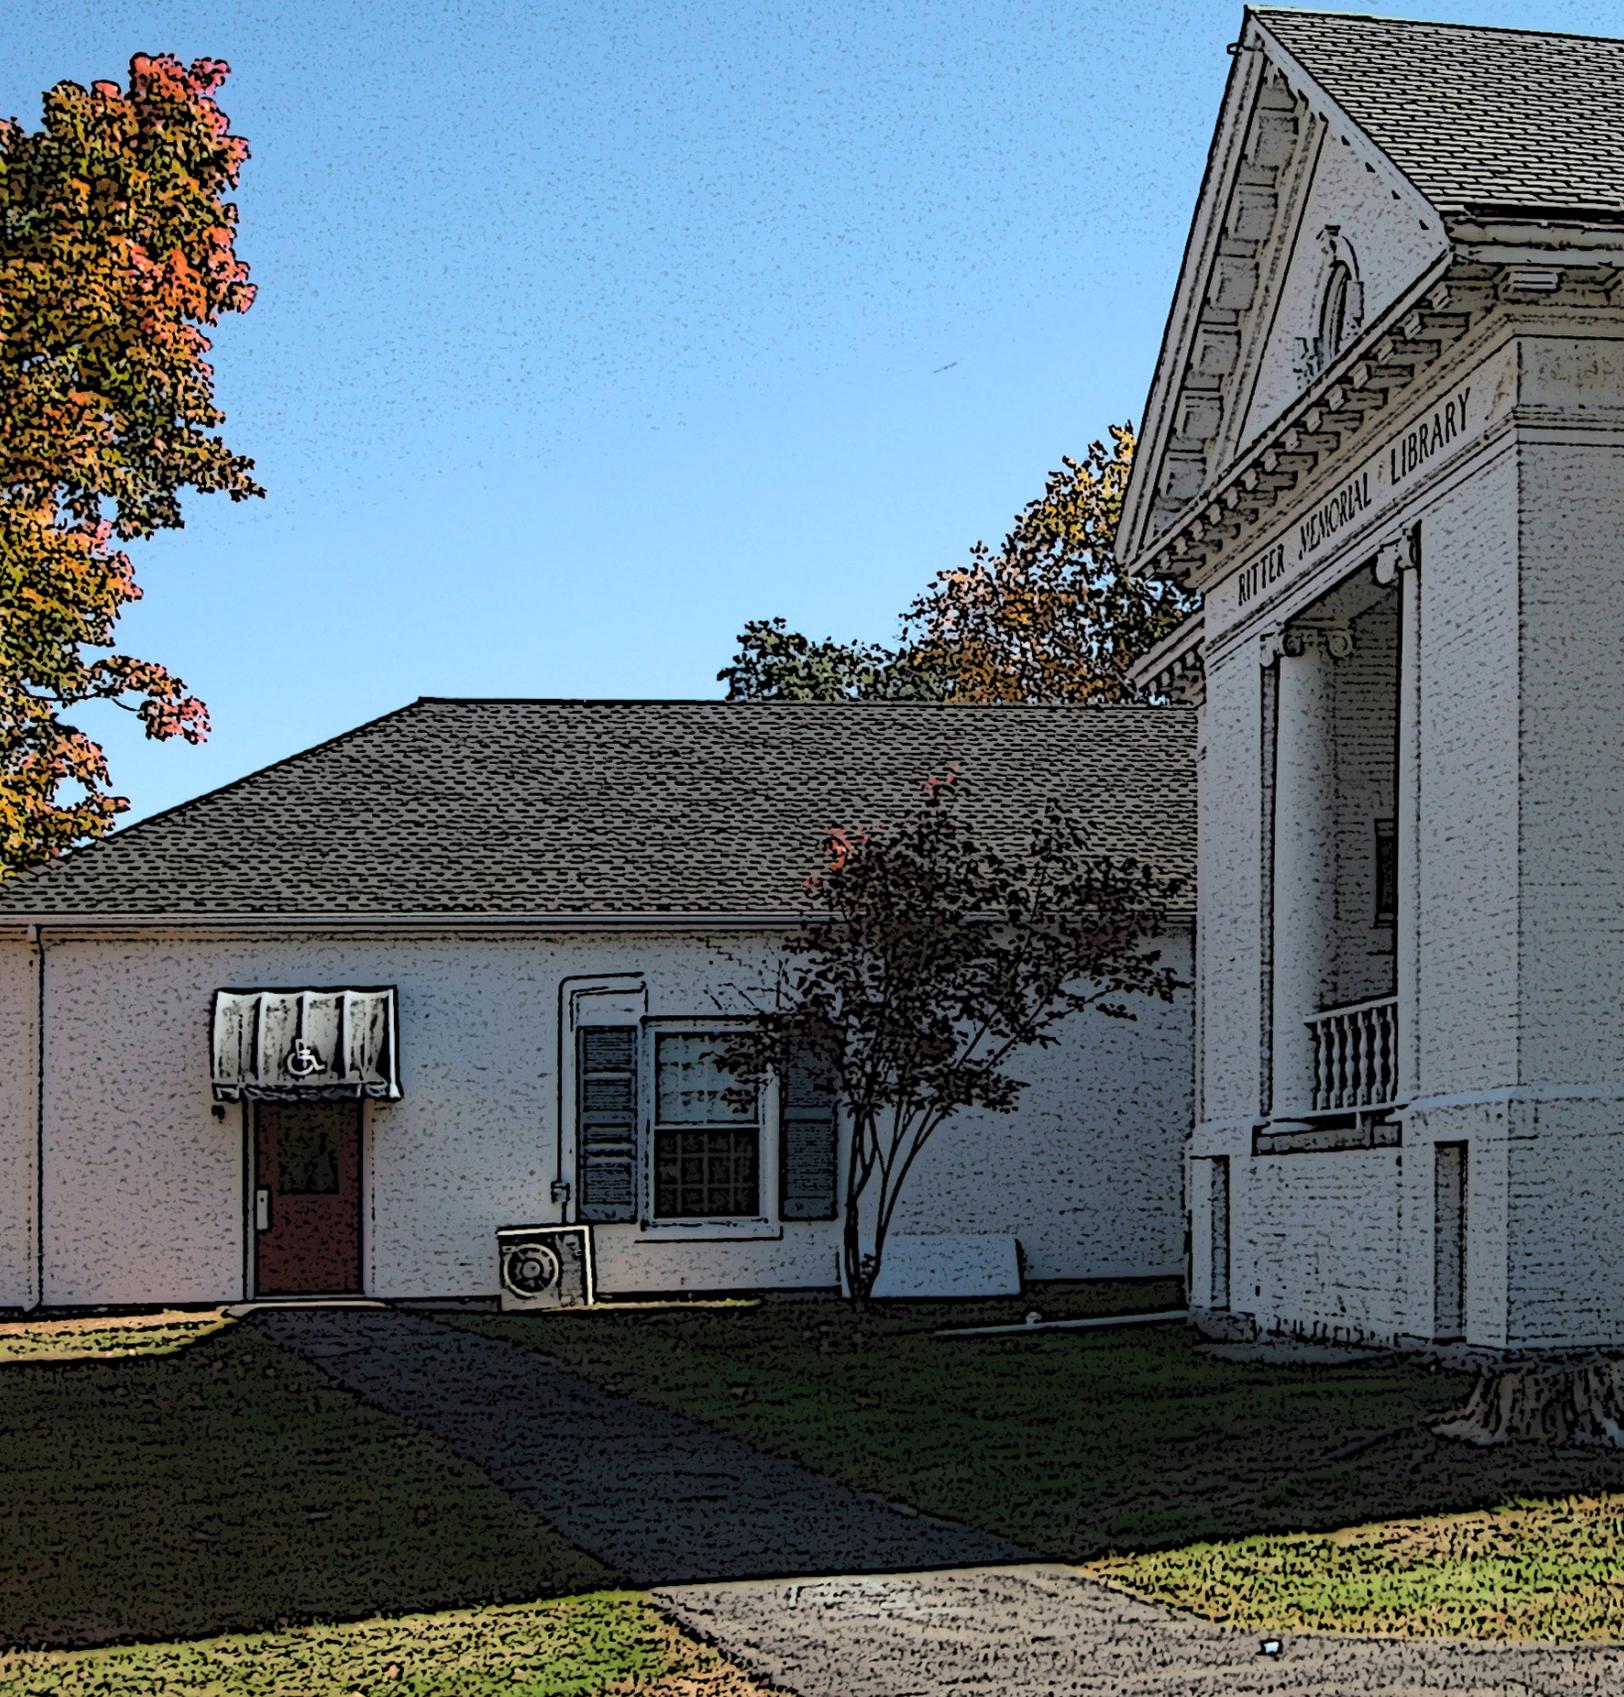
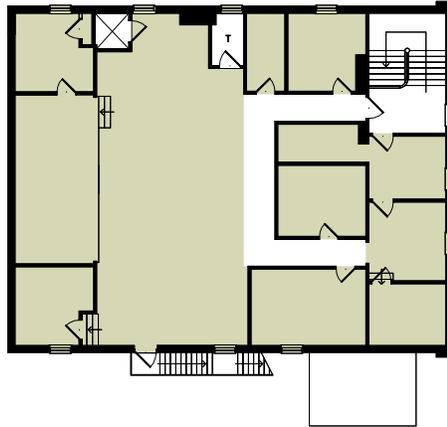
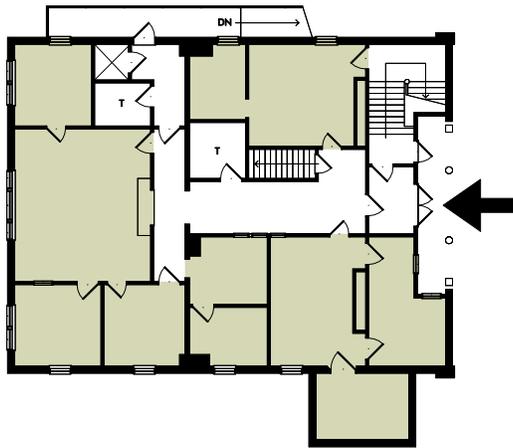
EXISTING CONDITIONS - RITTER BUILDING

UPPER LEVEL

LOWER LEVEL

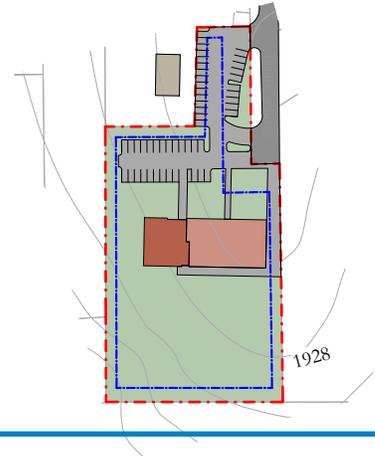
Comprehensive renovation of Primary School
with addition to accommodate new entrance and
required program

18,000 Overall GSF
12,300 SF Renovation
7,700 SF New Construction

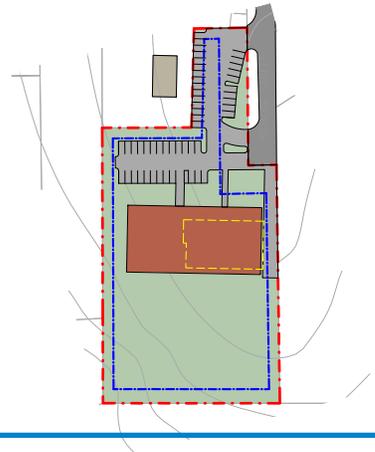
OPTION 1A

PRIMARY SCHOOL SITE NEW CONSTRUCTION

Demolish existing Primary School
Construct new Town Offices building

18,000 Overall GSF New Construction
One floor

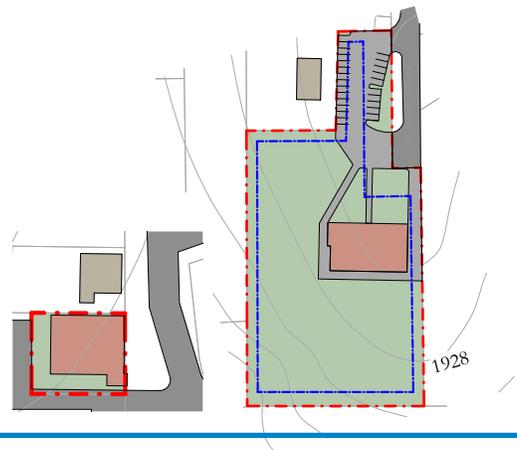
OPTION 1B

PRIMARY SCHOOL & TOWN HALL RENOVATION

Renovate existing Primary School
Renovate existing Town Hall

12,300 SF Renovations - Primary School
6,500 SF Renovations - Town Hall
18,800 SF Renovations - Total in two facilities to
accommodate required program

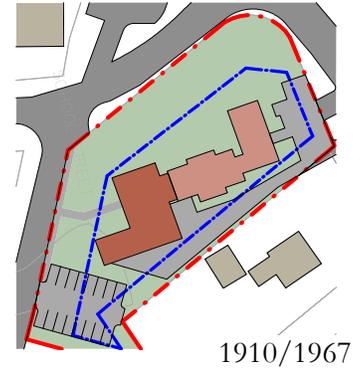
OPTION 2

RITTER BUILDING & TOWN HALL RENOVATION & ADDITION

Comprehensive renovation of Town Hall and renovation of Ritter Building with Addition

12,700 SF - Ritter Building
(5,700 SF renovation / 7,000 SF new construction)
6,500 SF - Renovations to Town Hall
19,200 SF - Total in two facilities to accommodate program

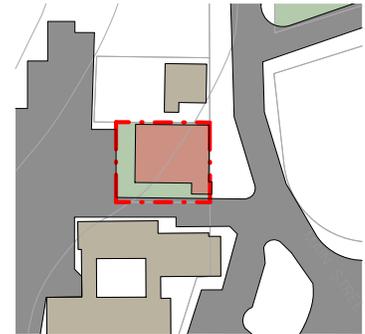
OPTION 3

TOWN HALL RENOVATIONS

Comprehensive renovation of existing Lunenburg Town Hall building.

5,700 approx SF - Renovation of building does not accommodate program

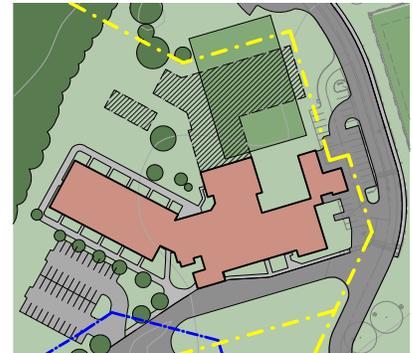
OPTION 4

Select renovations to the existing Passios School building and select demolition

35,000 SF - Area remaining following demolition
22,500 SF - Area of demolition

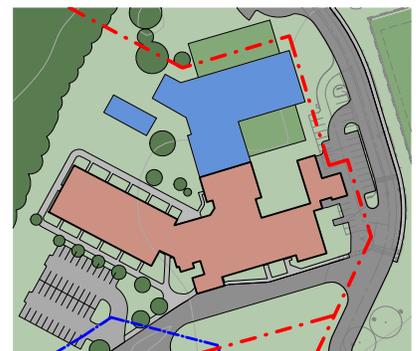
OPTION 4A

Maintain entire existing Passios School building
Rent or lease portion of building for non-municipal use.

35,000 SF - Approx. overall existing area

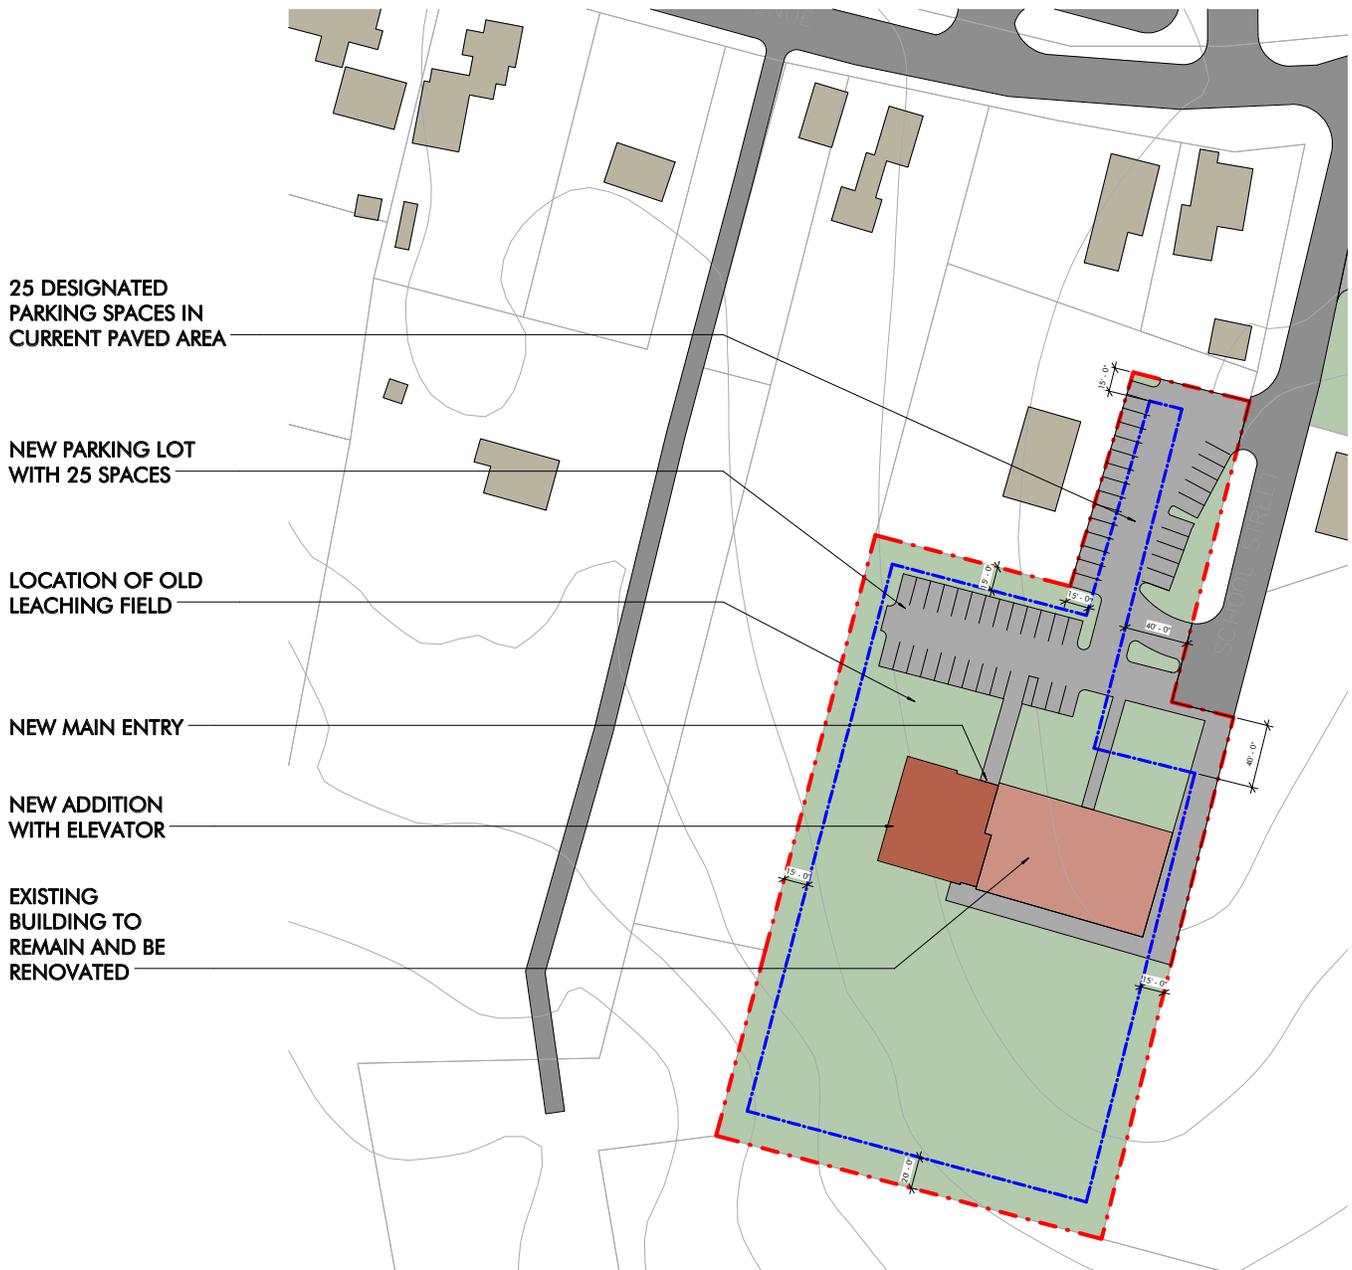
OPTION 1 - PRIMARY SCHOOL - PROPOSED SITE PLAN

- ADDITION REQUIRED TO ACCOMMODATE PROGRAM
- REQUIRES SIGNIFICANT UPGRADES PRIOR TO REUSE SIGNIFICANT COSTS POSSIBLE
- MULTIPLE STORIES MAKE ADJACENCIES MORE DIFFICULT TO ACCOMMODATE
- BUILDING INTERIOR HAS MULTIPLE LEVEL CHANGES
- FARTHER FROM TOWN CENTER
- GETTING PROGRAM TO FIT REQUIRES INTERIOR RECONFIGURATION OF PARTITIONS ETC, SOME OF WHICH OF WHICH ARE BEARING WALLS

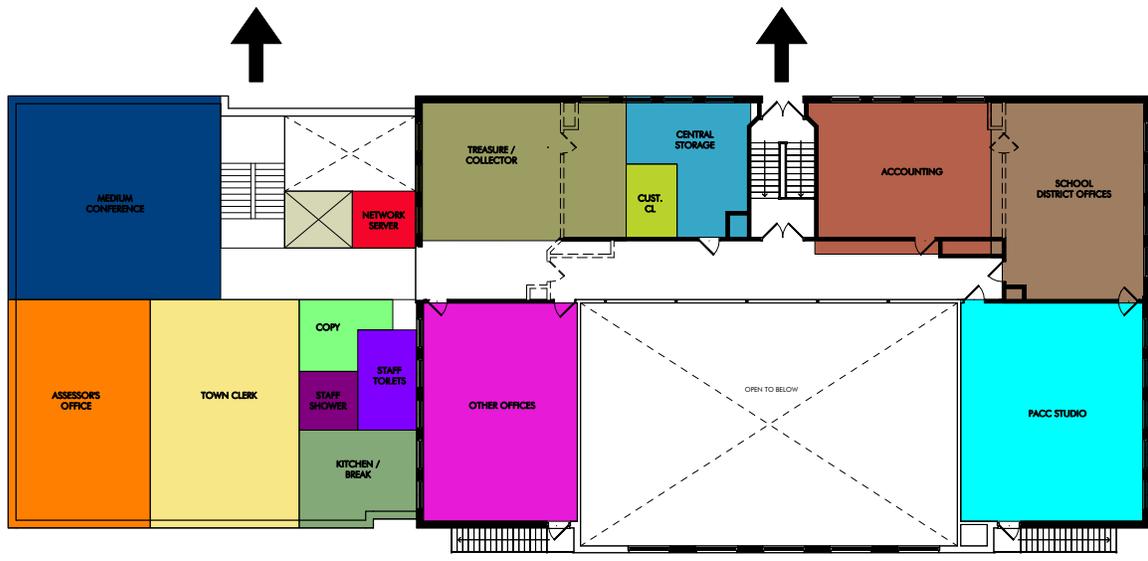
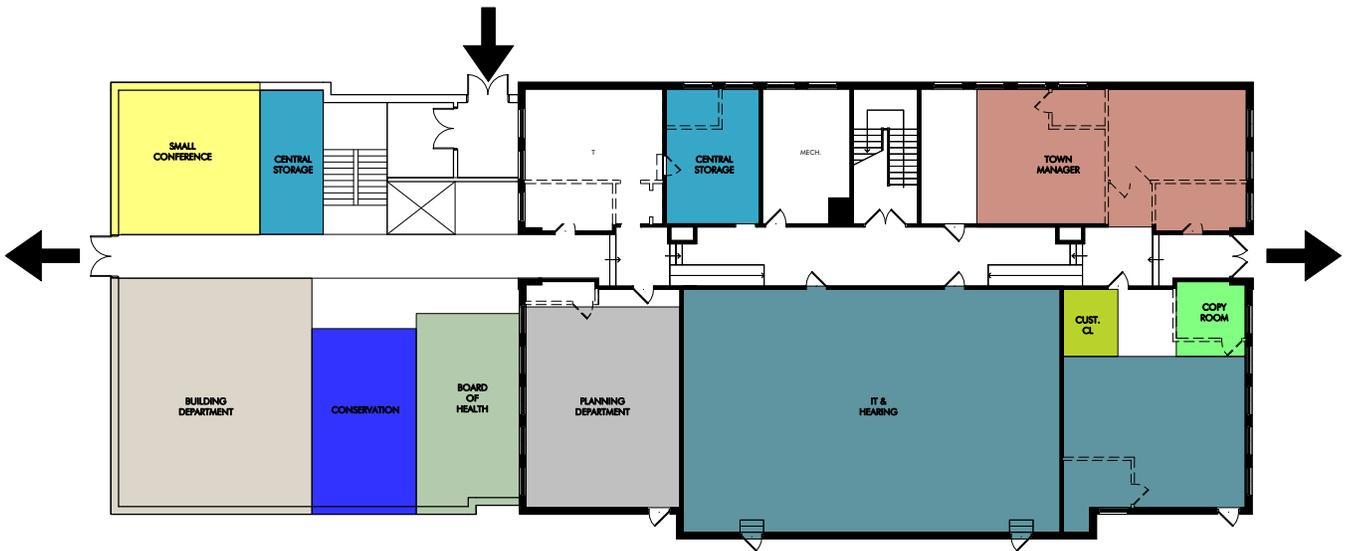
OPTION 1 - PRIMARY SCHOOL - PROPOSED PROGRAM DIAGRAM

UPPER LEVEL

LOWER LEVEL

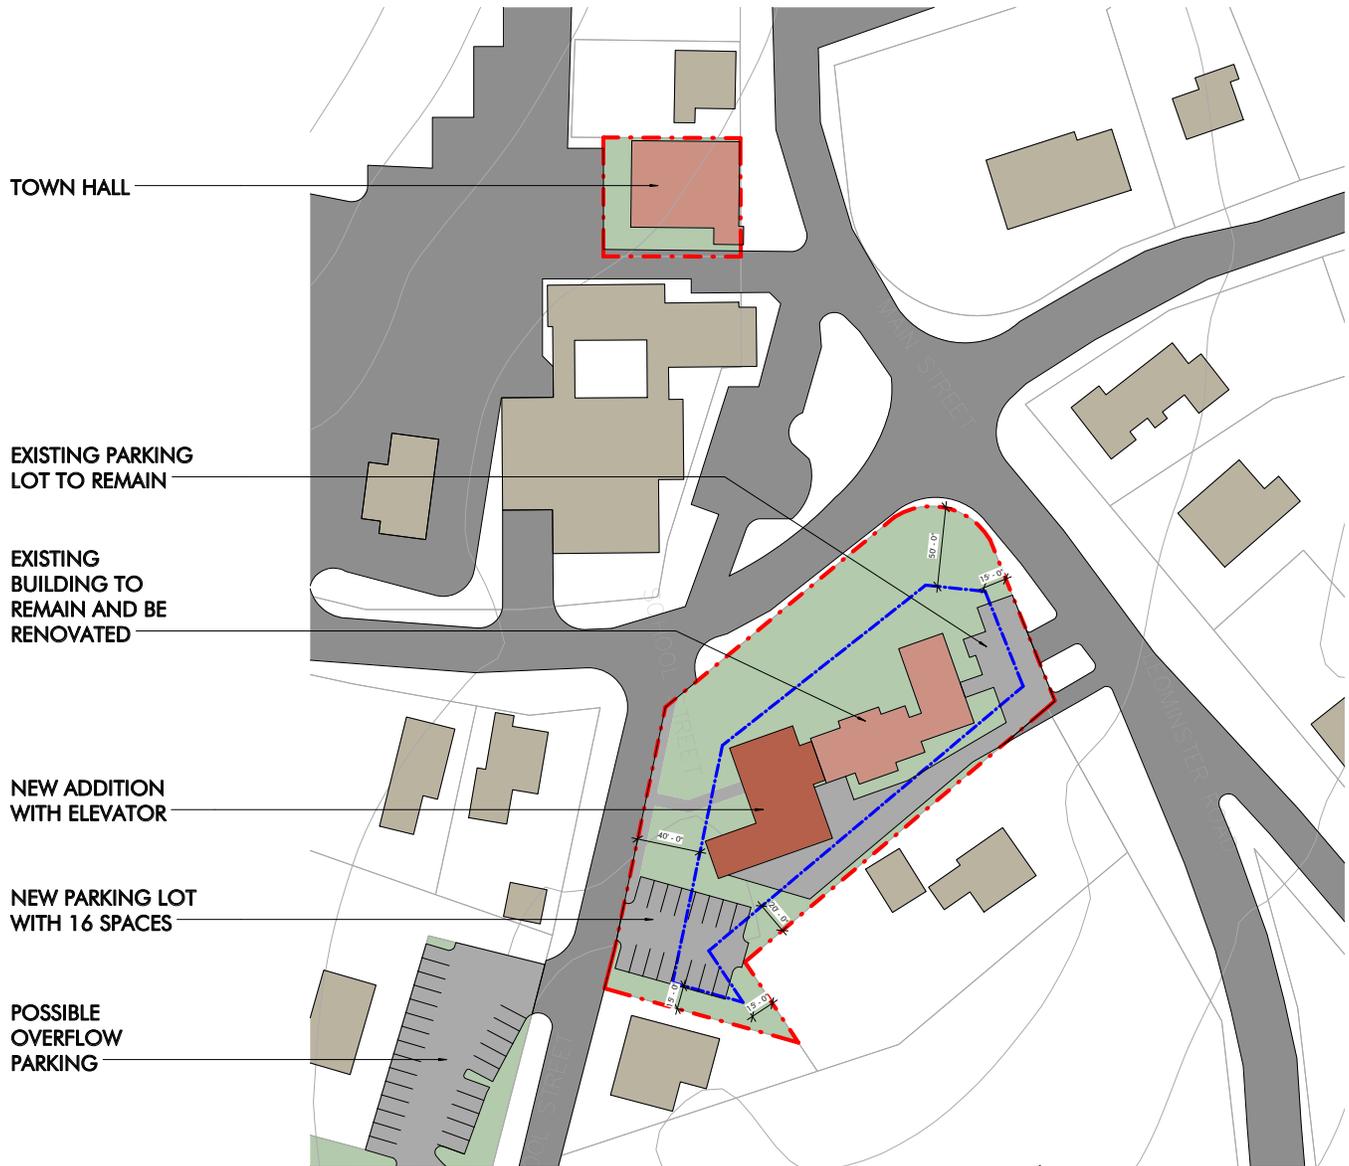
OPTION 2 - RITTER BUILDING - PROPOSED SITE PLAN

- CENTRAL LOCATION
- HIGHLY VISIBLE BUILDING
- EXISTING BUILDING IS IN GOOD CONDITION

- LIMITED SITE FOR EXPANSION
- EXISTING BUILDING LAYOUT DOES NOT SUPPORT PROGRAM EFFECTIVELY
- MULTIPLE STORIES / LEVELS MAKE ADJACENCIES DIFFICULT
- LIMITED SITE FOR PARKING
- DOES NOT ACCOMMODATE LARGE PROGRAM AREAS: HEARING ROOM, MEDIUM CONFERENCE ROOM, IT / PACC STUDIO
- INADEQUATE SITE AREA TO ACCOMMODATE A TWO STORY ADDITION

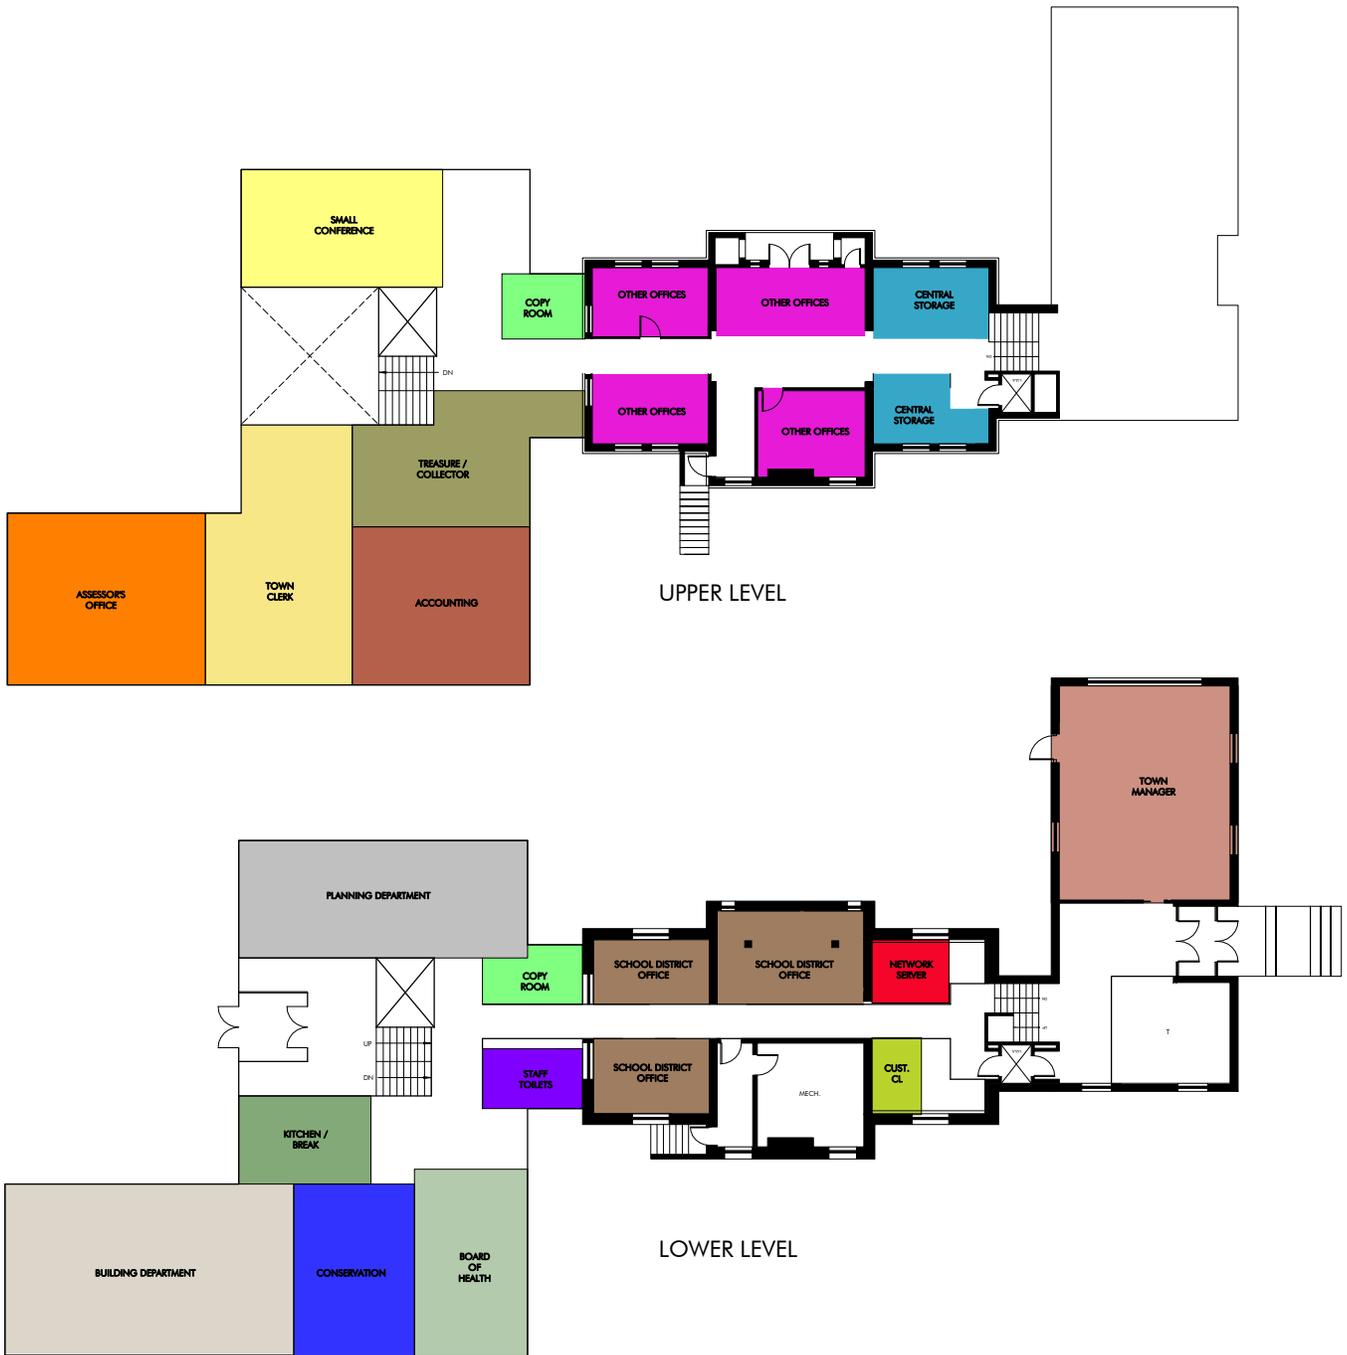
OPTION 2 - RITTER BUILDING - PROPOSED PROGRAM DIAGRAM

EXISTING PLAN AND SITE DO NOT ALLOW FOR EFFICIENT LAYOUT OF PROGRAM OR ADDITION

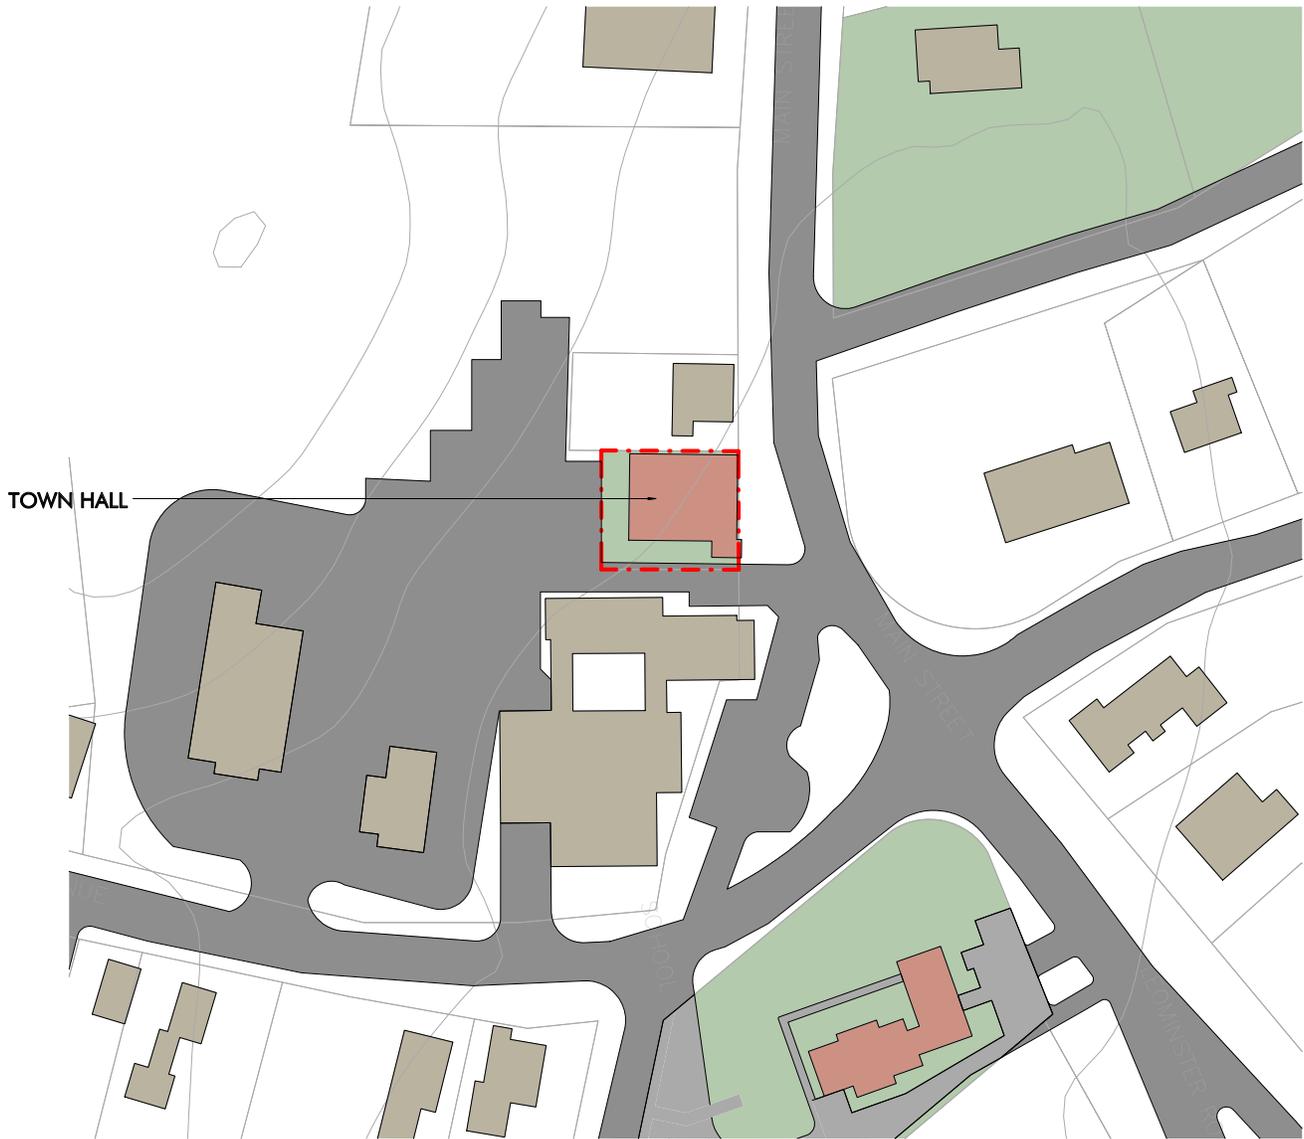
OPTION 3 - TOWN HALL - SELECT INTERIOR RENOVATIONS

- BUILDING NEEDS REMEDIAL WORK
- NO SITE AREA FOR EXPANSION
- SMALL FLOOR AREA IS DIFFICULT TO FIT PROGRAM
- DOES NOT ACCOMMODATE PROGRAM NEEDS

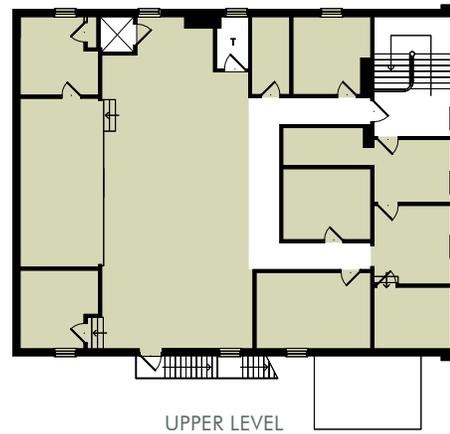
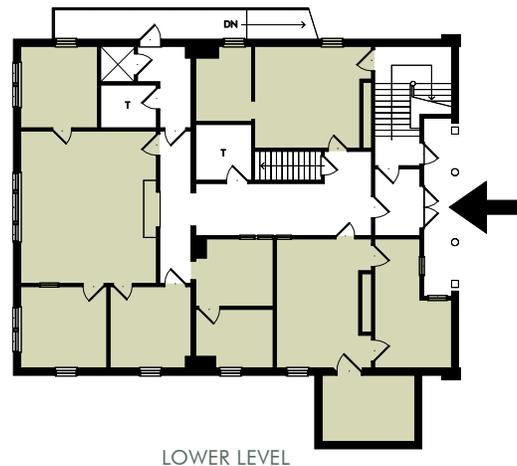
TOWN HALL - SELECT INTERIOR RENOVATIONS

Comprehensive renovation of existing Lunenburg Town Hall building does not accommodate the required programmatic needs of the Town.

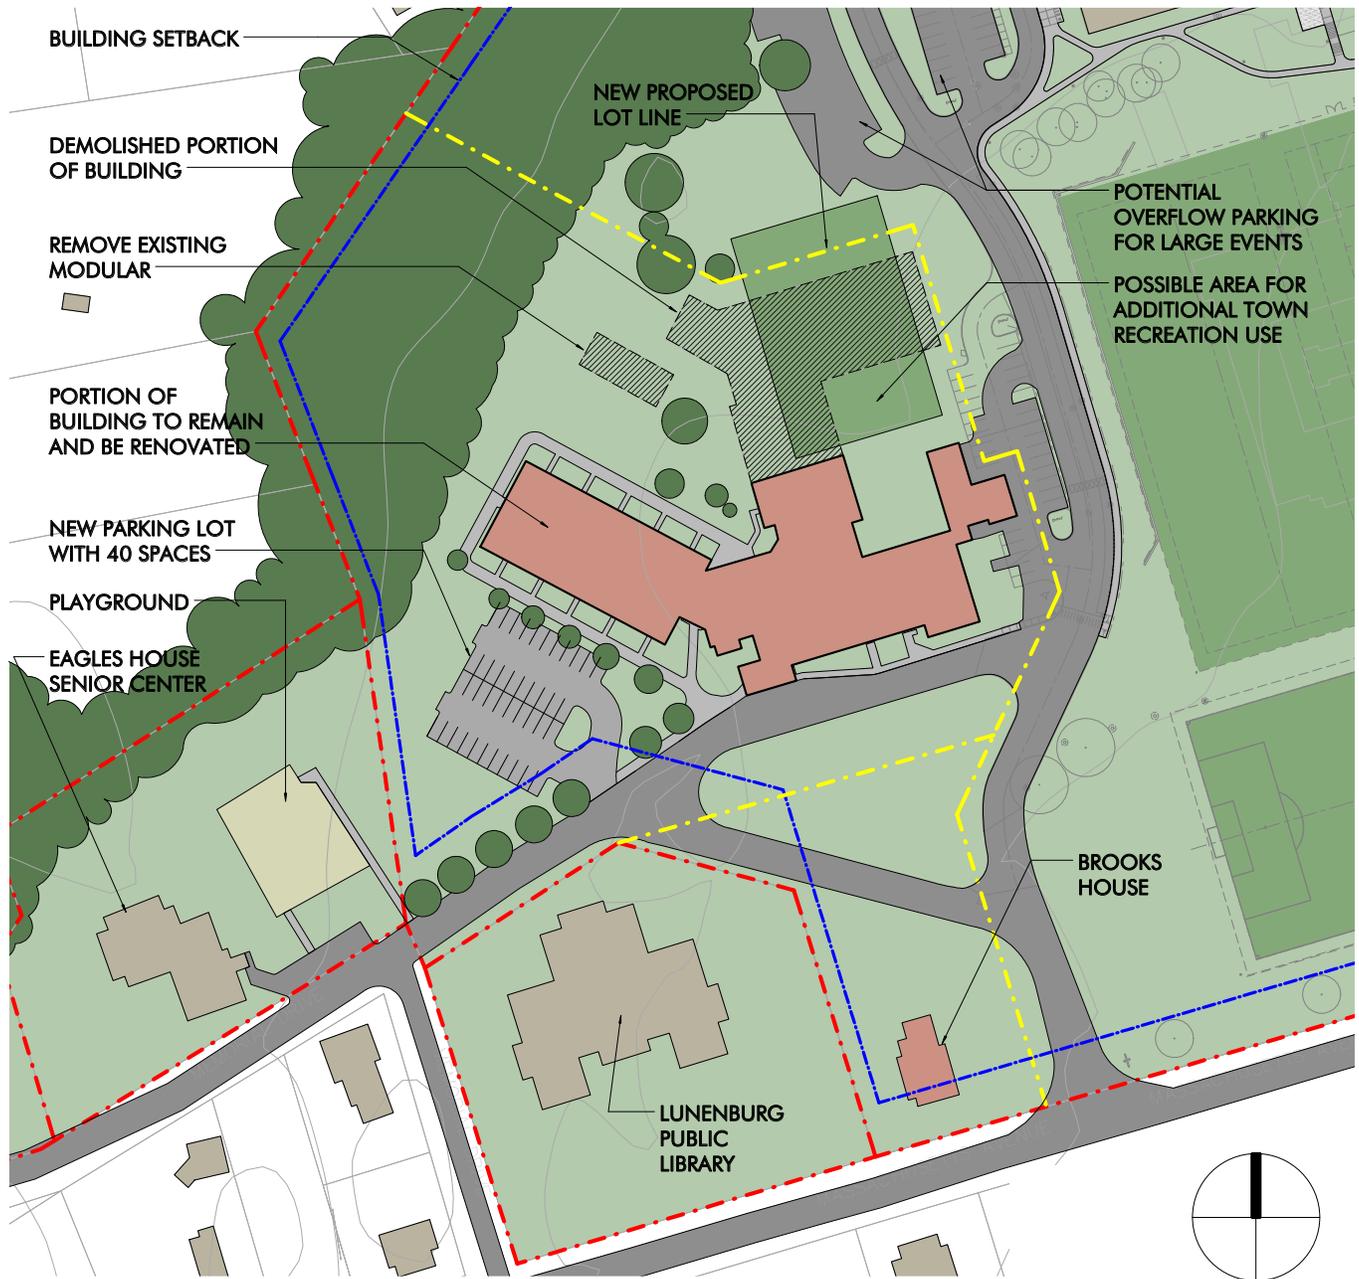
OPTION 4 - PASSIOS SCHOOL - PROPOSED SITE PLAN

- BUILDING IN GOOD CONDITION AND ACTIVE USE
- CLOSE TO TOWN CENTER
- AVAILABLE OVERFLOW PARKING FOR LARGER EVENTS
- NEW PARKING DOUBLES AS LIBRARY OVERFLOW PARKING
- ADEQUATE SQ FT FOR FULL PROGRAM AND EXPANSION
- TOWN RETAINS COMMUNITY USE OF GYM AND CAFETERIA WITH COMMUNITY ENTRANCE POSSIBLE
- PROGRAM GENERALLY LAYS OUT WELL IN EXIST. CLASSROOMS
- LIMITED TRAFFIC VOLUME TO BUILDING WORKS WELL WITH ADJACENT SCHOOL SITE

- COST ASSOCIATED WITH PARTIAL DEMOLITION / ABATEMENT AND INTERIOR UPGRADES

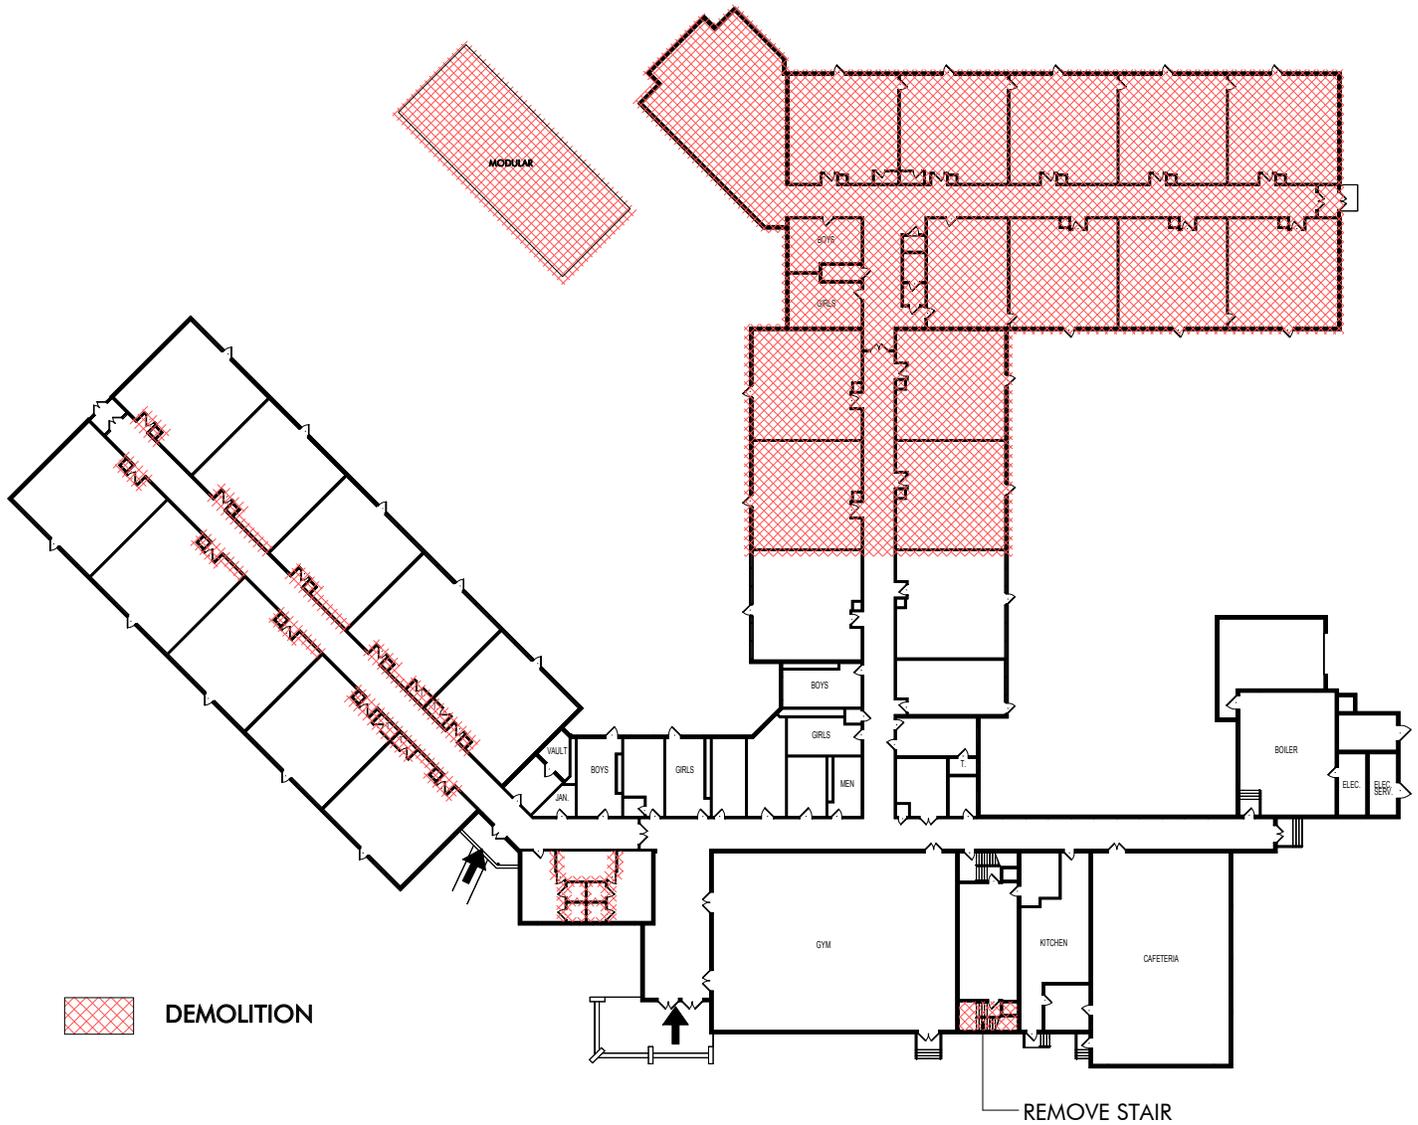
OPTION 4 - PREFERRED CONCEPTUAL DEMOLITION PLAN

- DEMOLISH APPROX. 20,800 SQUARE FEET EXISTING BUILDING
- REMOVE FOOTINGS & FOUNDATION, RESTORE SITE
- SELECTIVE DEMOLITION INCLUDES SOME PARTITION, PORTION OF CORRIDOR WALLS
- REMOVE CEILING AT CLASSROOMS & CLASSROOM CORRIDOR
- REMOVE CLASSROOM FLOOR FINISHES
- REMOVE BLACK BOARDS AND WHITE BOARDS & CASEWORK AT CLASSROOMS

The Passios School has more space than is required for the anticipated town office space needs. Therefore Option 4 would remove a section of the existing building to limit the size of the building in use by the Town. This plan includes construction of a new parking lot and the possibility of a new field being installed at the location of the demolished building wing.
