# TOWN OF LUNENBURG BUILDING ASSESSMENT & SPACE NEEDS STUDY

PASSIOS SCHOOL  
TOWN HALL  
OLD PRIMARY SCHOOL  
RITTER MEMORIAL BUILDING

JANUARY 11, 2016

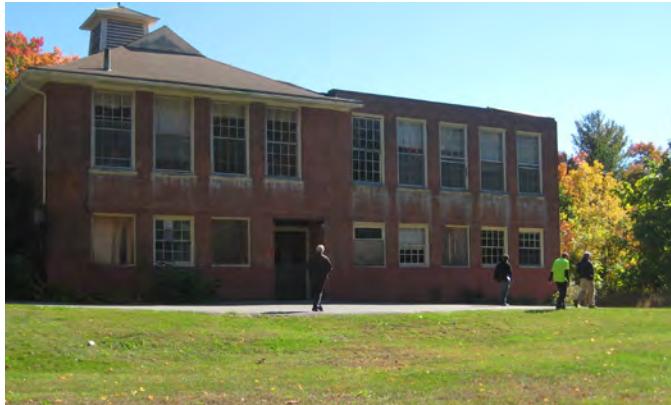
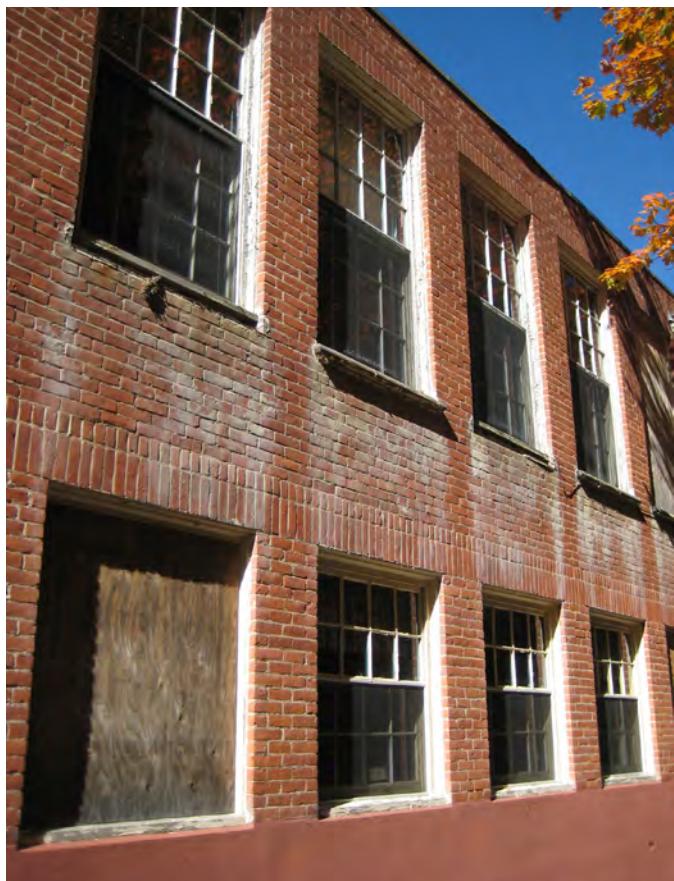
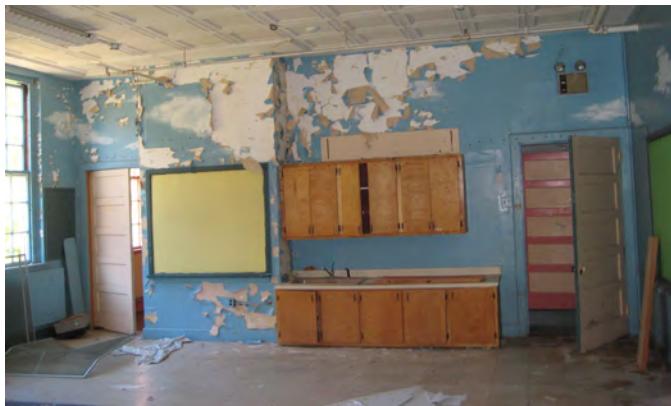
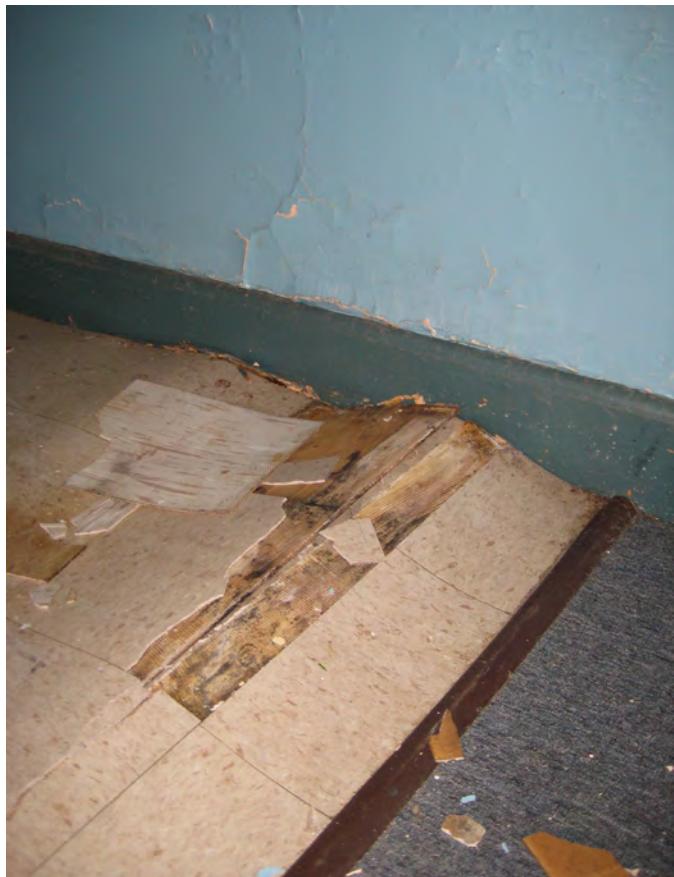
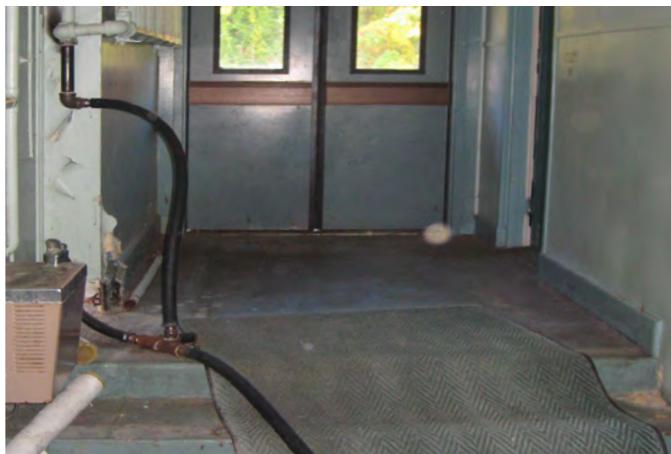
## PRIMARY SCHOOL

The building has not been in active use for ten years and this condition has led to a general deterioration of the building. The structure is a combination of masonry exterior and bearing walls, concrete slabs and steel roof trusses. The exterior envelope is in need of repairs including lintel replacement, window and roof replacement and masonry restoration in various locations. Removal of interior walls would need to be carefully analyzed relative to structural integrity of the building.

Water has been entering the building resulting in interior slabs that have cracked and heaved. Interior finishes are

generally damaged and in need of repair and all building systems require replacement. The building has multiple interior floor elevations and grade is at a mid-level, making the building generally non-accessible.

- EMPTY FOR 15 YEARS
- MAJOR WATER ISSUES / FLOODING
- MINOR ROOF LEAKS
- WARPED FLOORS
- MULTIPLE LEVEL CHANGES - NOT ADA ACCESSIBLE
- COMPLETE INTERIOR GUT RENOVATION REQUIRED

- EXTERIOR ENVELOPE REPAIRS REQUIRED  
WINDOWS REQUIRE REPLACEMENT
- ADDITION REQUIRED TO FIT ALL PROGRAM SPACE
- MOLD ON INTERIOR
- MEP/FP SYSTEMS IN NEED OF REPLACEMENT

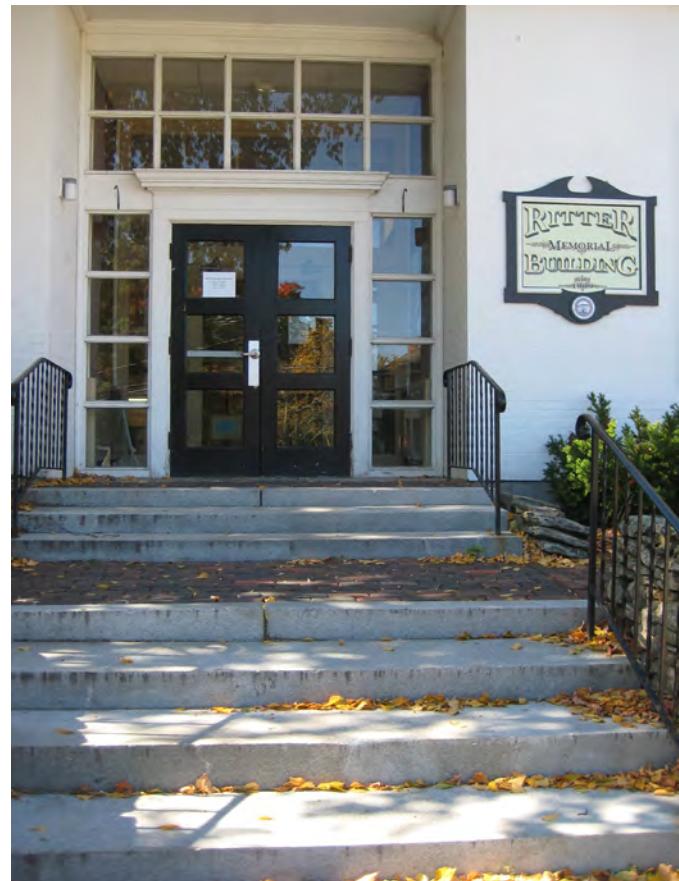
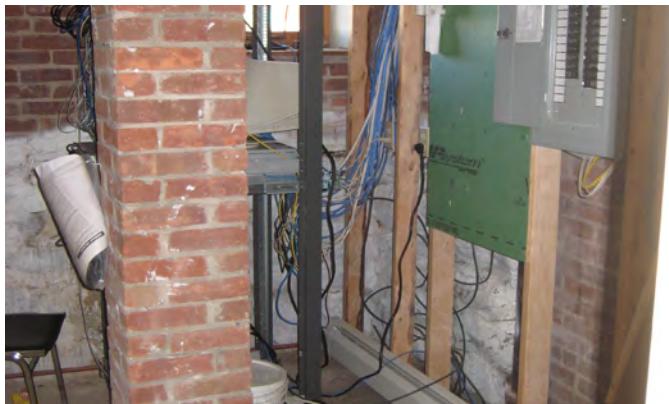
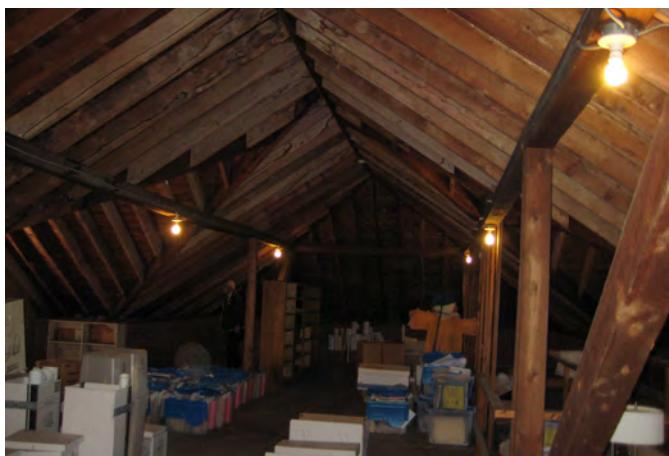
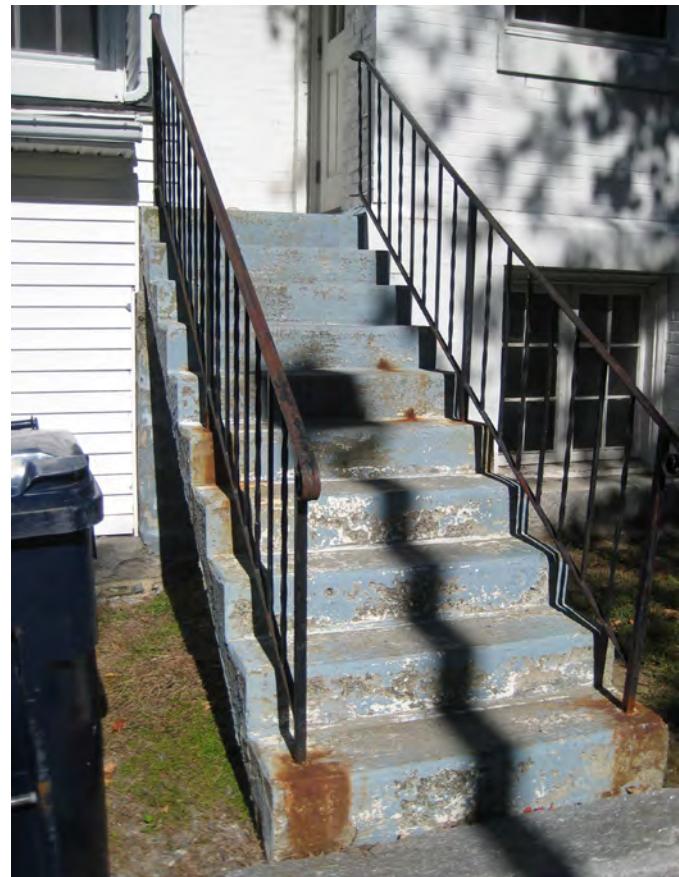
RITTER BUILDING

The Ritter Building was constructed in 1910 with an addition in 1963 and served as the Town Library for many years. The overall area is approximately 6,000 SF on two levels. The building is in generally good condition with limited upgrades required. There is currently no sprinkler system or air conditioning.

The building structure is wood with exterior masonry bearing walls. Interior finishes are generally in good condition and the building has been generally well maintained. The current condition is not fully accessible and any anticipated renovation and re-use would need to make modifications to accommodate a main building entrance and bathrooms that is accessible, as well as accommodating the public on both floors of the building.

- CENTRAL LOCATION
- HIGHLY VISIBLE BUILDING
- EXISTING BUILDING IS IN GOOD CONDITION

- LIMITED SITE FOR EXPANSION
- EXISTING BUILDING LAYOUT DOES NOT SUPPORT PROGRAM EFFECTIVELY
- MULTIPLE STORIES / LEVELS MAKE ADJACENCIES DIFFICULT
- LIMITED SITE FOR PARKING
- DOES NOT ACCOMMODATE LARGE PROGRAM AREAS: HEARING ROOM, MEDIUM CONFERENCE ROOM, IT / PACC STUDIO
- INADEQUATE SITE AREA TO ACCOMMODATE A TWO STORY ADDITION

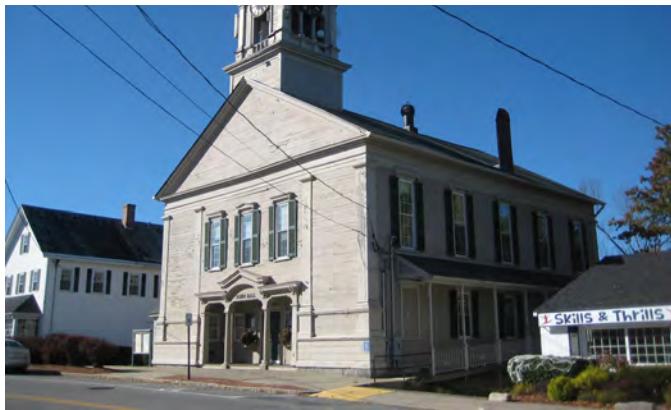
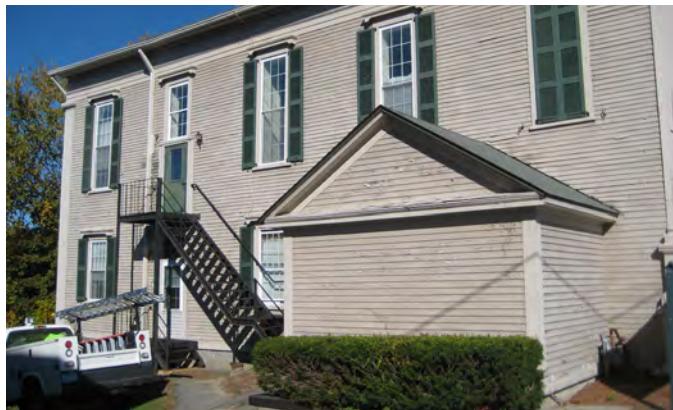
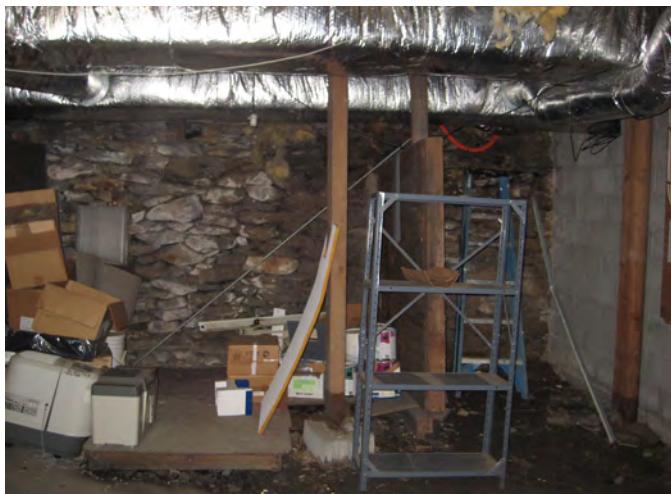
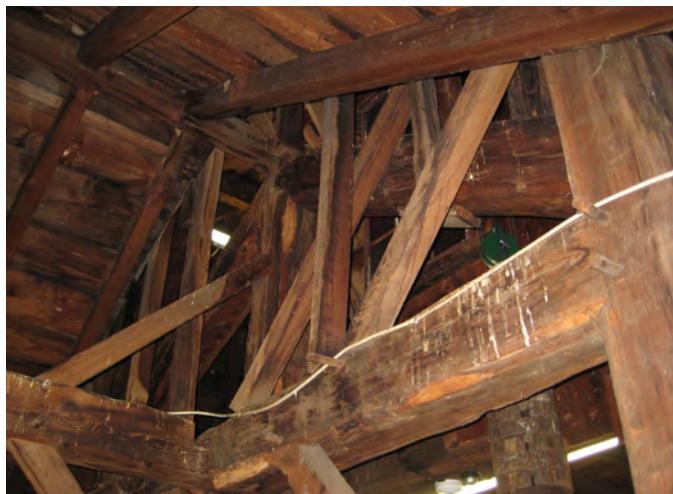
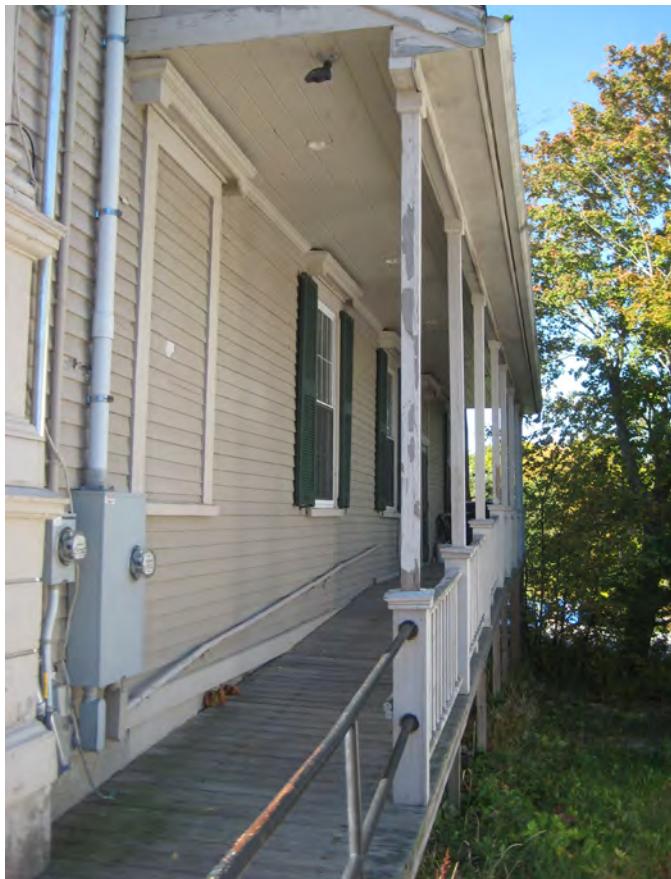
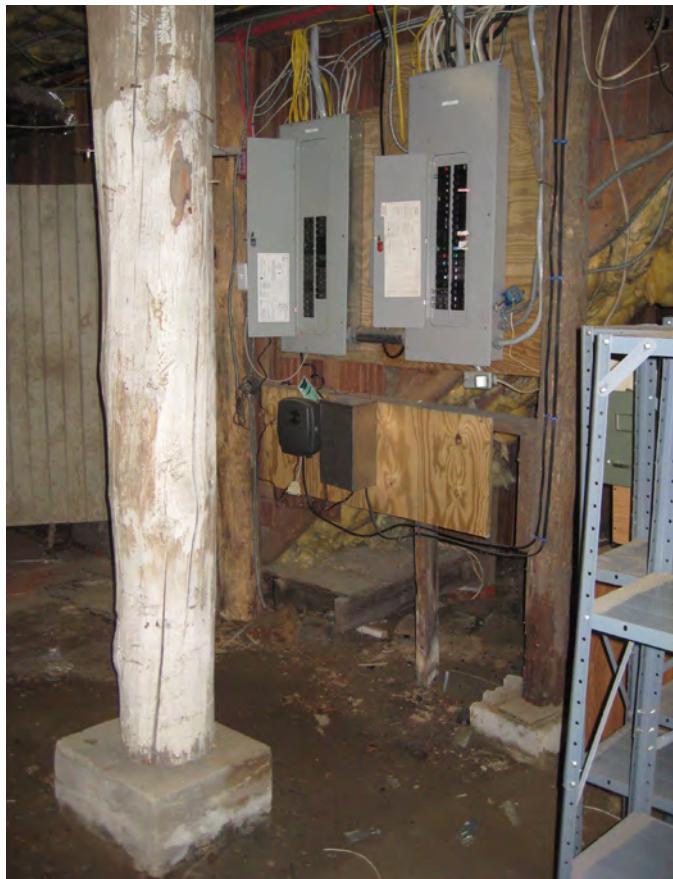
TOWN HALL

The building is a wooden post and beam structure and wood framing and siding. There is evidence of some rot in structural members and excess deflection of some floor joists. There has been some water infiltration into the building from the roof and possibly through the foundation walls which are stone. There is a relatively detailed inspection report from 2013 that can be used as a guide to the condition of the building. It should be anticipated that at some point, a structural and envelope upgrade should be undertaken to stabilize the building and upgrade the building envelope. Consideration might also be given to upgrades to the electrical systems.

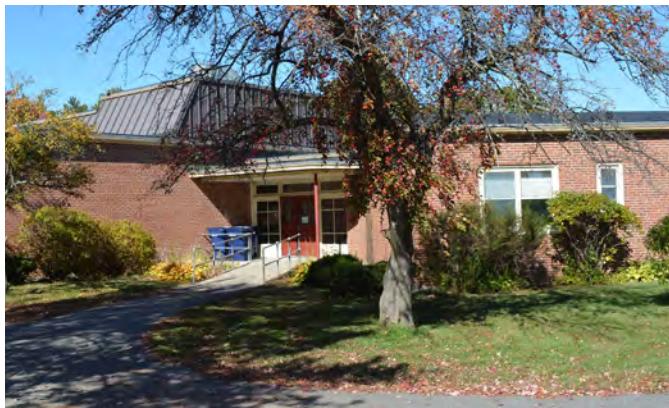
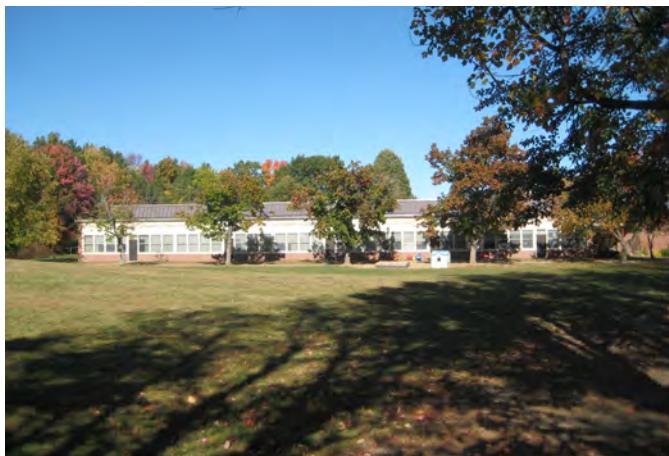
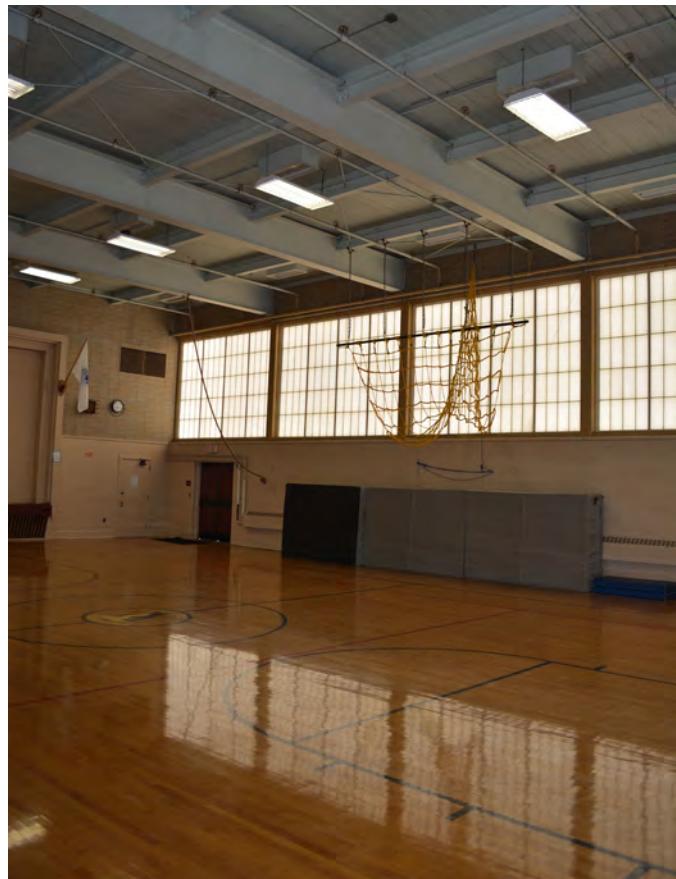
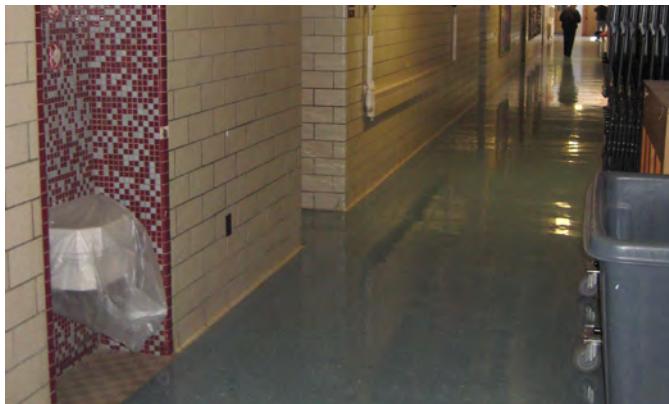
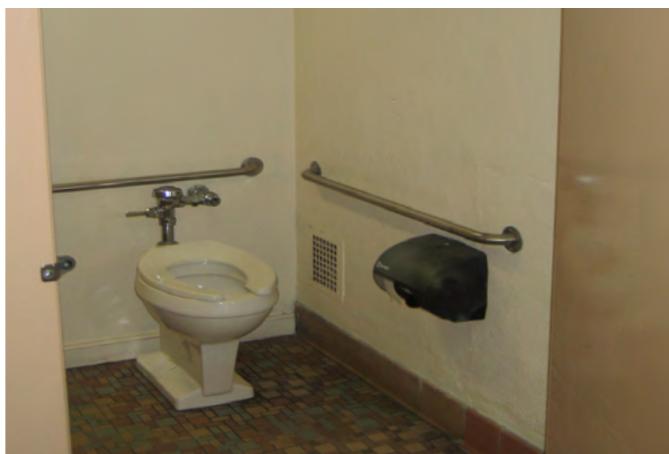
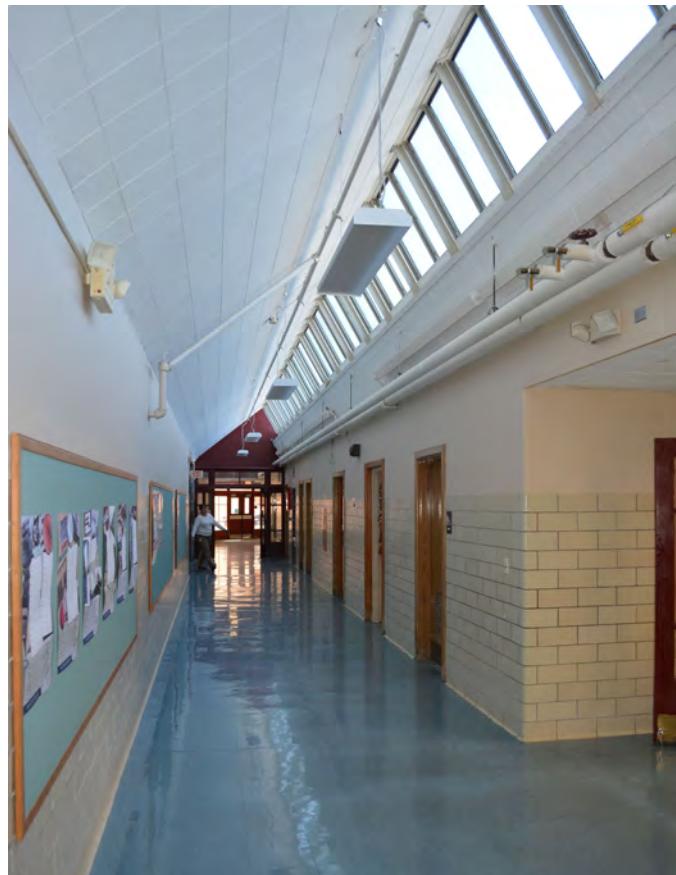
## PASSIOS SCHOOL

The Passios was constructed in 1952 with an addition constructed in 1976. The building is approximately 55,000 SF on one level. The building is in good condition and the Town has made periodic investments in upgrades and enhancements.

The building is a steel frame structure with a brick exterior and wood plank roof framing. Systems in the building are in generally good condition although the fire protection is in need of updating and there is no air conditioning presently. It is recommended that lighting within the building be upgraded and that bathrooms and toilet fixtures be replaced to meet code. It does not appear that classroom entrances have adequate clearances to meet accessibility code and consideration might be given to improving the layout of these locations.

Town improvements over time have included selective re-roofing, updated kitchen equipment and gym floor, accessible main entrance, replacement of some sprinkler heads. The building has asbestos containing materials within it including VAT flooring, plaster and caulking, pipe insulation as well as roofing materials that would require abatement if work was done to modify and upgrade the building.

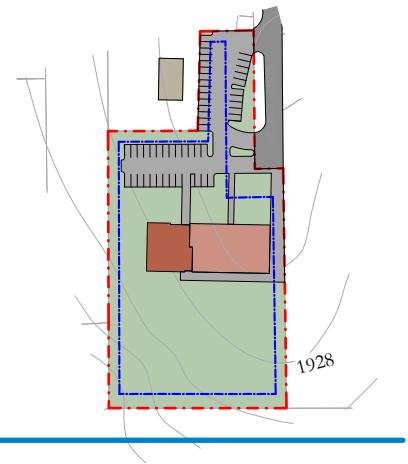
## OPTION 1A

### PRIMARY SCHOOL SITE NEW CONSTRUCTION

Demolish existing Primary School  
Construct new Town Offices building

18,000 Overall GSF New Construction  
One floor

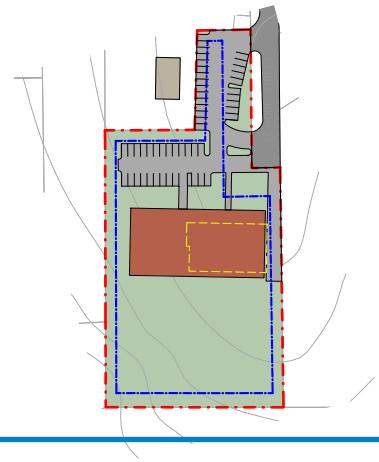
## OPTION 1B

### PRIMARY SCHOOL & TOWN HALL RENOVATION

Renovate existing Primary School  
Renovate existing Town Hall

12,300 SF Renovations - Primary School  
6,500 SF Renovations - Town Hall  
18,800 SF Renovations - Total in two facilities to accommodate required program

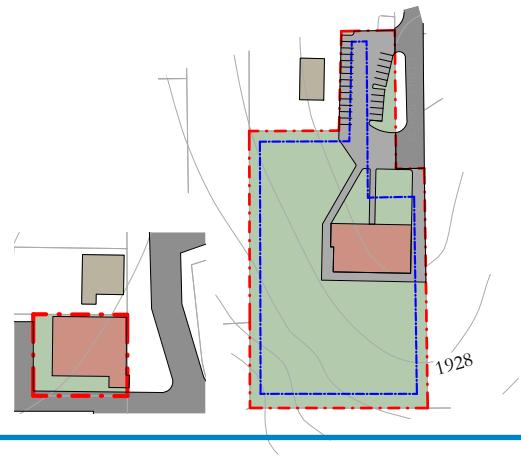
## OPTION 2

### RITTER BUILDING & TOWN HALL RENOVATION & ADDITION

Comprehensive renovation of Town Hall and renovation of Ritter Building with Addition

12,700 SF - Ritter Building  
(5,700 SF renovation / 7,000 SF new construction)  
6,500 SF - Renovations to Town Hall  
19,200 SF - Total in two facilities to accommodate program

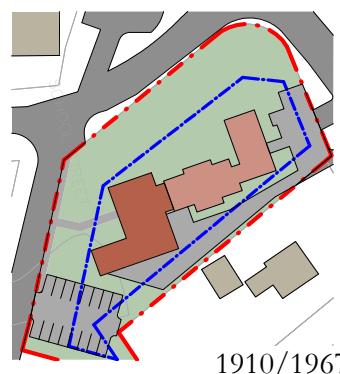
## OPTION 3

### TOWN HALL RENOVATIONS

Comprehensive renovation of existing Lunenburg Town Hall building.

5,700 approx SF - Renovation of building does not accommodate program

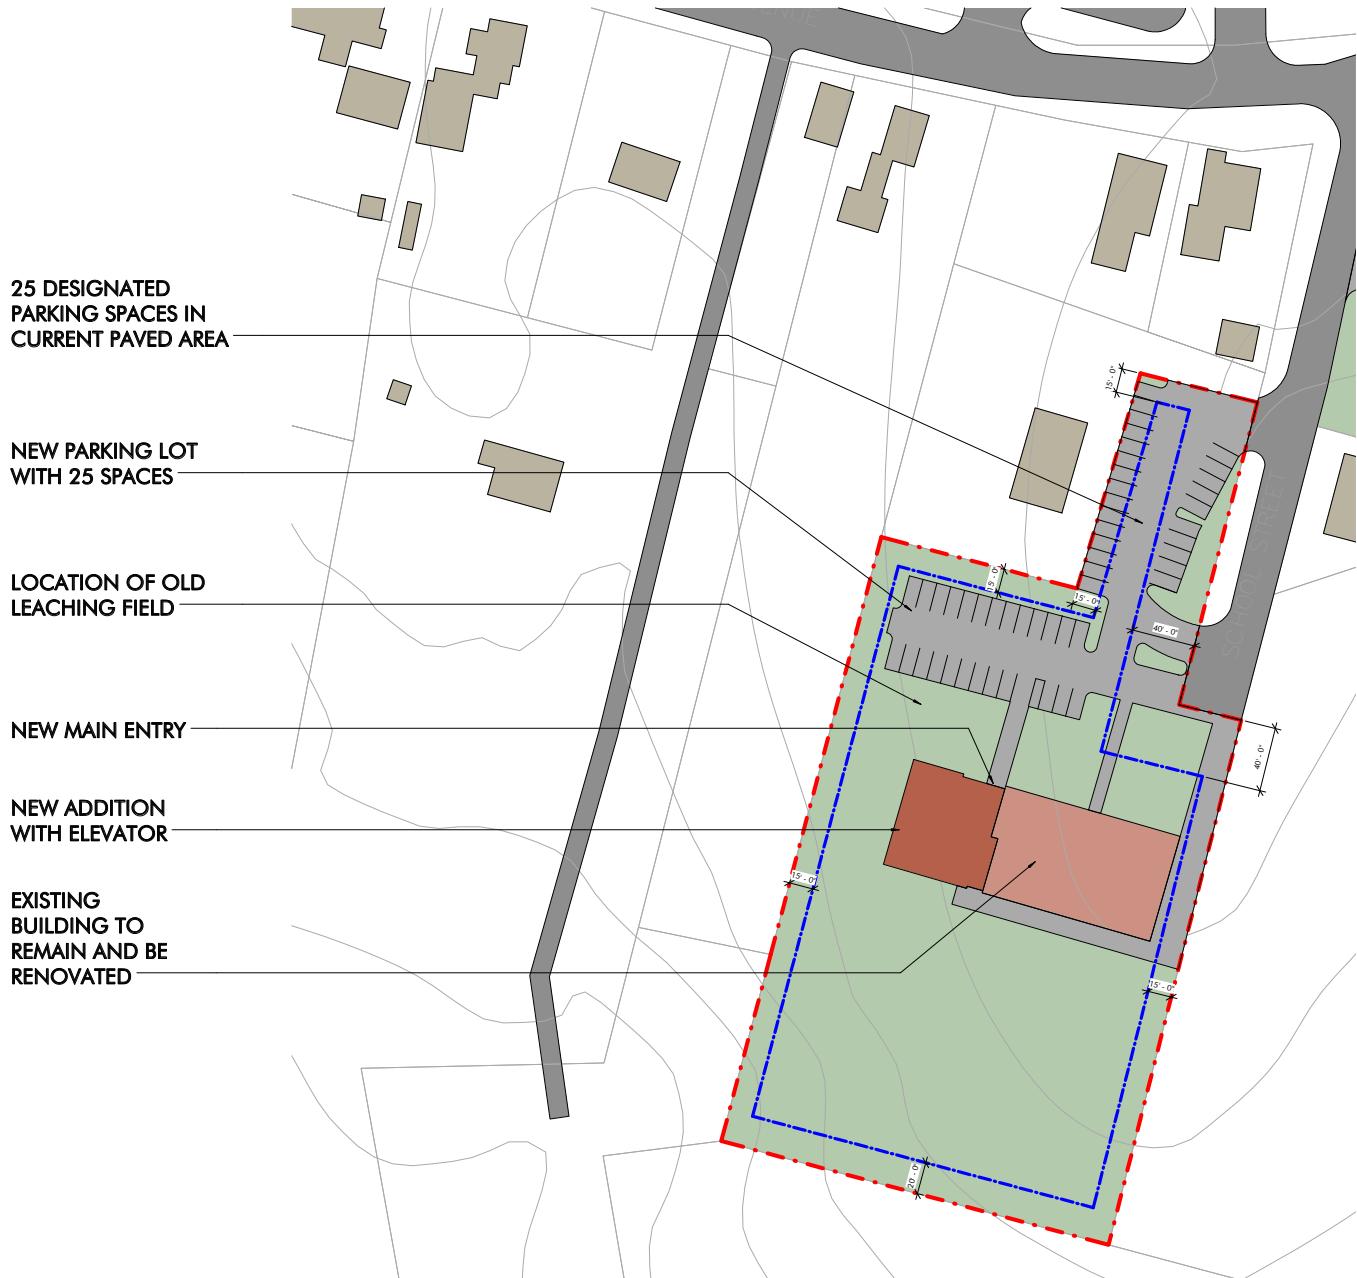
## OPTION 1 - PRIMARY SCHOOL - PROPOSED SITE PLAN

- ADDITION REQUIRED TO ACCOMMODATE PROGRAM
- REQUIRES SIGNIFICANT UPGRADES PRIOR TO REUSE SIGNIFICANT COSTS POSSIBLE
- MULTIPLE STORIES MAKE ADJACENCIES MORE DIFFICULT TO ACCOMMODATE
- BUILDING INTERIOR HAS MULTIPLE LEVEL CHANGES
- FARTHER FROM TOWN CENTER
- GETTING PROGRAM TO FIT REQUIRES INTERIOR RECONFIGURATION OF PARTITIONS ETC, SOME OF WHICH ARE BEARING WALLS

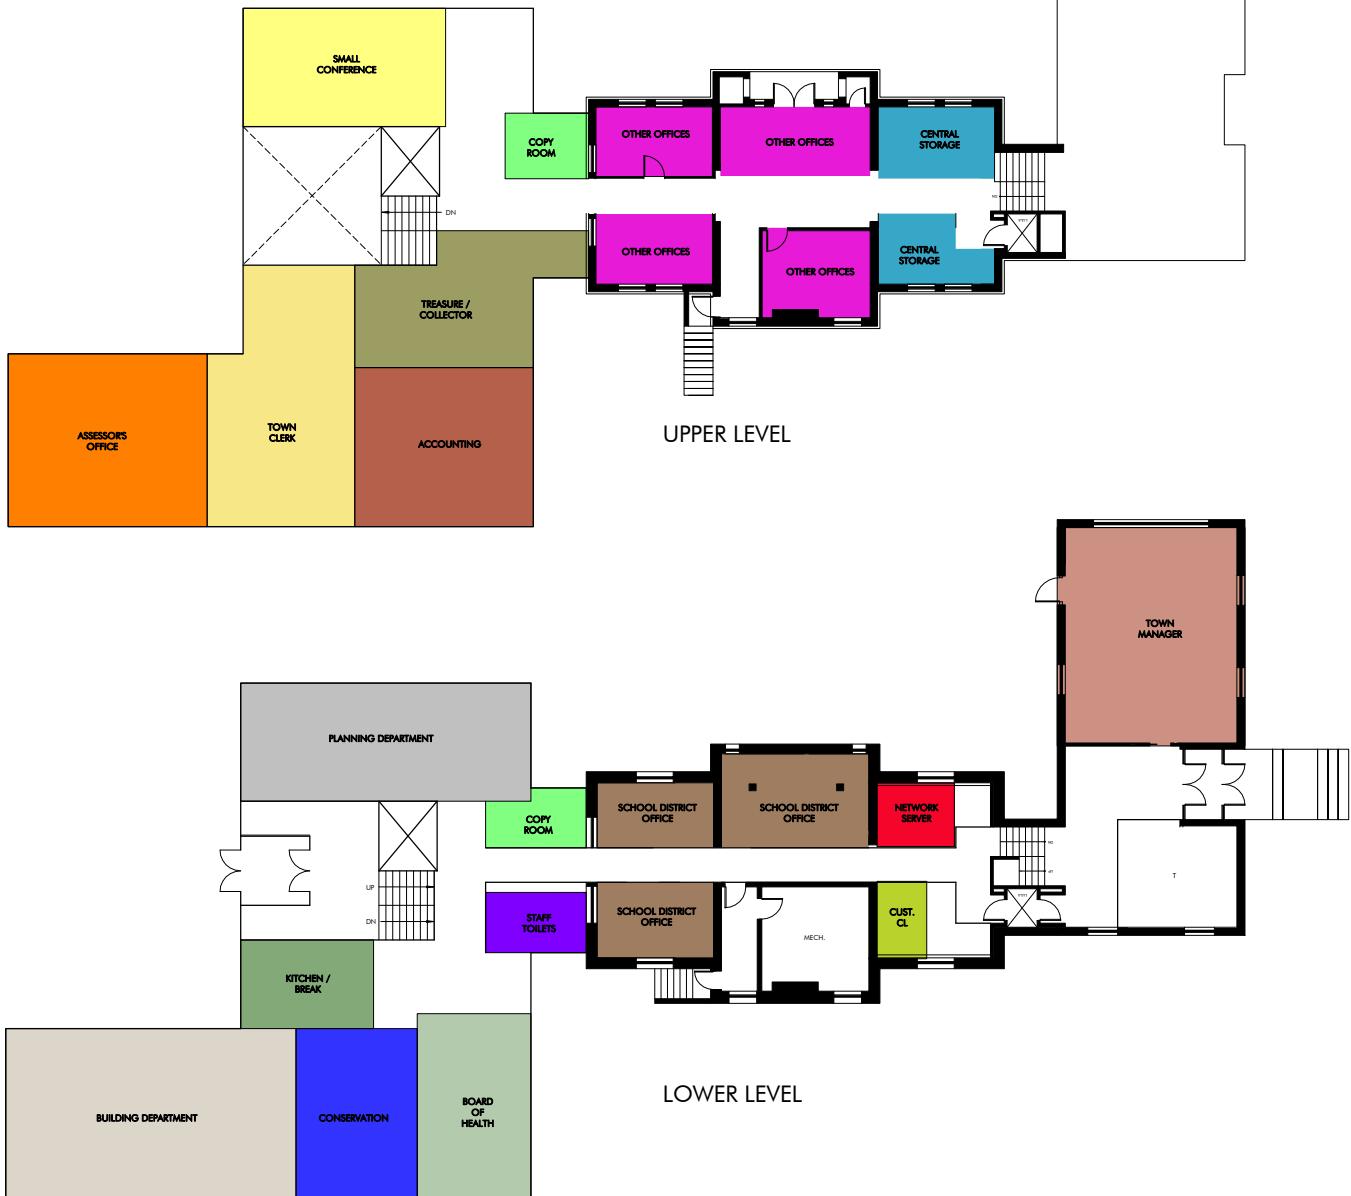
## OPTION 2 - RITTER BUILDING - PROPOSED PROGRAM DIAGRAM

EXISTING PLAN AND SITE DO NOT ALLOW FOR EFFICIENT  
LAYOUT OF PROGRAM OR ADDITION

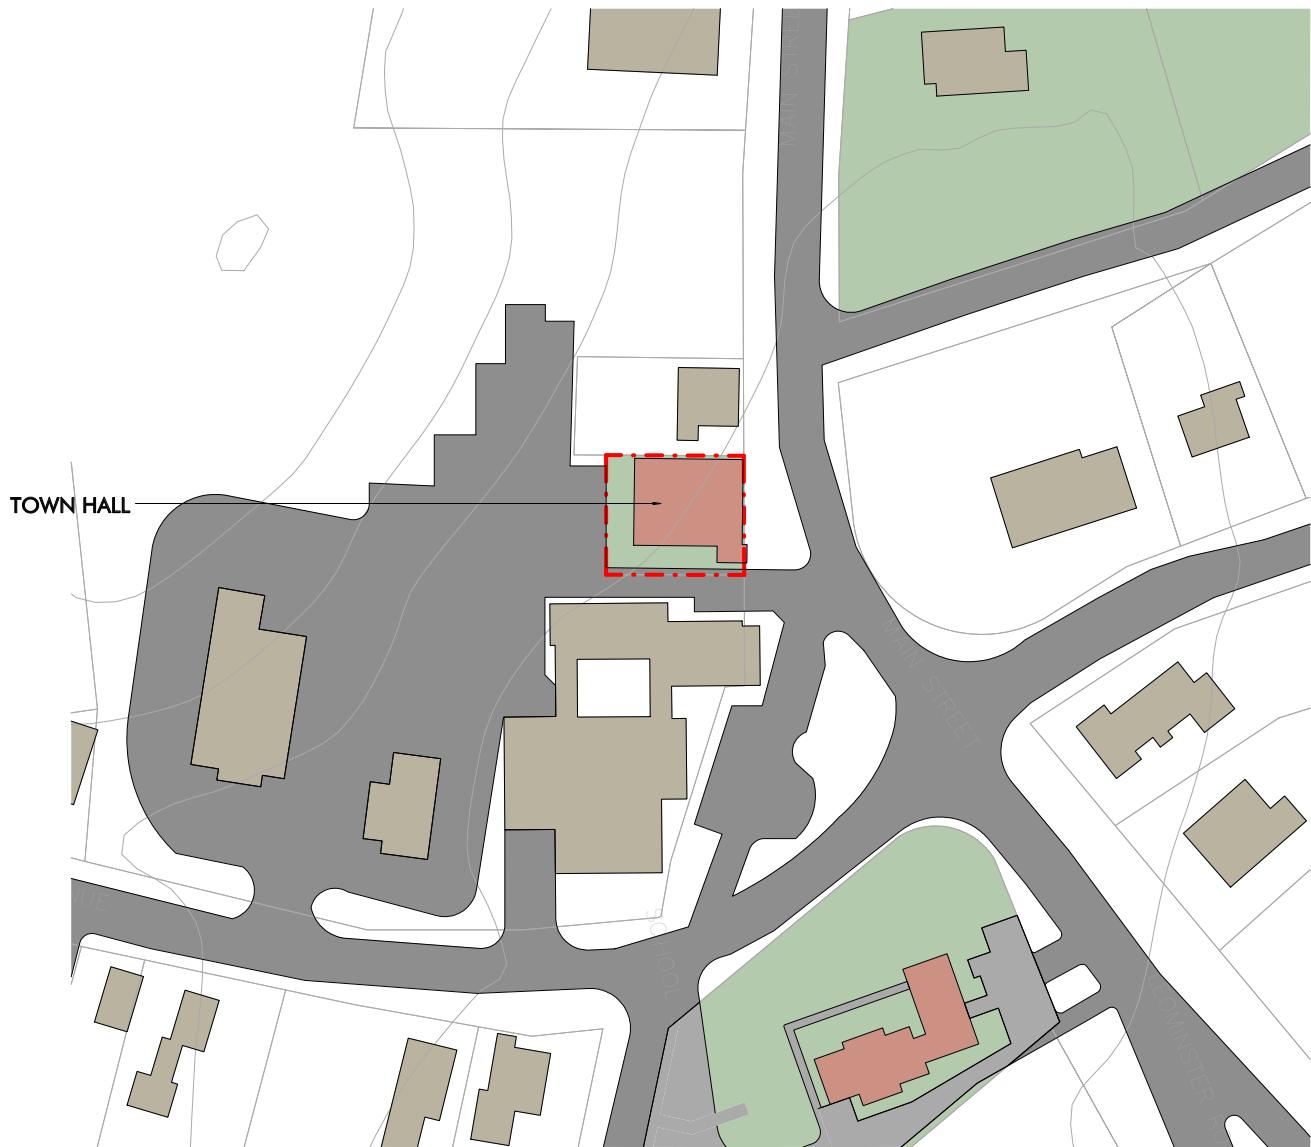
## OPTION 3 - TOWN HALL - SELECT INTERIOR RENOVATIONS

- BUILDING NEEDS REMEDIAL WORK
- NO SITE AREA FOR EXPANSION
- SMALL FLOOR AREA IS DIFFICULT TO FIT PROGRAM
- DOES NOT ACCOMMODATE PROGRAM NEEDS

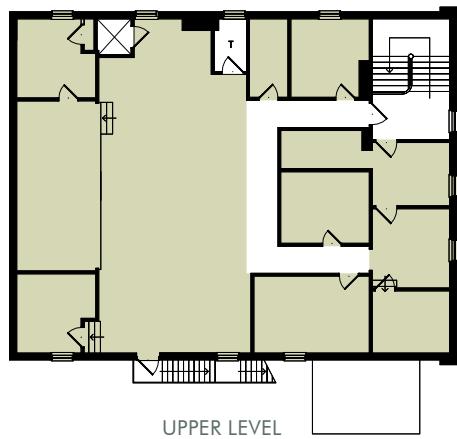
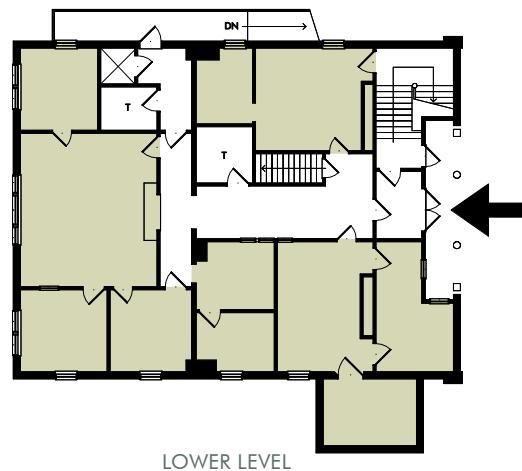
## TOWN HALL - SELECT INTERIOR RENOVATIONS

Comprehensive renovation of existing Lunenburg Town Hall building does not accommodate the required programmatic needs of the Town.

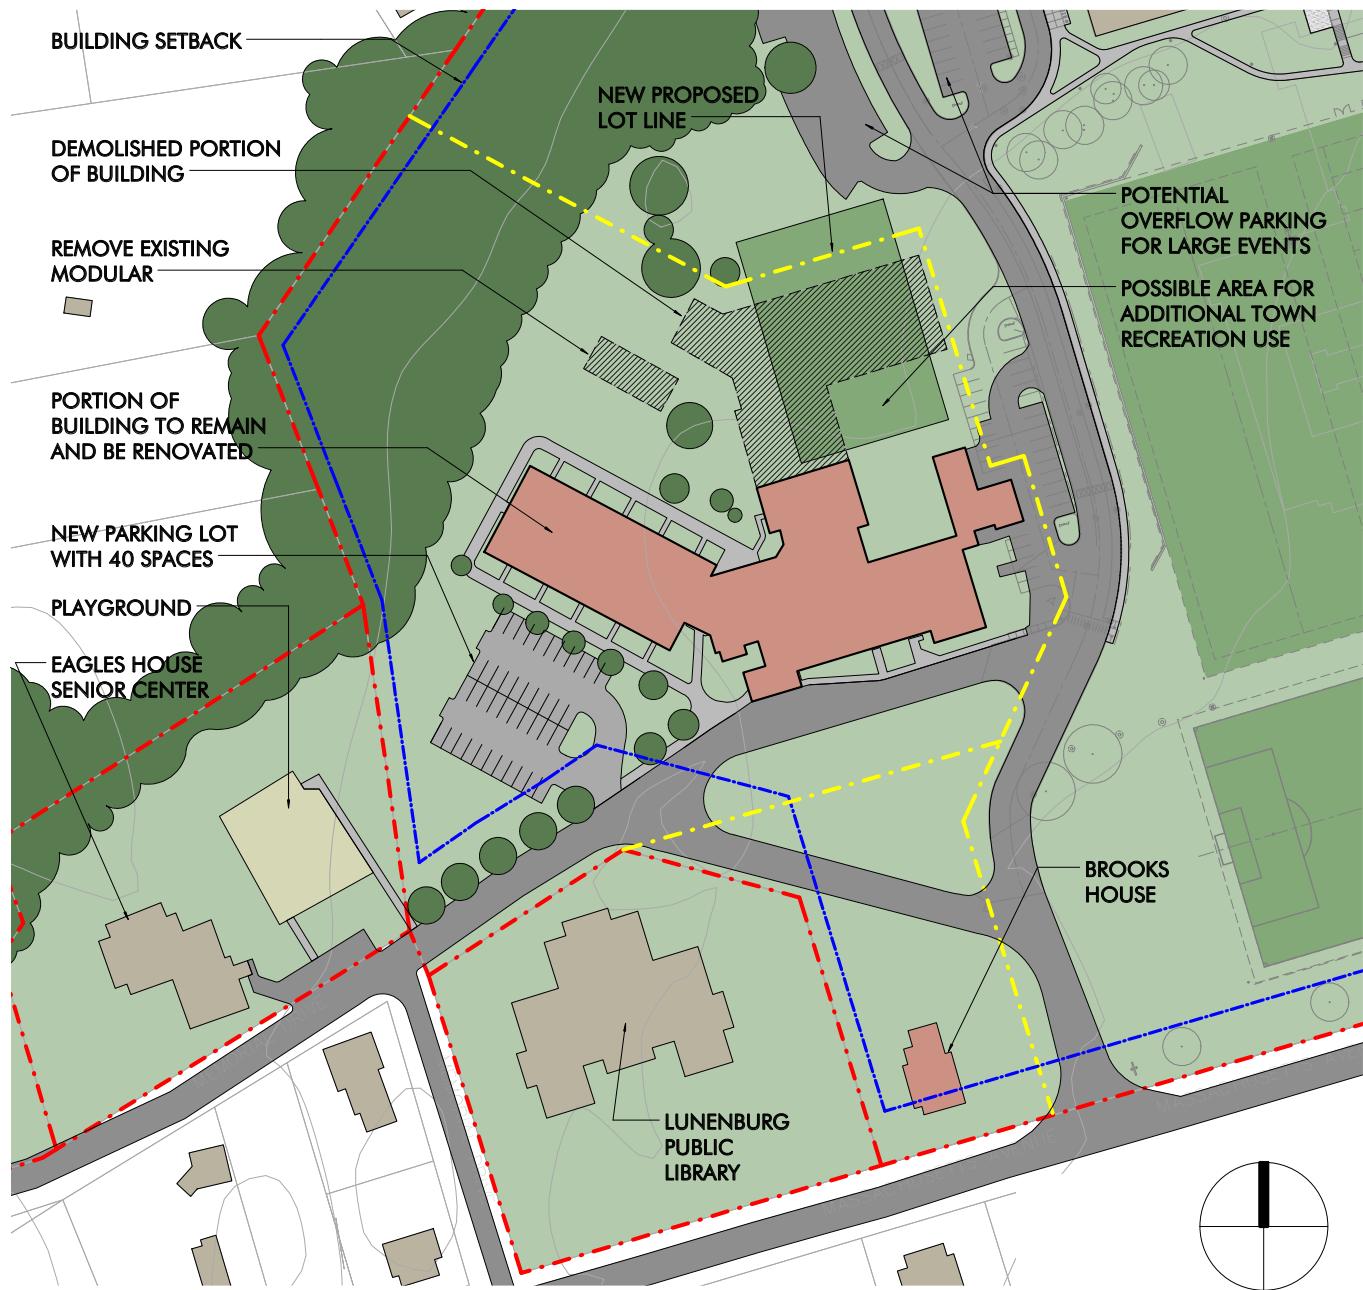
## OPTION 4 - PASSIOS SCHOOL - PROPOSED SITE PLAN

- BUILDING IN GOOD CONDITION AND ACTIVE USE
- CLOSE TO TOWN CENTER
- AVAILABLE OVERFLOW PARKING FOR LARGER EVENTS
- NEW PARKING DOUBLES AS LIBRARY OVERFLOW PARKING
- ADEQUATE SQ FT FOR FULL PROGRAM AND EXPANSION
- TOWN RETAINS COMMUNITY USE OF GYM AND CAFETERIA WITH COMMUNITY ENTRANCE POSSIBLE
- PROGRAM GENERALLY LAYS OUT WELL IN EXIST. CLASSROOMS
- LIMITED TRAFFIC VOLUME TO BUILDING WORKS WELL WITH ADJACENT SCHOOL SITE

- COST ASSOCIATED WITH PARTIAL DEMOLITION / ABATEMENT AND INTERIOR UPGRADES

The Passios School has more space then is required for the anticipated town office space needs. Therefore Option 4 would remove a section of the existing building to limit the size of the building in use by the Town. This plan includes construction of a new parking lot and the possibility of a new field being installed at the location of the demolished building wing.

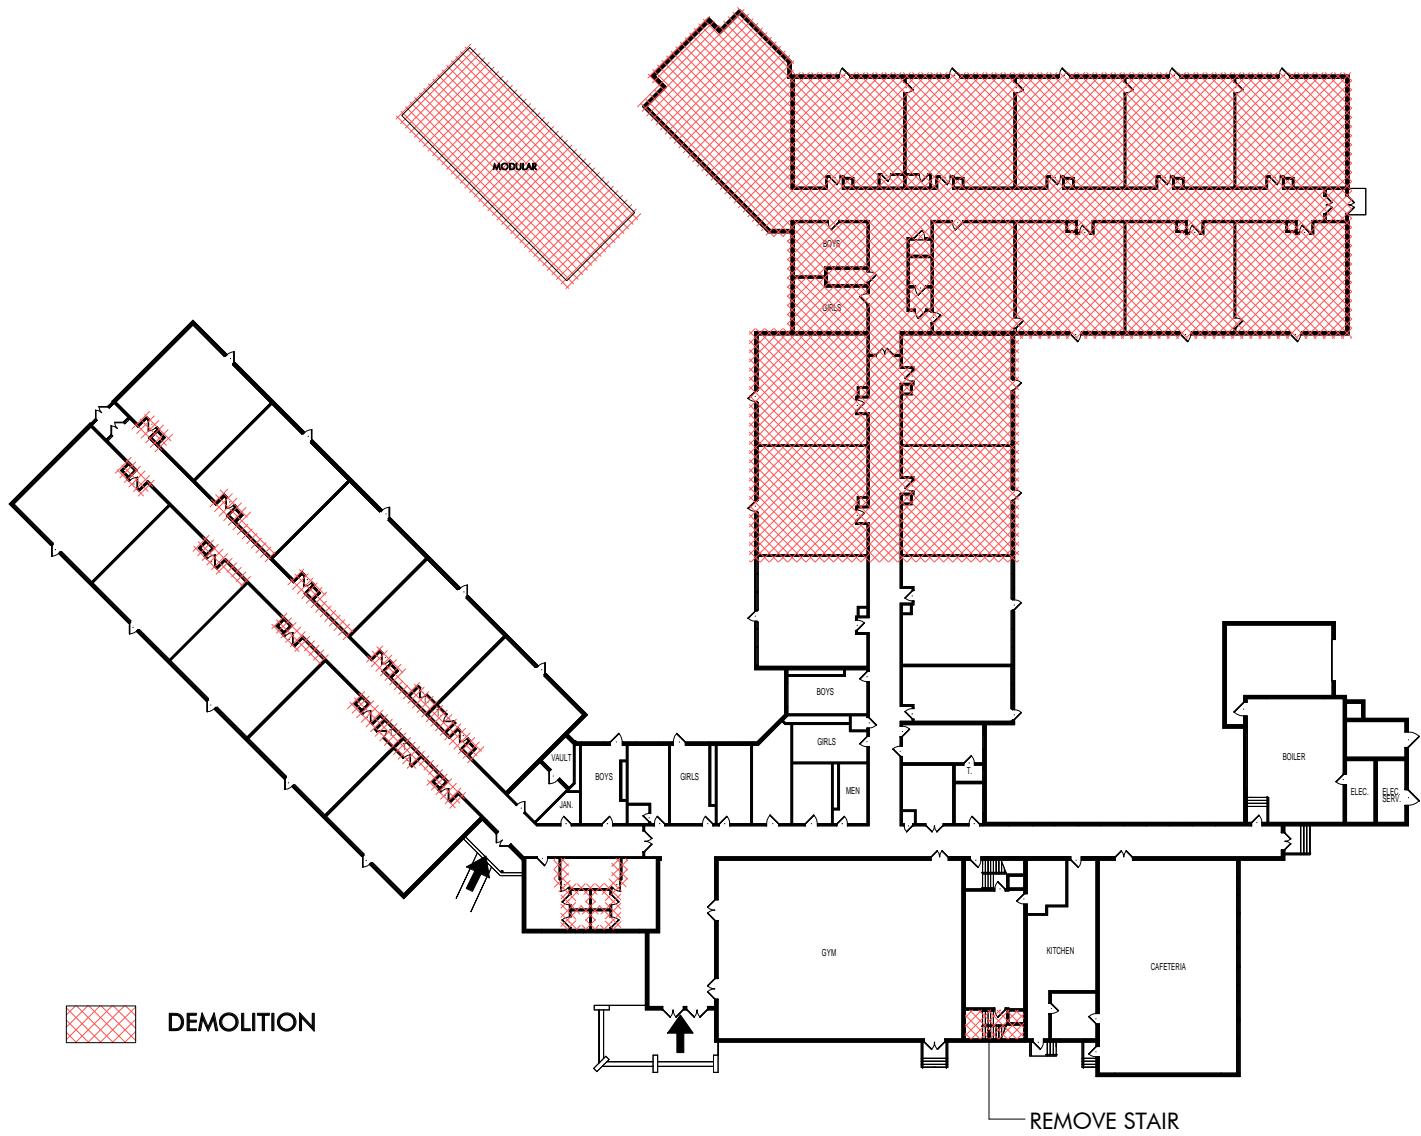
## OPTION 4 - PREFERRED CONCEPTUAL DEMOLITION PLAN

- DEMOLISH APPROX. 20,800 SQUARE FEET EXISTING BUILDING
- REMOVE FOOTINGS & FOUNDATION, RESTORE SITE
- SELECTIVE DEMOLITION INCLUDES SOME PARTITION, PORTION OF CORRIDOR WALLS
- REMOVE CEILINGS AT CLASSROOMS & CLASSROOM CORRIDOR
- REMOVE CLASSROOM FLOOR FINISHES
- REMOVE BLACK BOARDS AND WHITE BOARDS & CASEWORK AT CLASSROOMS

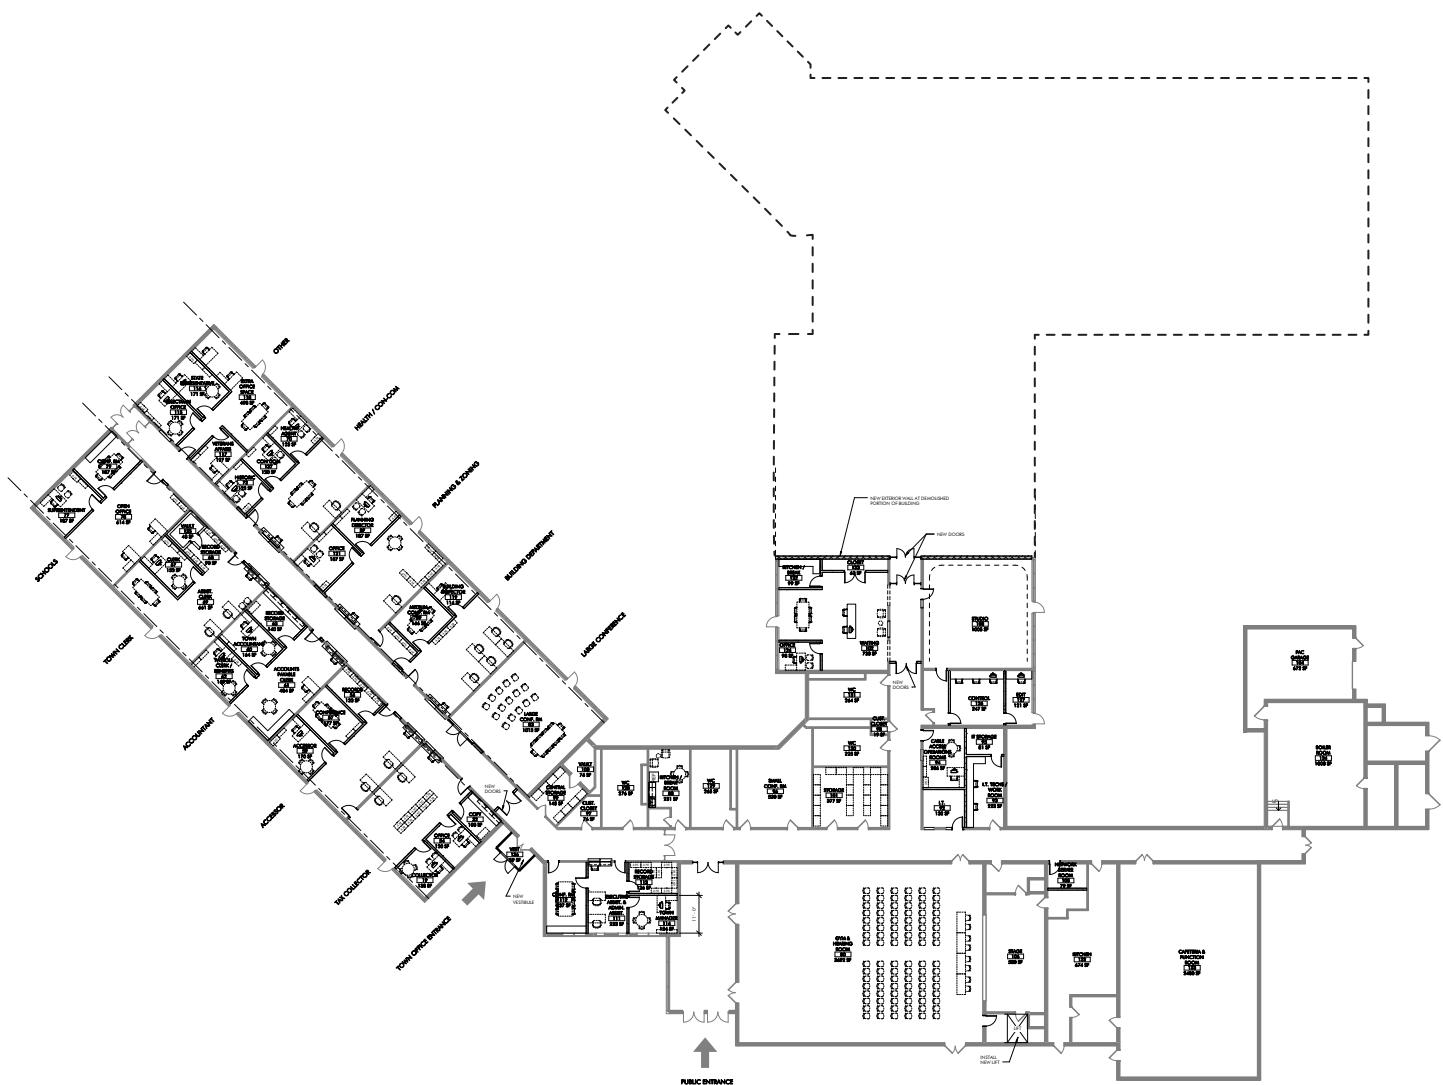
## OPTION 4 - PREFERRED CONCEPTUAL FURNISHINGS PLAN

- ASSUME RENOVATION OF WC'S (4) NEW FINISHES & FIXTURES ADA ACCESSIBLE
- ASSUME NEW CEILINGS AND LIGHT FIXTURES
- ASSUME ALLOWANCE FOR MISC. UPDATES TO FIXTURES, CABINETS & HARDWARE FOR ADA COMPLIANCE
- ASSUME PARTIAL CORRIDOR WALL DEMOLITION AND NEW ENTRANCE
- ASSUME NEW TRANSACTION COUNTERS & SECURE GLASS PARTITIONS AT EACH DEPARTMENT
- NEW PAINT, ALL LOCATIONS
- ASSUME NEW FLOORING IN OFFICE WING
