**Brooks House**

1033 Massachusetts Avenue  
Lunenburg, MA 01462

## Property Condition Assessment

**February 6, 2018**

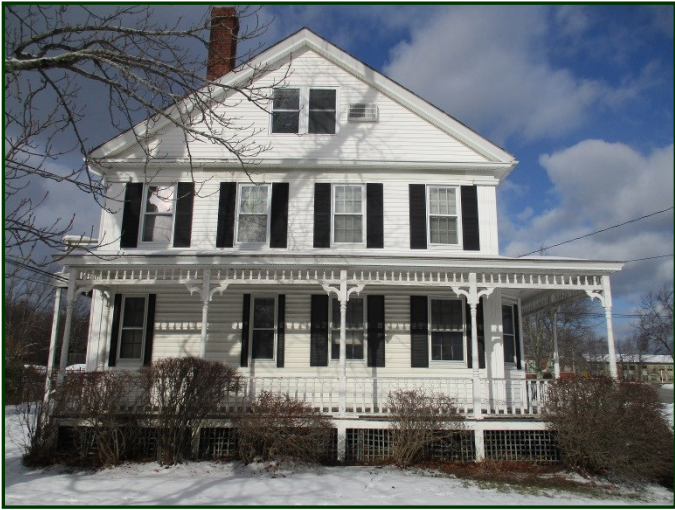
**Photo #2:** South elevation (front of building)

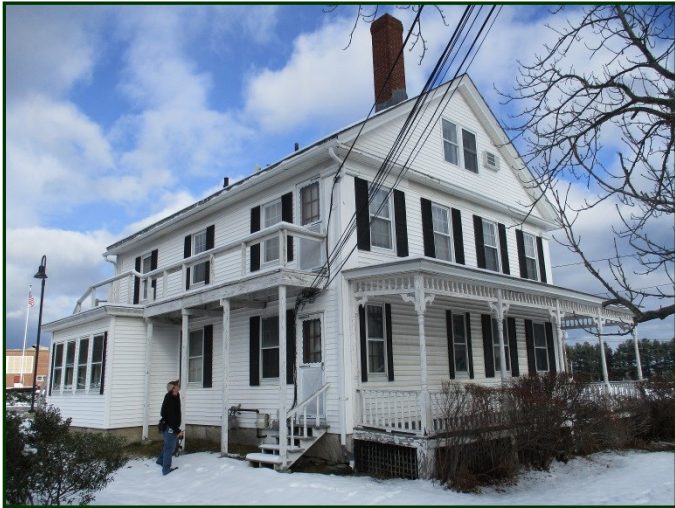
**Photo #3:** View from southwest corner of building

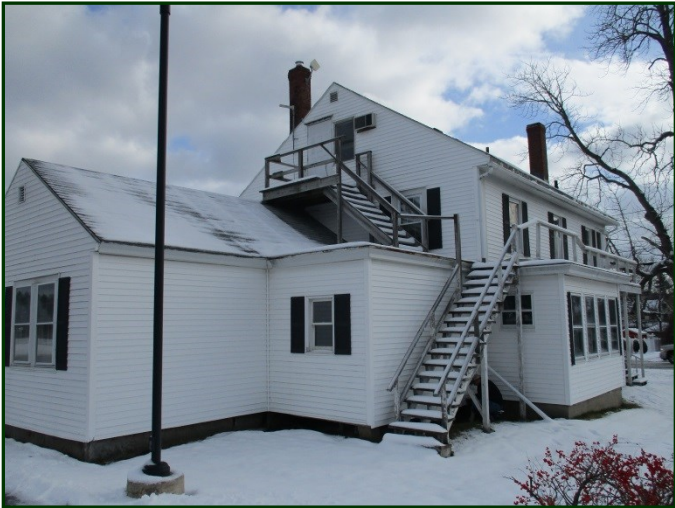
**Photo #4:** View from northwest corner of building. Note wooden fire escape

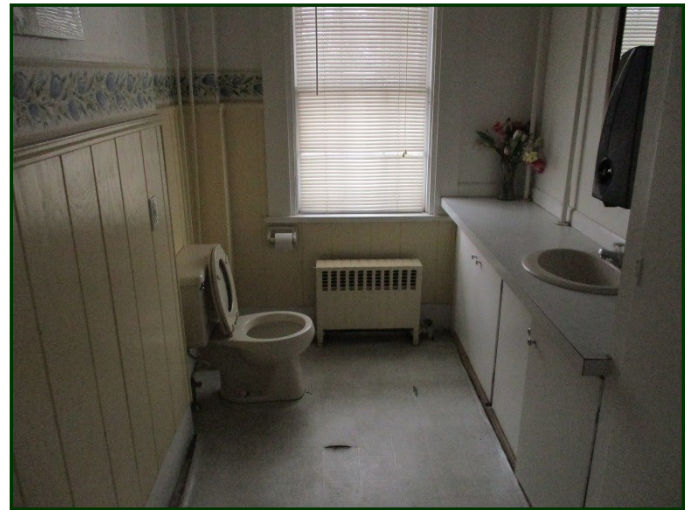
**Photo #22:** First floor level bathroom with resilient floor tiles

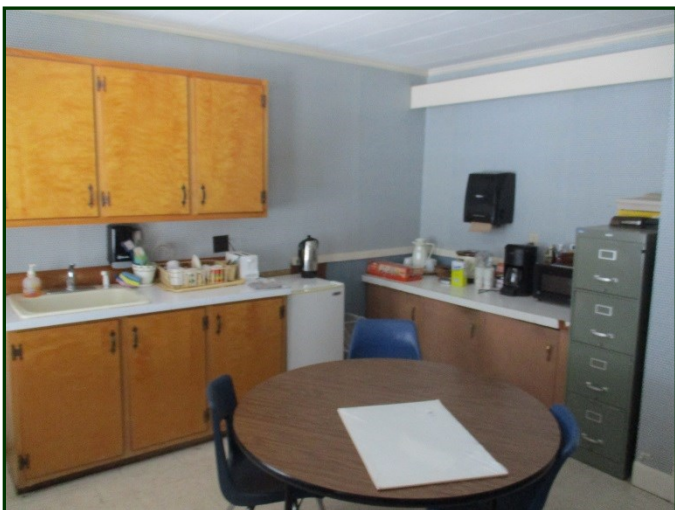
**Photo #23:** Wood cabinetry with laminate countertops

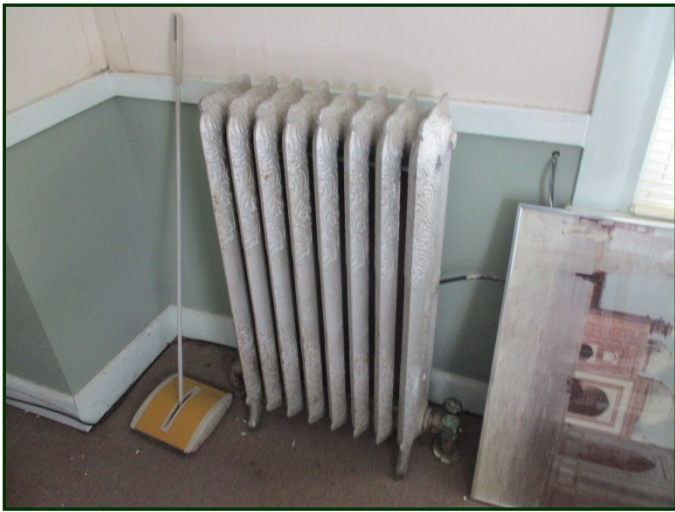
**Photo #31:** Cast iron radiator

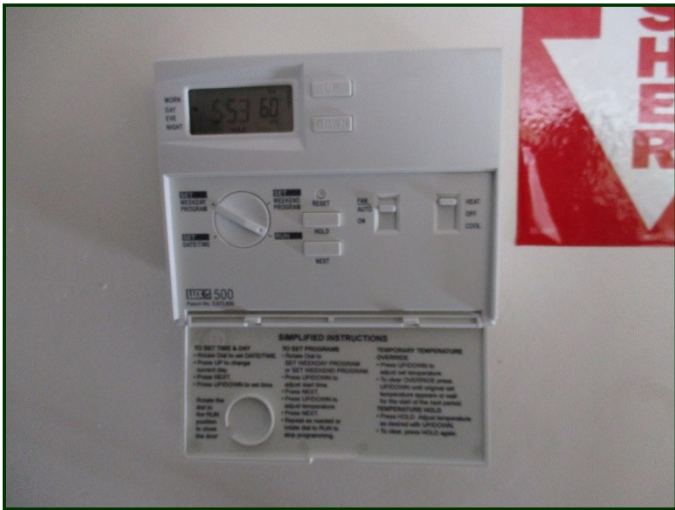
**Photo #33:** Programable thermostat

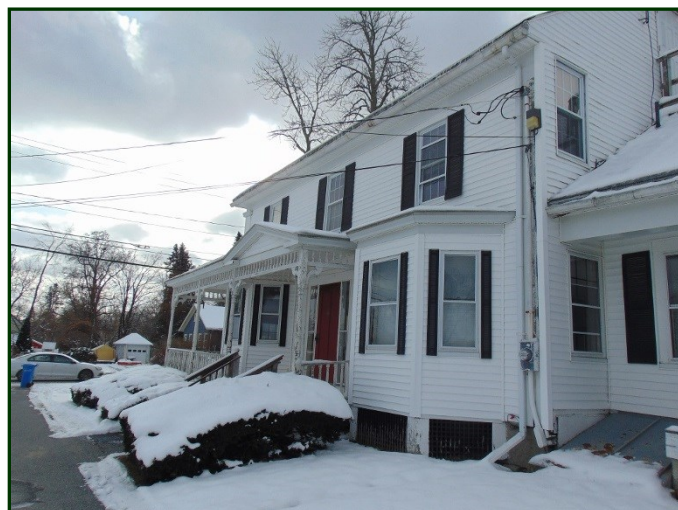
**Photo #38:** East (side) elevation of Brooks House.

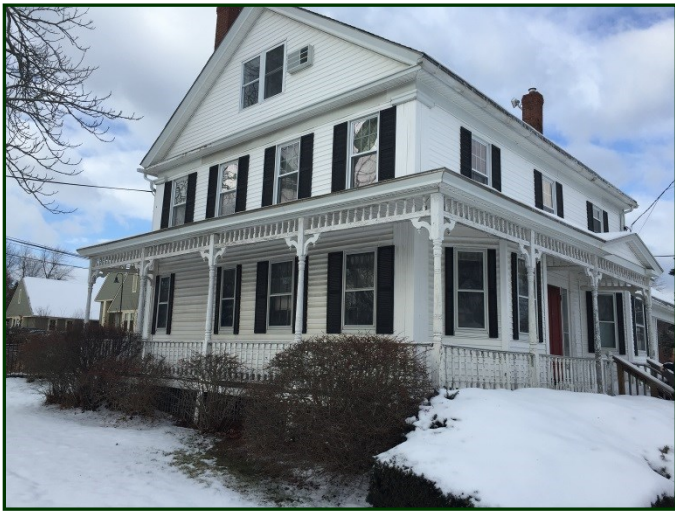
**Photo #49:** Photograph depicts general view of the front side of the Site Building

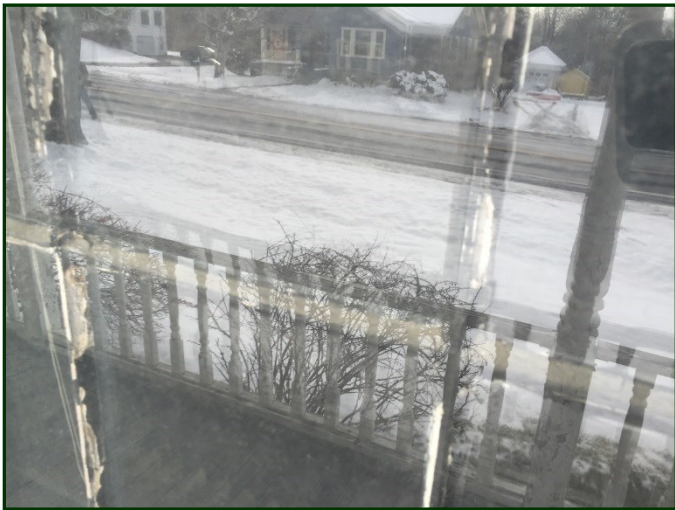
**Photo #51:** Photograph depicts general view of exterior window glazing

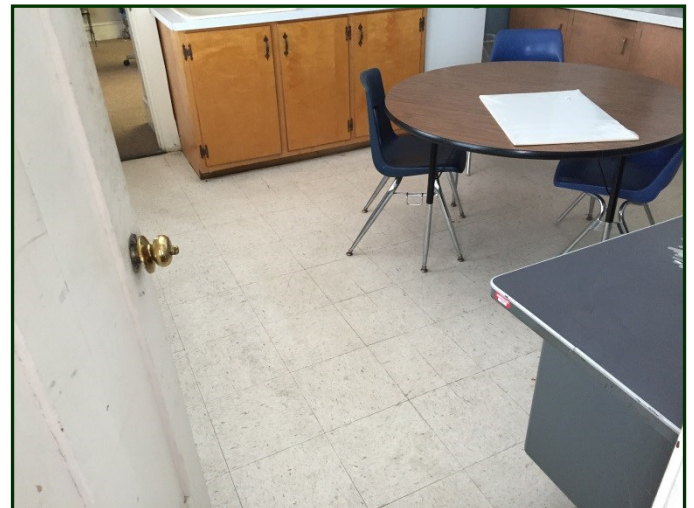
**Photo #54:** Photograph depicts general view of 12" Floor Tile within the Breakroom

At the time of the assessment, the suspect ACMs identified were observed to be in fair condition. Please refer to Attachment A which includes photographic documentation of the suspect ACMs identified during the assessment.

Prior to any renovation or demolition activities, sampling of suspect ACMs that may be disturbed would need to be conducted in applicable areas to determine asbestos content. A comprehensive ACM survey is required to be conducted to comply with the Environmental Protection Agency (EPA) National Emission Standard for Hazardous Air Pollutants (NESHAPs) 40 CFR Part 61. Until these materials have been sampled and determined to be non-asbestos containing, these materials should be managed in place as presumed asbestos-containing materials (PACMs).

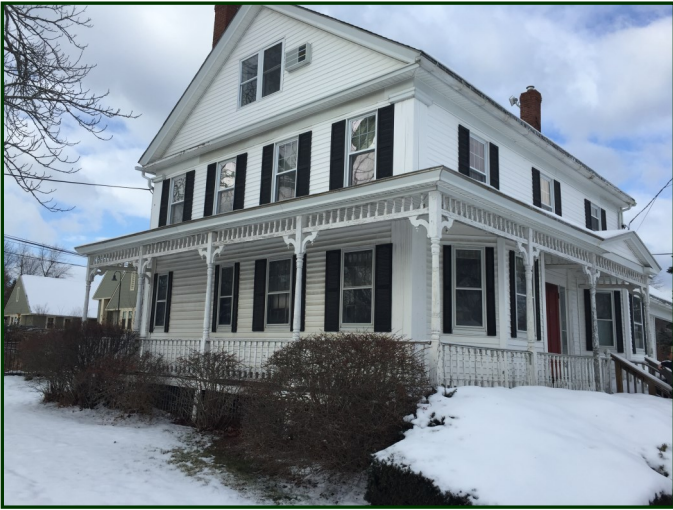
**Photo #1:** Photograph depicts general view of the front side of the Site Building

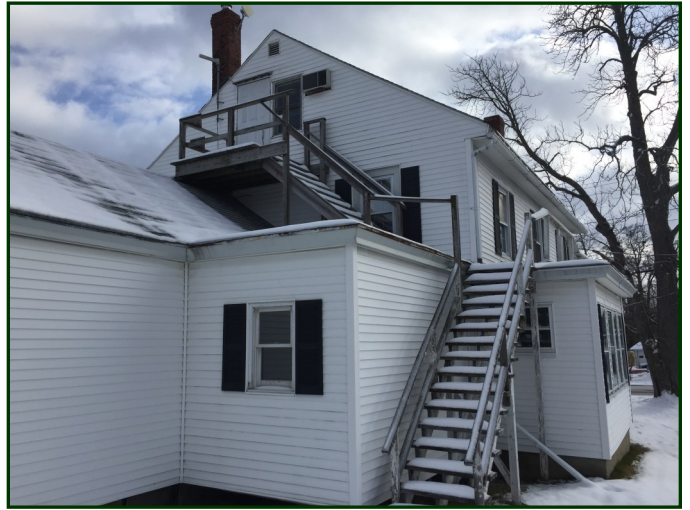
**Photo #2:** Photograph depicts general view of the backside of the Site Building

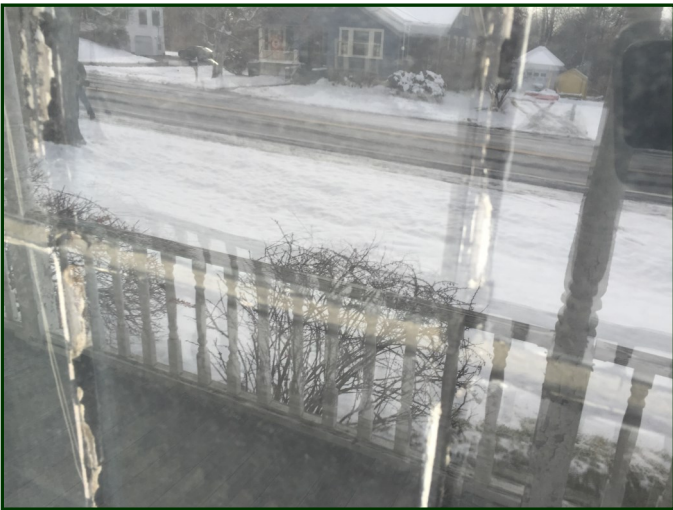
**Photo #3:** Photograph depicts general view of exterior window glazing

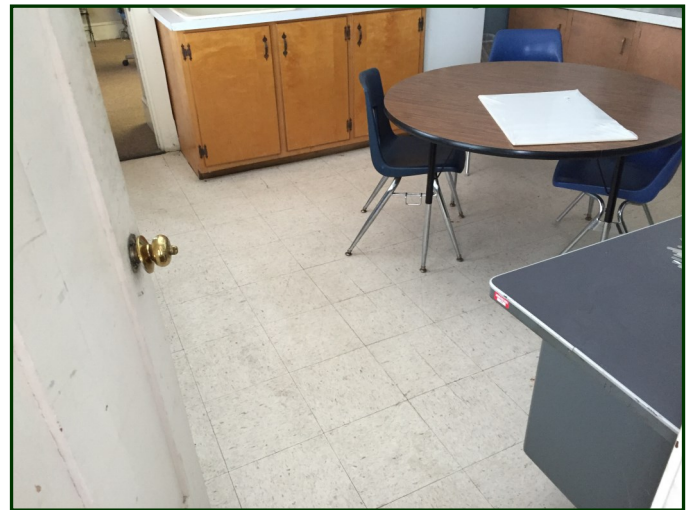
**Photo #6:** Photograph depicts general view of 12" Floor Tile within the Breakroom

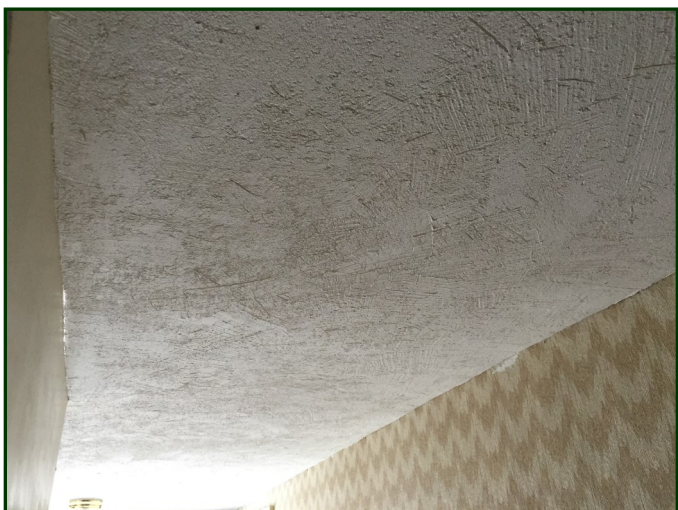
**Photo #7:** Photograph depicts general view of the Textured Ceiling with the 2nd Floor Hallway

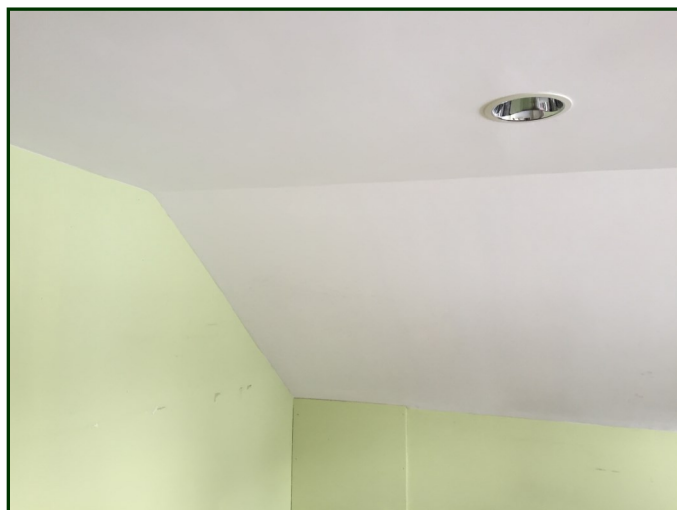
**Photo #8:** Photograph depicts general view of the Wall-board Walls and Ceiling within the 3rd Floor

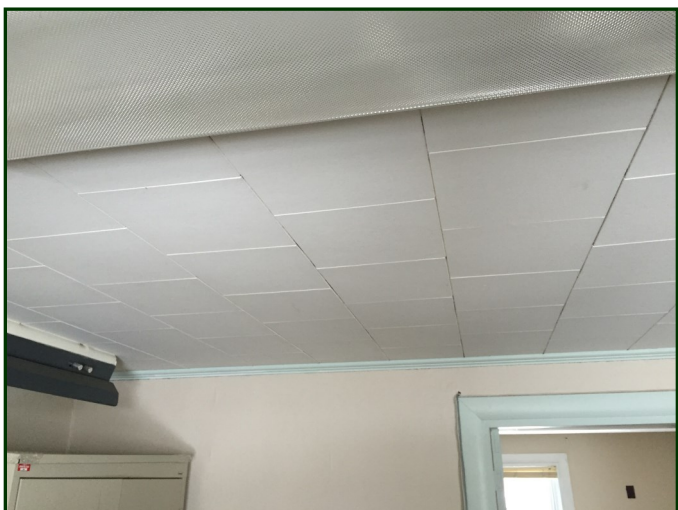
**Photo #9:** Photograph depicts general view of the 1'x 1' Ceiling Tile within the 2nd Floor Office Area

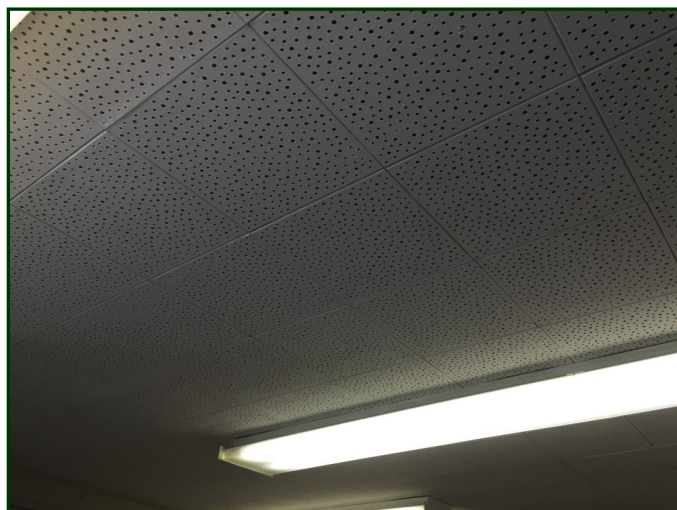
**Photo #10:** Photograph depicts general view of the 1'x 1' Ceiling Tile within the 1st Floor Office Area

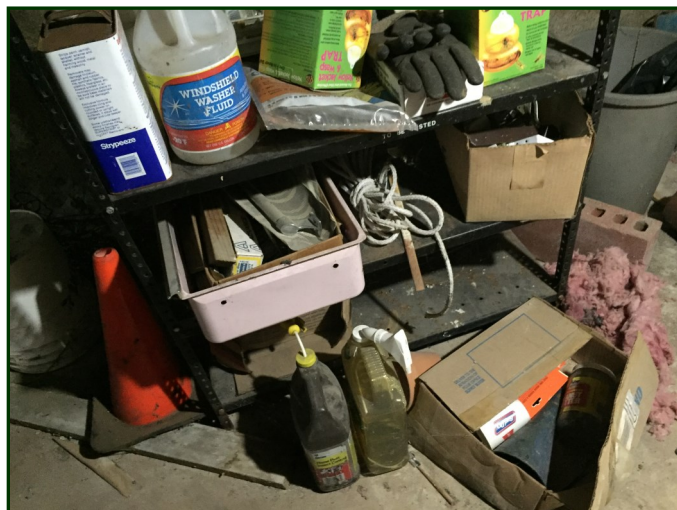
**Photo #12:** Photograph depicts general view of Chemical Storage within Basement Area
