**Brooks House**

1033 Massachusetts Avenue
Lunenburg, MA 01462

Property Condition Assessment**February 6, 2018****PREPARED FOR:**

VERTEX Project No: 48237

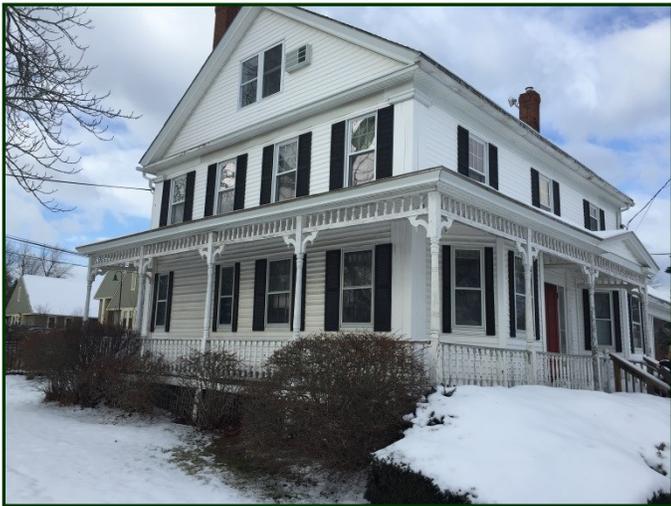
Photo #49: Photograph depicts general view of the front side of the Site Building

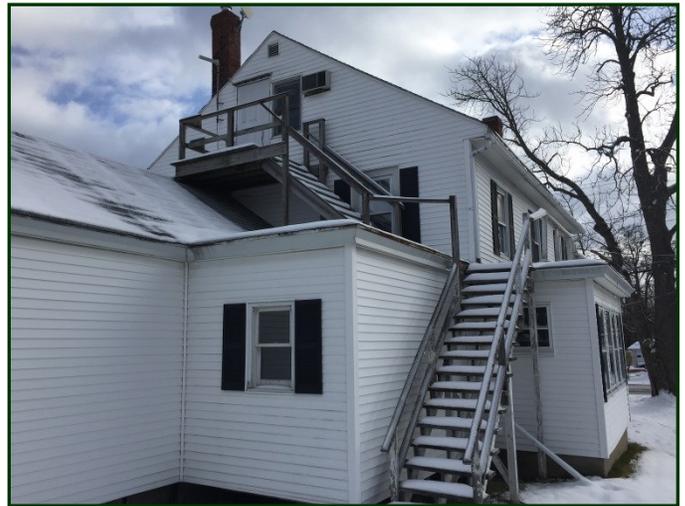
Photo #50: Photograph depicts general view of the backside of the Site Building

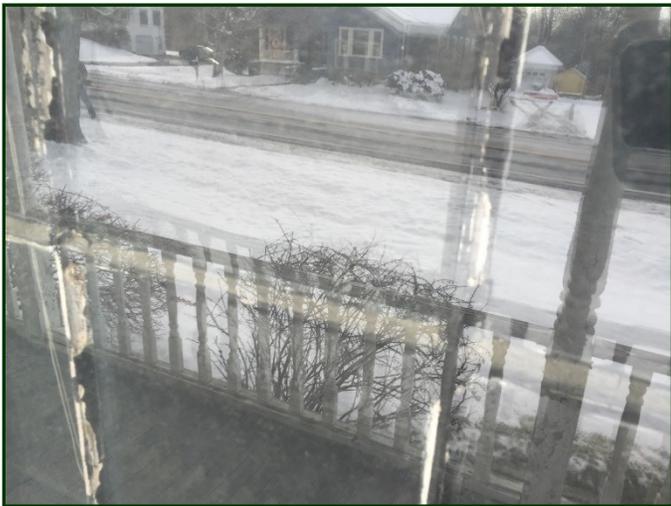
Photo #51: Photograph depicts general view of exterior window glazing

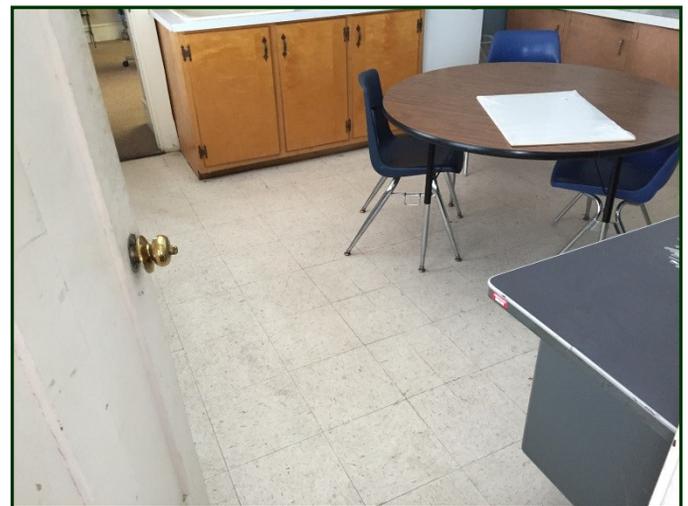
Photo #54: Photograph depicts general view of 12" Floor Tile within the Breakroom

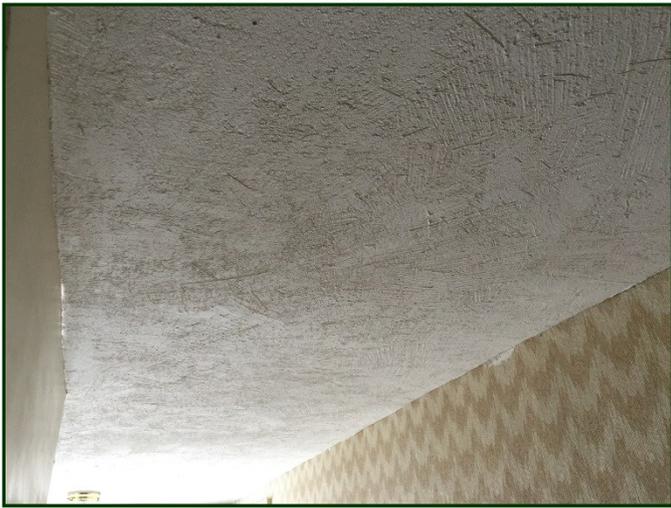
Photo #55: Photograph depicts general view of the Textured Ceiling with the 2nd Floor Hallway

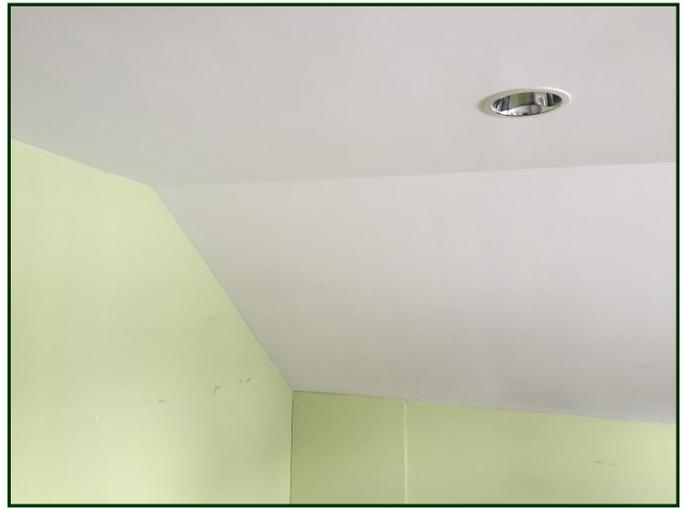
Photo #56: Photograph depicts general view of the Wall-board Walls and Ceiling within the 3rd Floor

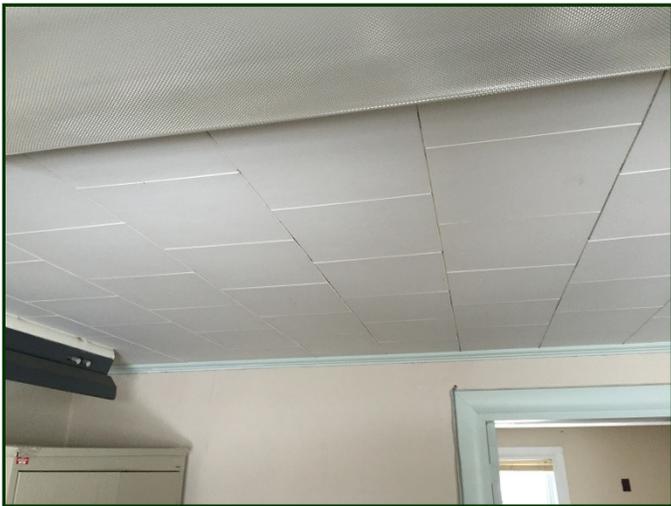
Photo #57: Photograph depicts general view of the 1'x 1' Ceiling Tile within the 2nd Floor Office Area

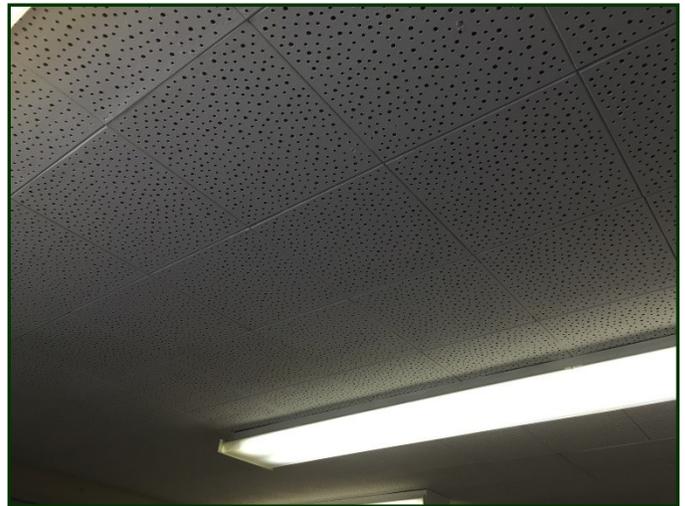
Photo #58: Photograph depicts general view of the 1'x 1' Ceiling Tile within the 1st Floor Office Area

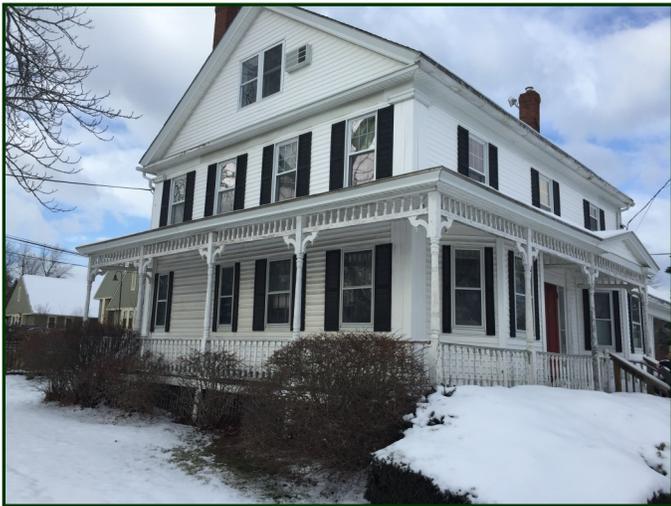
Photo #1: Photograph depicts general view of the front side of the Site Building

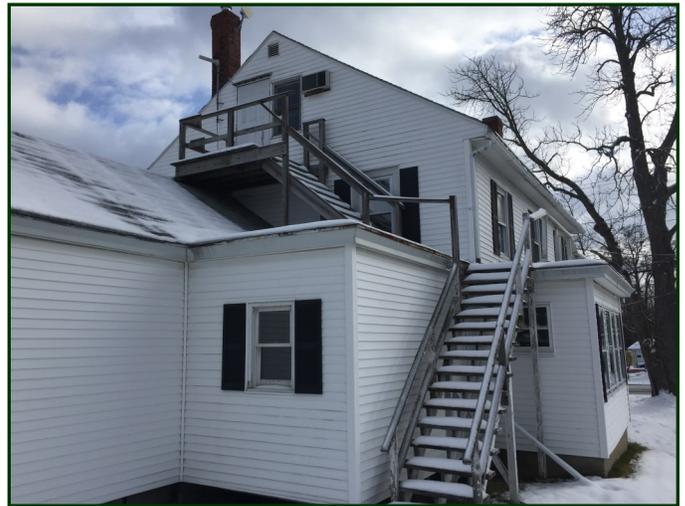
Photo #2: Photograph depicts general view of the backside of the Site Building

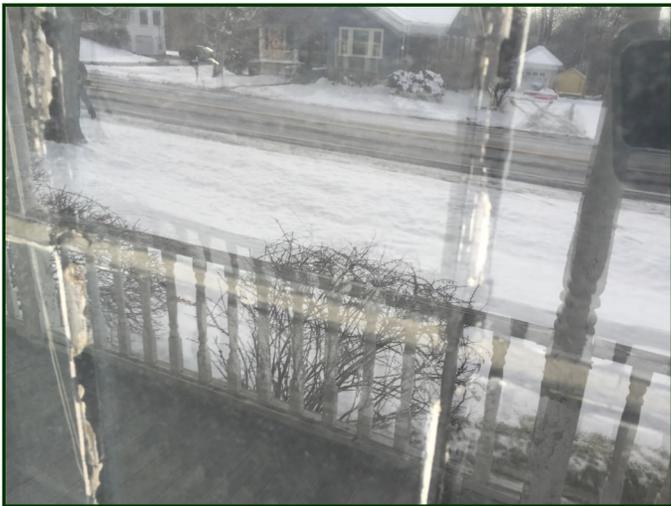
Photo #3: Photograph depicts general view of exterior window glazing

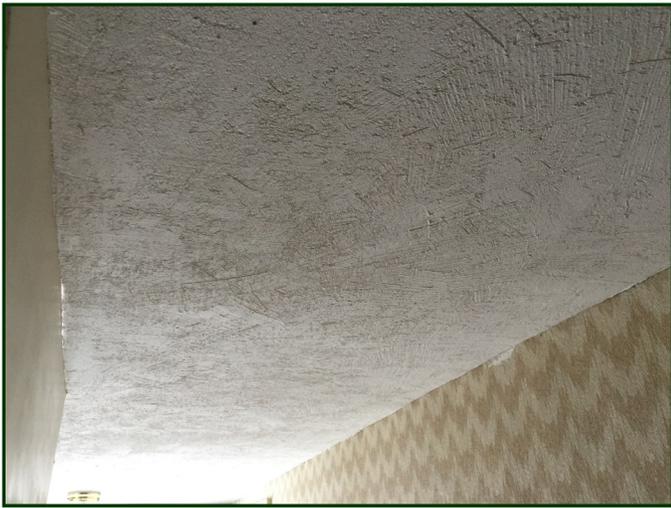
Photo #7: Photograph depicts general view of the Textured Ceiling with the 2nd Floor Hallway

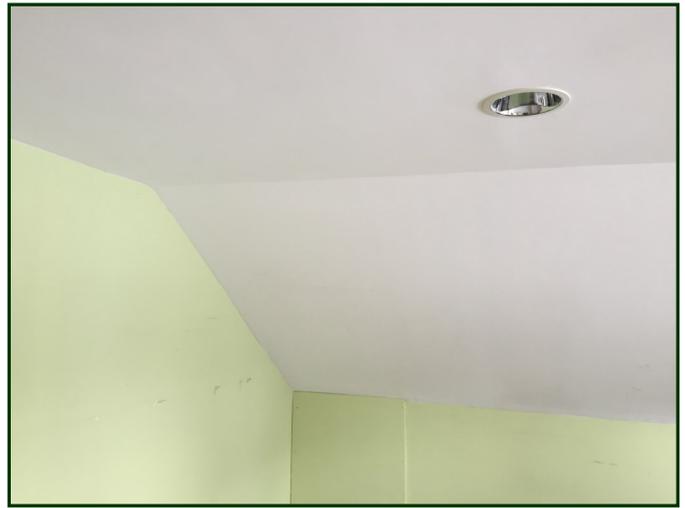
Photo #8: Photograph depicts general view of the Wall-board Walls and Ceiling within the 3rd Floor

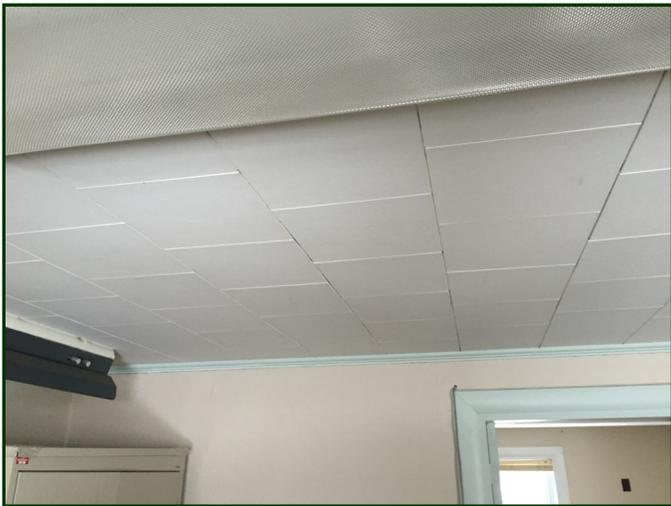
Photo #9: Photograph depicts general view of the 1'x 1' Ceiling Tile within the 2nd Floor Office Area

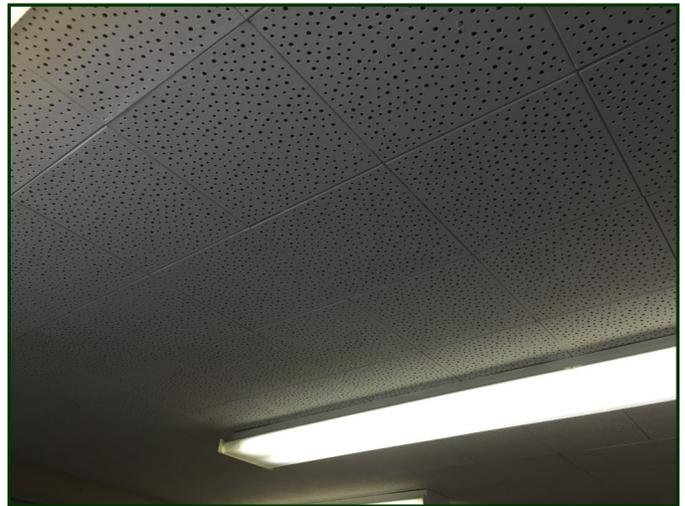
Photo #10: Photograph depicts general view of the 1'x 1' Ceiling Tile within the 1st Floor Office Area
