Turkey Hill Elementary School

Property Condition Assessment

March 9, 2018

VERTEX Project No: 48237

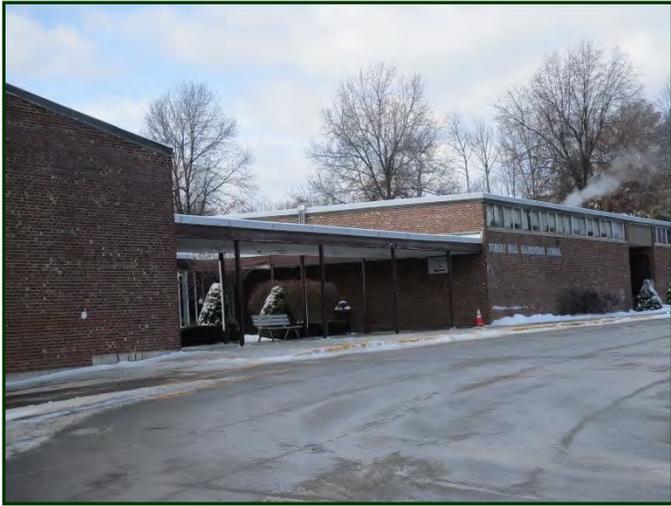
Photo #1: Partial east elevation (front of school building)

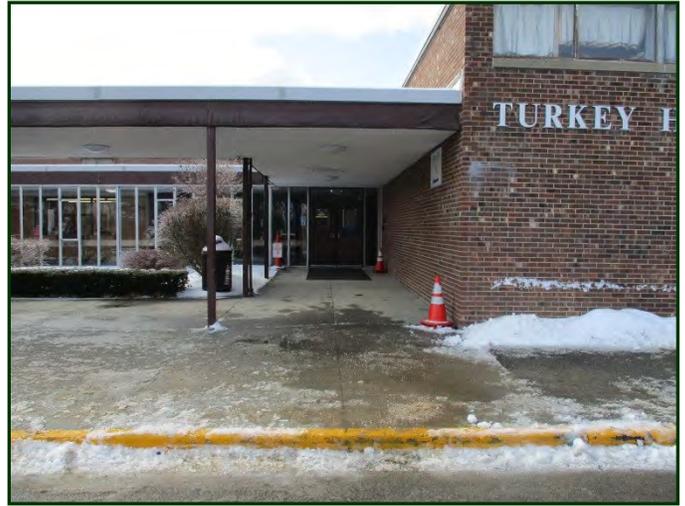
Photo #2: Main building entrance at east elevation . Note painted concrete curbing

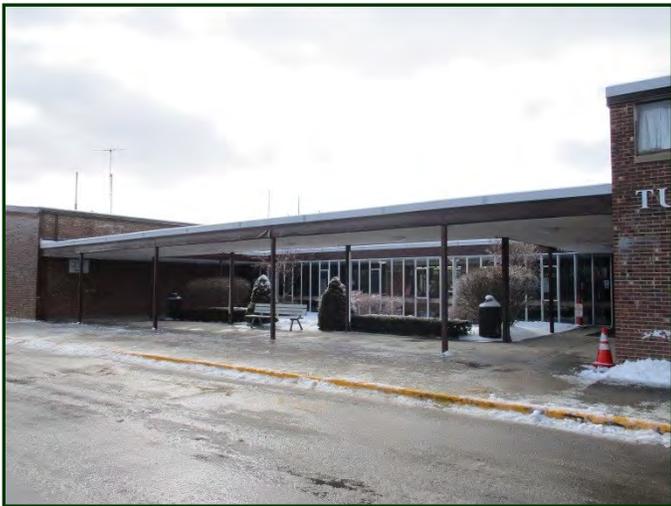
Photo #3: Canopy at front of building

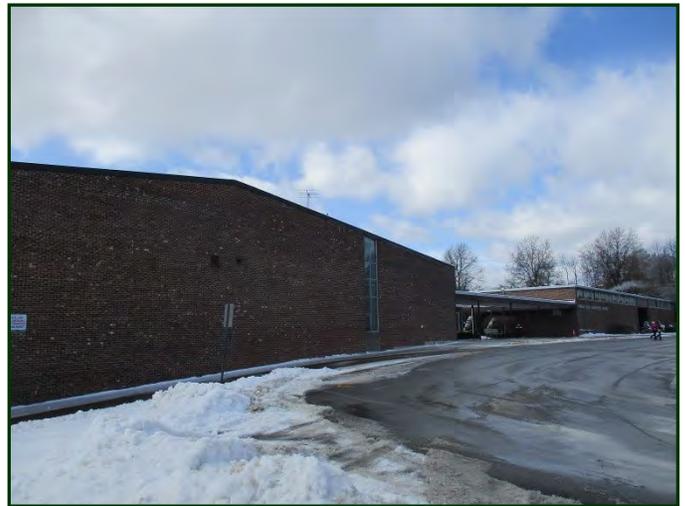
Photo #4: Overview of front of building (called east elevation). Note gymnasium in foreground

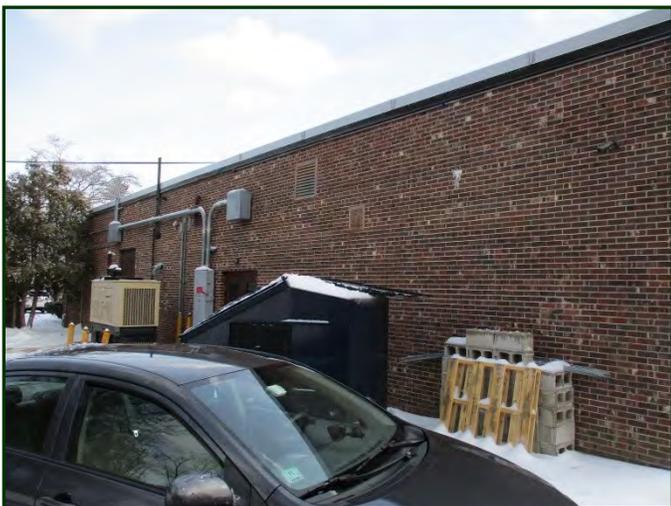
Photo #5: Partial north elevation (adjacent to mechanical room)

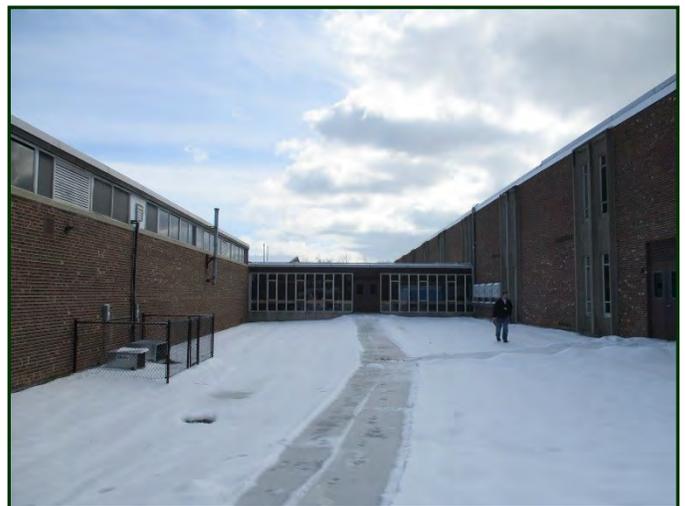
Photo #6: Partial north elevation. Note link (beyond) between building wings

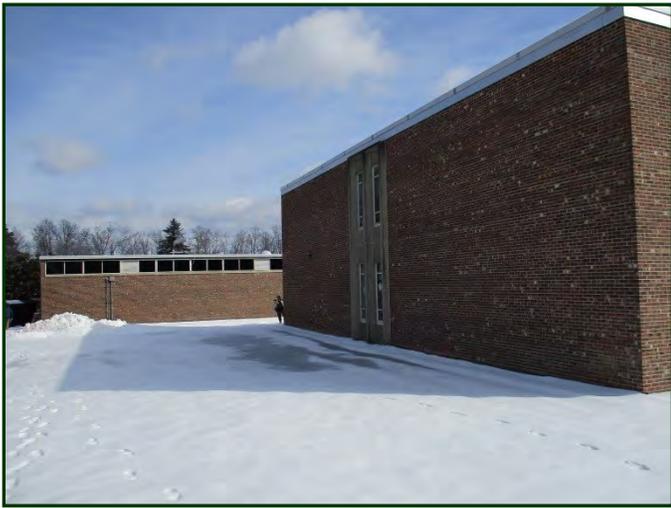
Photo #7: Partial north elevation

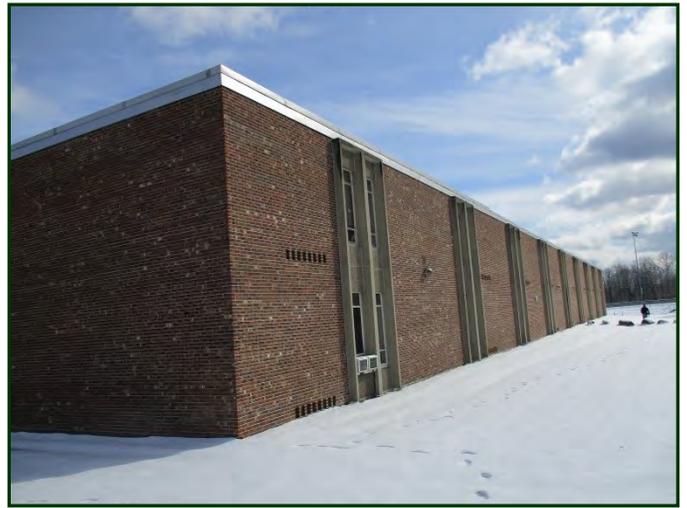
Photo #8: Partial west elevation

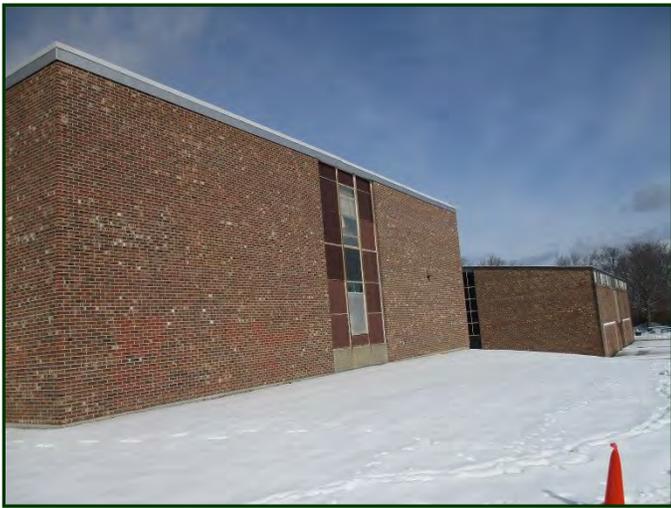
Photo #9: Partial south elevation

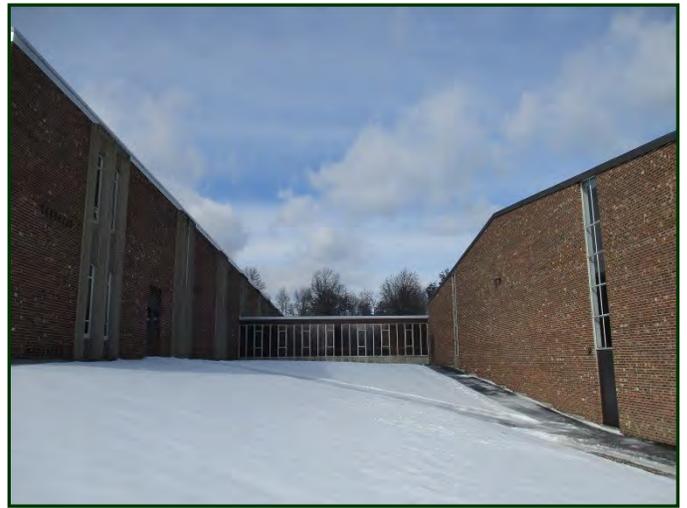
Photo #10: Partial south elevation. Note link beyond between wings

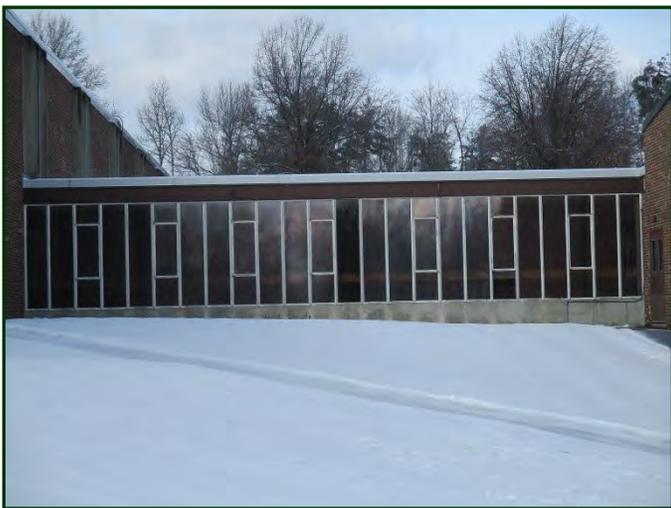
Photo #11: Close-up view of link between wings.

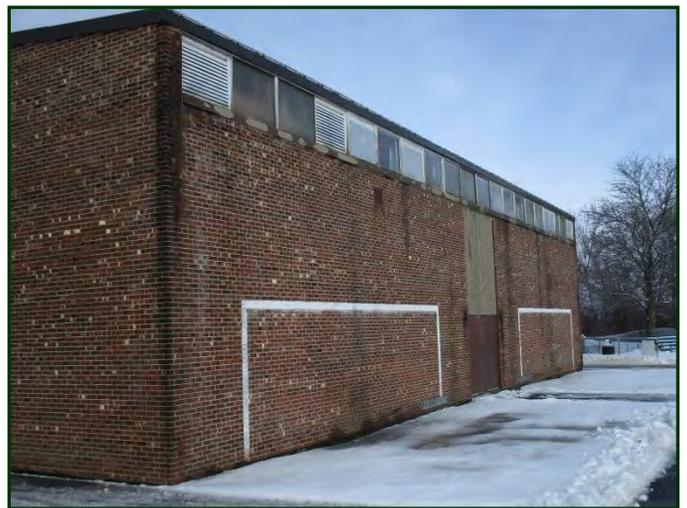
Photo #12: South side of gymnasium

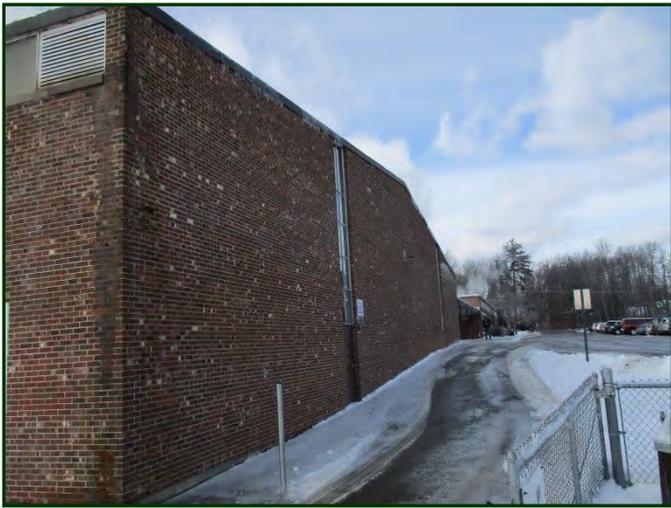
Photo #13: East side of gymnasium. Note asphalt paving and chain link fencing

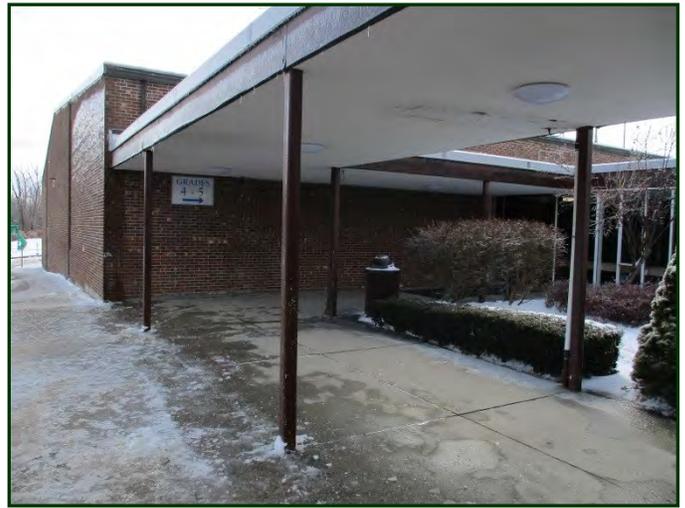
Photo #14: View of concrete sidewalk at courtyard entrance

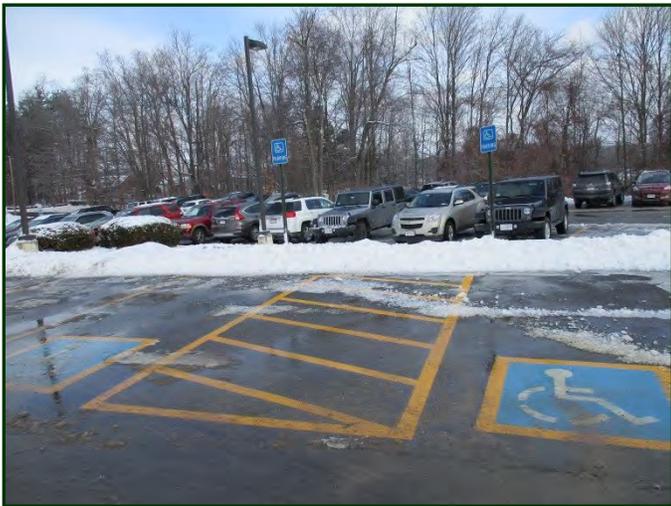
Photo #15: Accessible parking spaces adjacent to main building entrance. Note asphalt paving

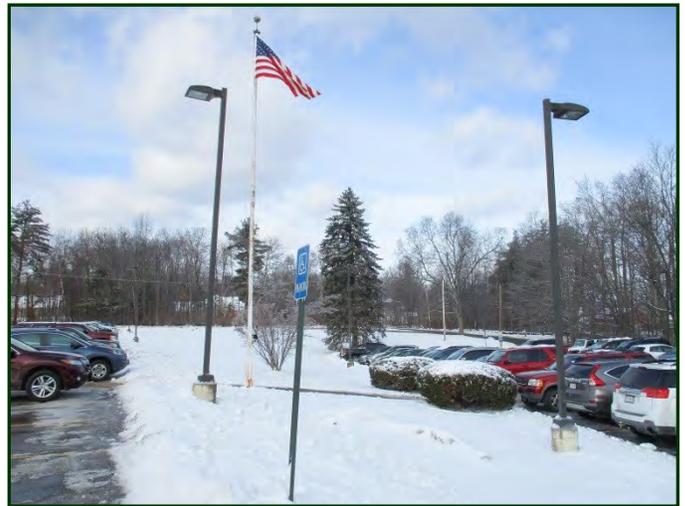
Photo #16: View of landscaping with metal pole-mounted (site) lighting fixtures

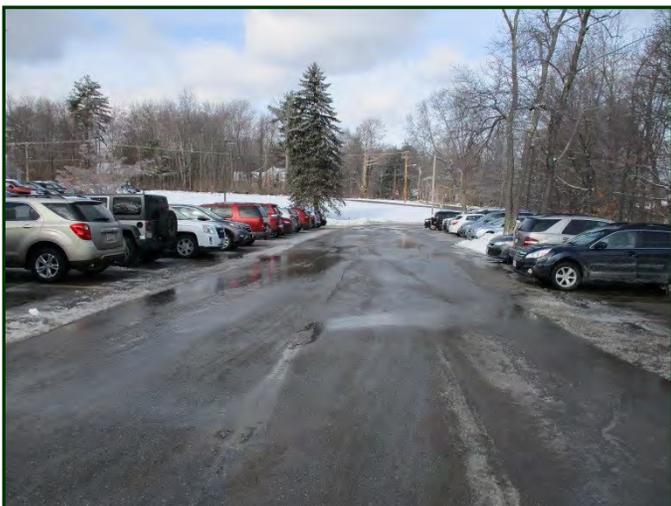
Photo #17: View of asphalt-paved driveway and parking lot (east side of site)

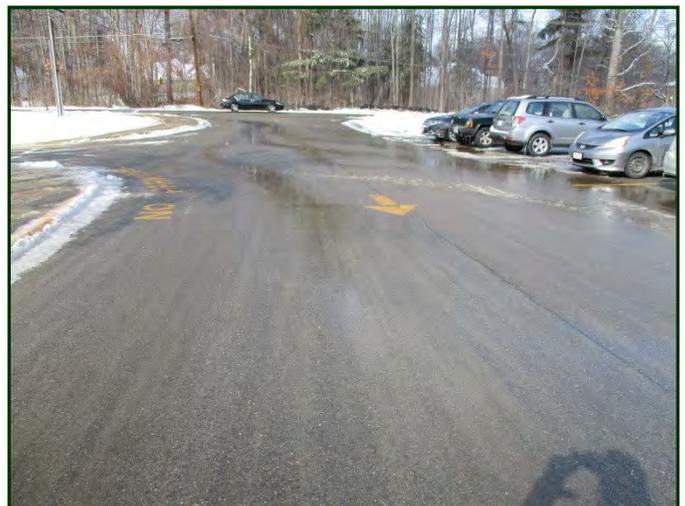
Photo #18: View of asphalt-paved driveway (north side of site)

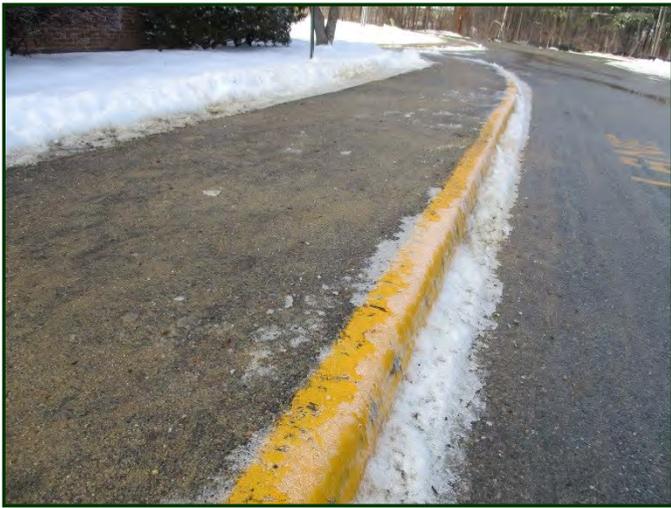
Photo #19: Close-up view of asphalt-paved sidewalk and curbing at north and east side of building

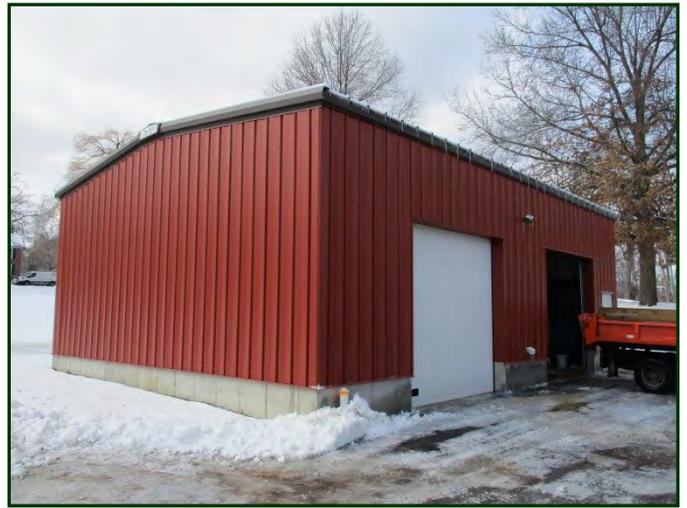
Photo #20: Garage at northwest corner of site. Pre-fabricated with painted metal rib siding

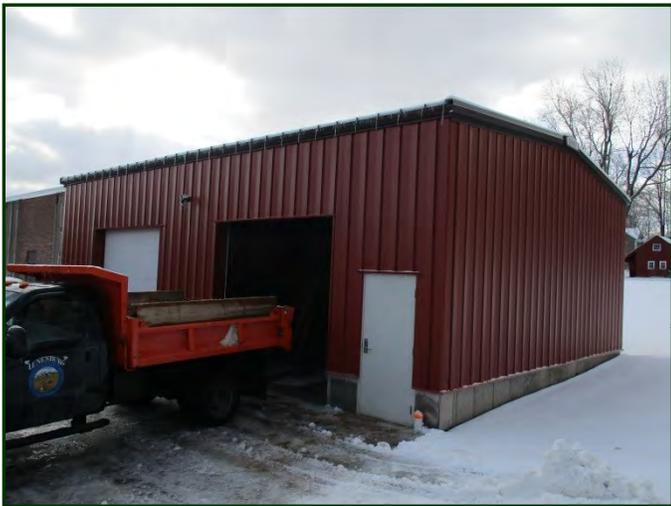
Photo #21: North and east elevations at garage. Note concrete foundation

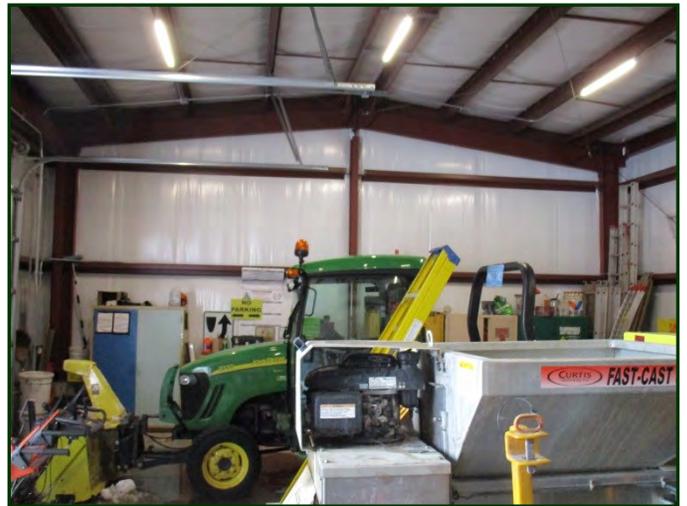
Photo #22: Interior view of garage. Note steel framing with vinyl-faced batt insulation at walls and underside of roof

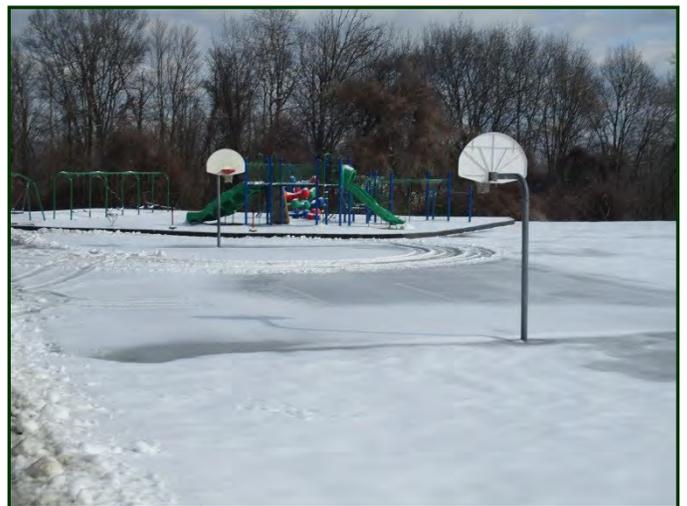
Photo #24: Playground equipment on south side of property

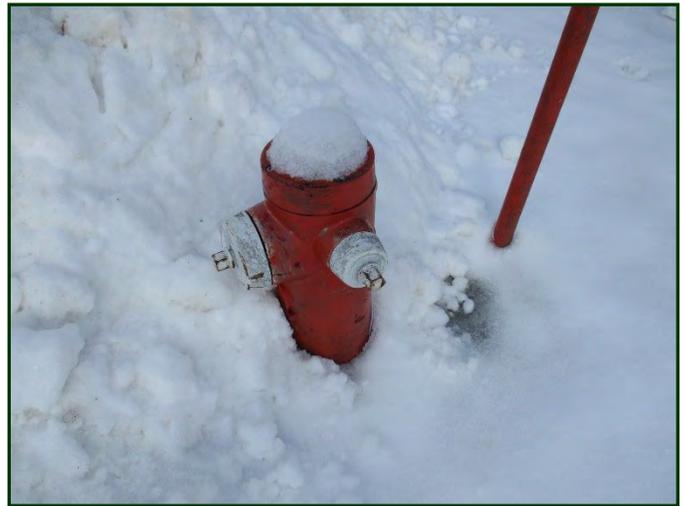
Photo #26: Fire hydrant on site

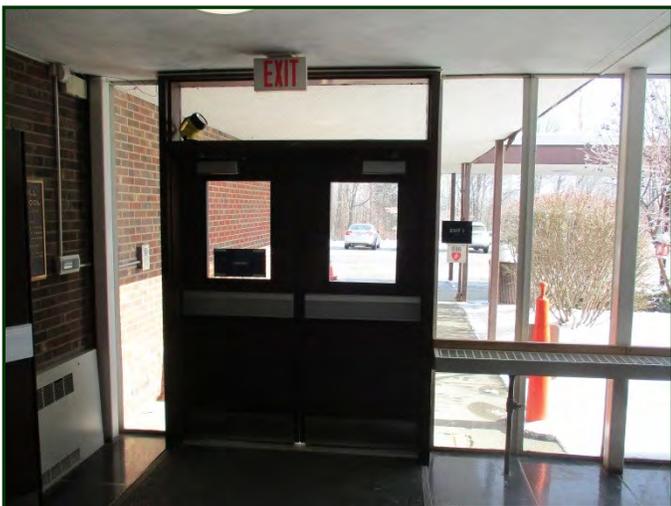
Photo #29: Interior view of main entrance doors

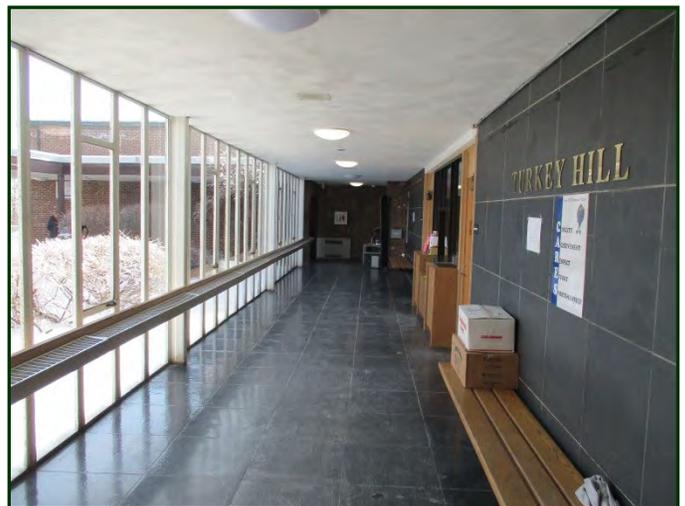
Photo #30: Hallway adjacent to main building entrance. Note cut stone flooring and wall veneer

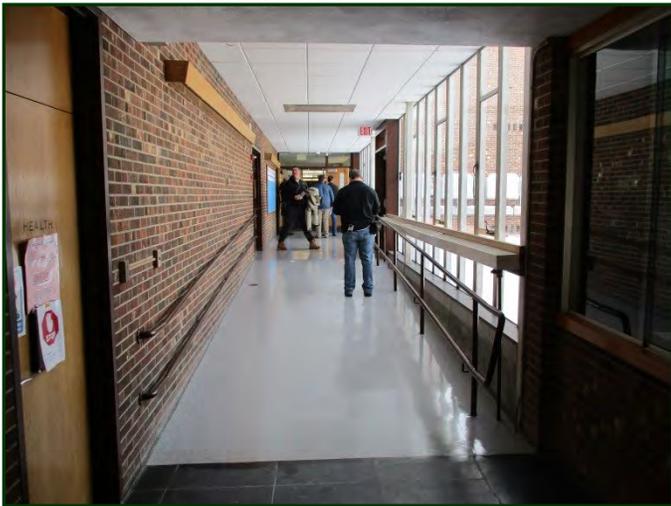
Photo #31: Ramp at north link. Note exposed brick, resilient floor tile & suspended acoustical ceiling system

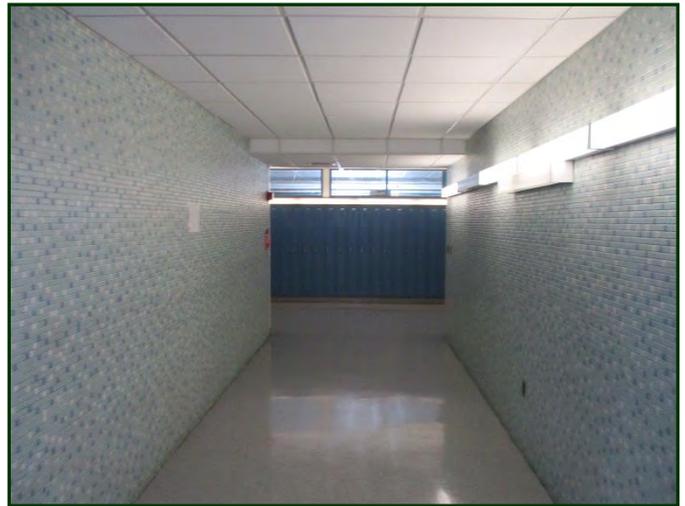
Photo #32: Hallway with ceramic tile at walls

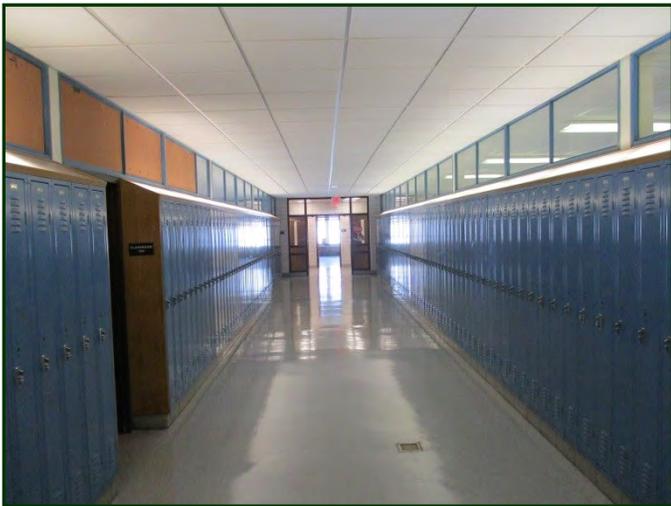
Photo #33: Hallway with painted metal lockers. Note borrowed lights above lockers

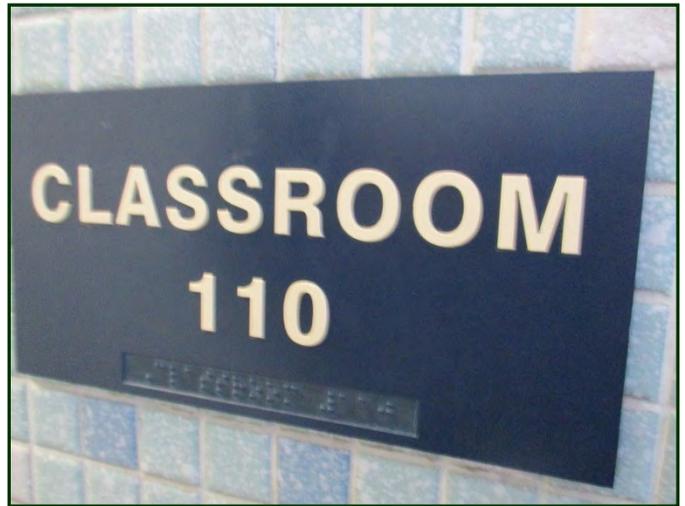
Photo #34: Wall-mounted room signage with braille lettering

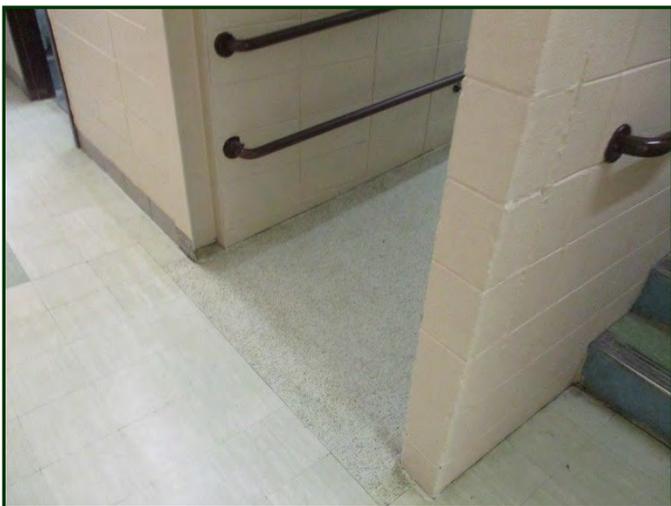
Photo #35: Ramp at Music Room with lack of level landing

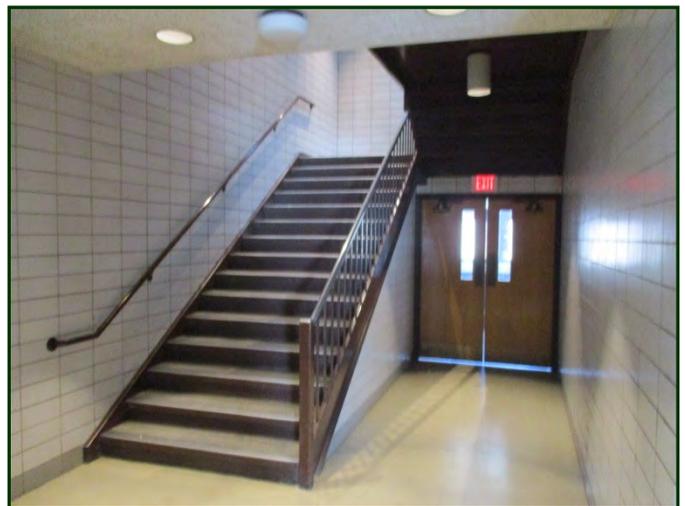
Photo #36: Egress stairwell with metal pan construction and metal railings. Note glaze faced CMU walls and resilient

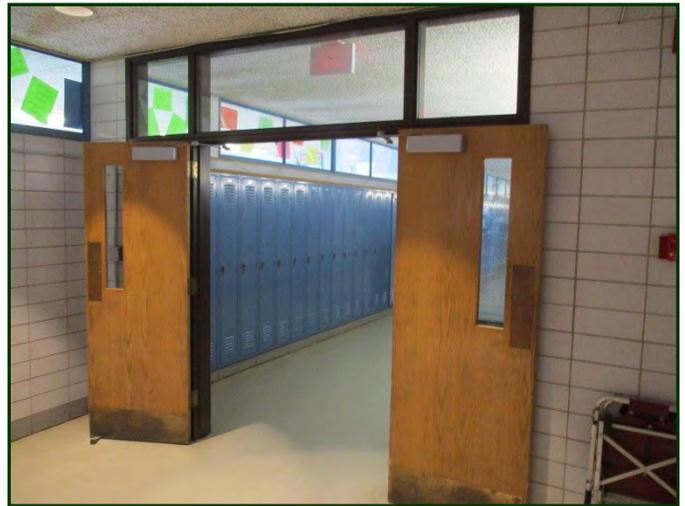
Photo #38: Compartment door assembly with solid wood doors with vision panels. Note wedge holding doors open

| ITEM | | | | | | Immediate | Reserves |
|---|---|--|---|---|---|---|---|
| 18 | 38 | Allowance to remove and replace interior doors and frames with new assemblies (solid core wood doors with steel frame) as required | 12 | EA | \$1,880.20 | | \$22,562 |

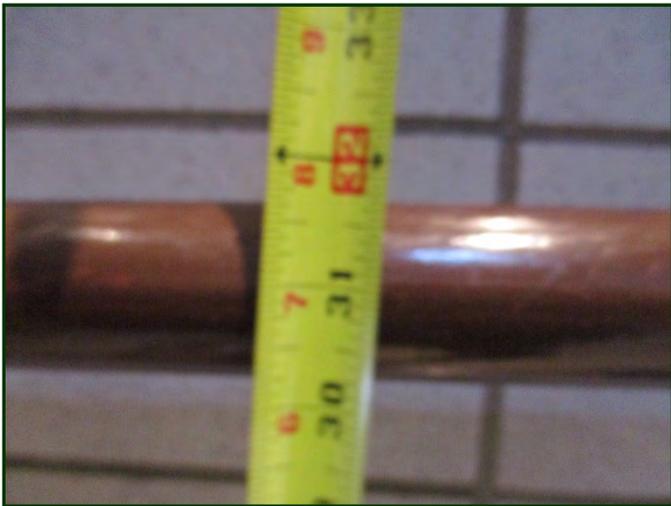
Photo #39: Handrails at stairway less than 32 inches above stairs/landing

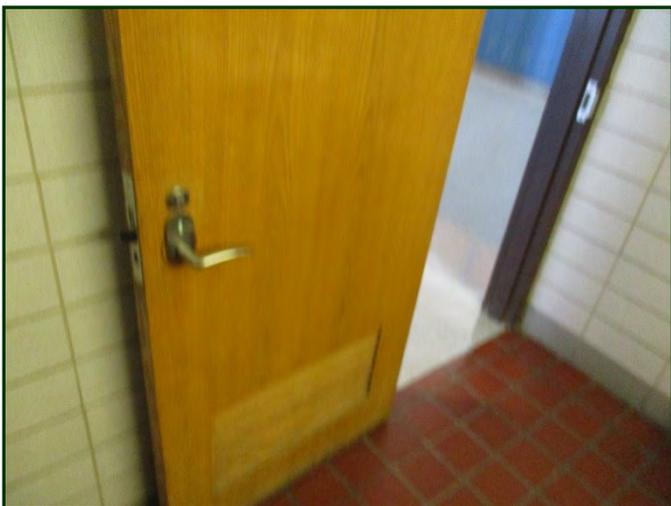
Photo #47: From photo #46, note lack of compliant clearance (18 inches) at pull side of door

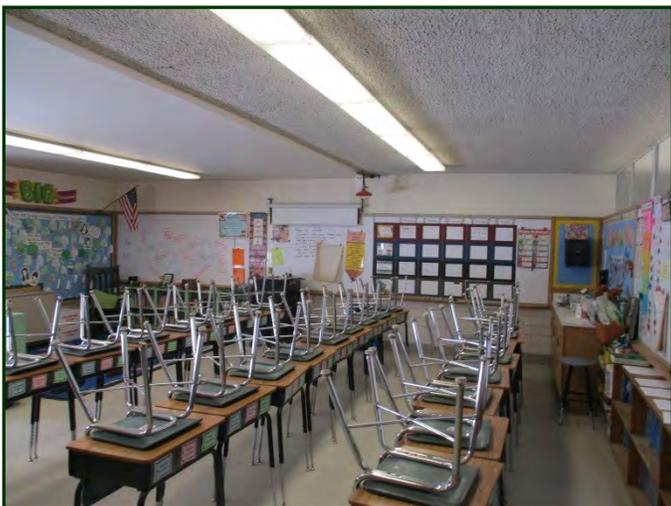
Photo #53: Classroom with older VAT flooring and painted plaster ceiling and concealed spline acoustical ceiling system

| ITEM | | | | | | Immediate | Reserves |
|---|---|--|---|---|---|---|---|
| 12 | 36, 69 | Replace existing VAT flooring with VCT resilient floor tile, vinyl composition tile | 49,000 | SF | \$4.89 | | \$239,610 |
| 17 | 53, 54 | Replace existing concealed spline acoustical tile system complete with new suspended 2 x 2 acoustical tile ceiling system | 49,160 | SF | \$7.66 | | \$376,566 |

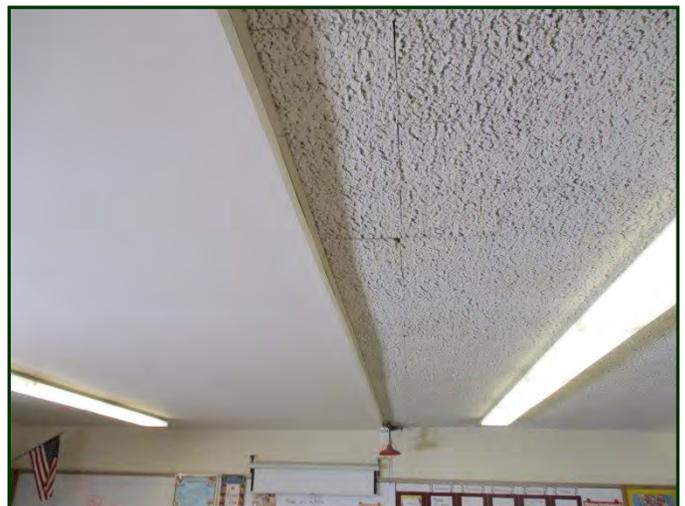
Photo #54: Close-up view of ceiling systems

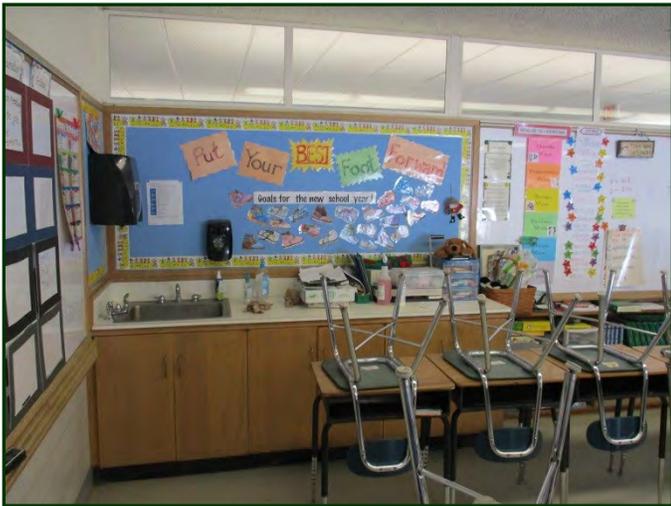
Photo #55: Classroom with typical stained wood casework with laminate countertop. Note borrowed lights above

| ITEM | | | | | | Immediate | Reserves |
|---|---|--|---|---|---|---|---|
| 15 | 55, 56, 57 | Casework, doors and partitions, refinishing, wood re-staining | 4,000 | SF | \$4.03 | | \$16,120 |

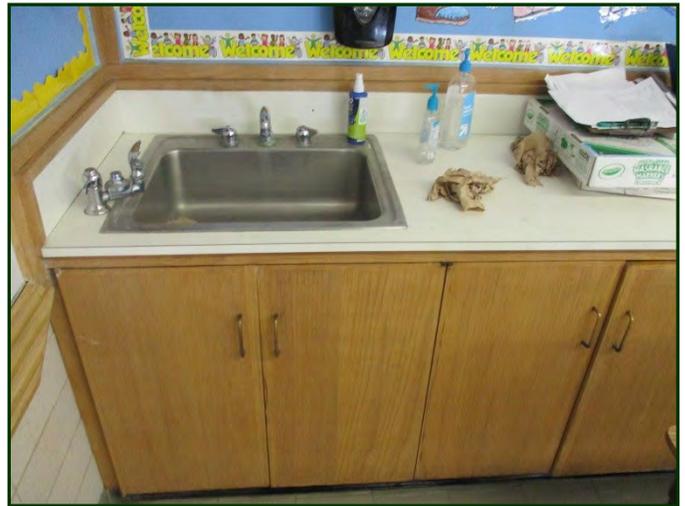
Photo #56: Close-up view of classroom casework. Note drinking fountain at sink

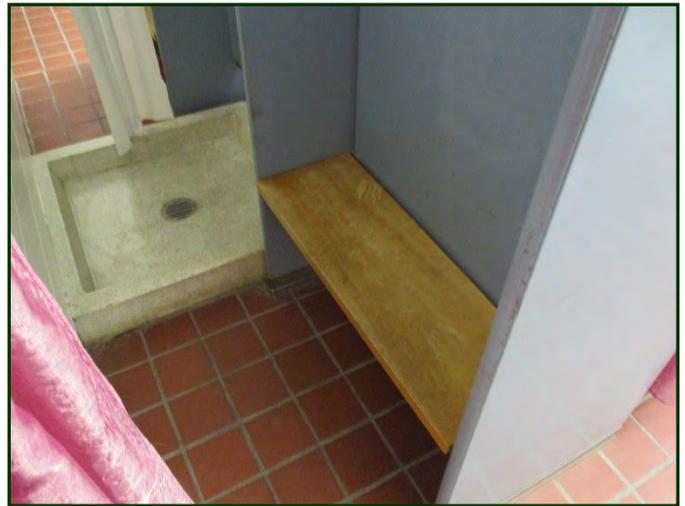
Photo #68: Shower stall at Girl's Locker Room. Note non-accessible stall

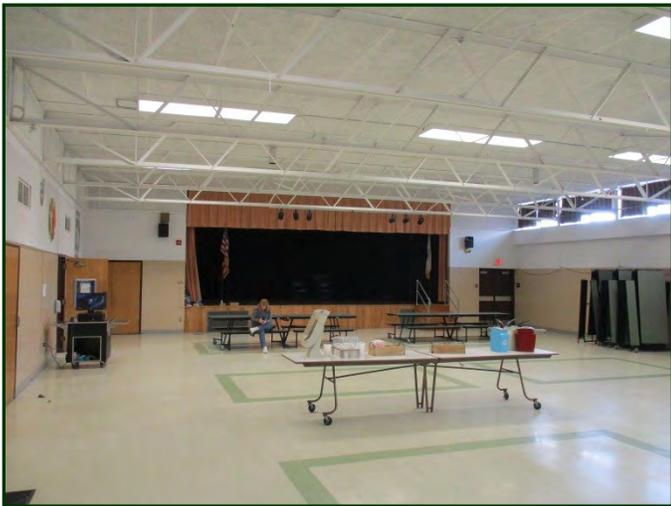
Photo #69: Cafetorium adjacent to main building entrance (east side of school). Note stage beyond

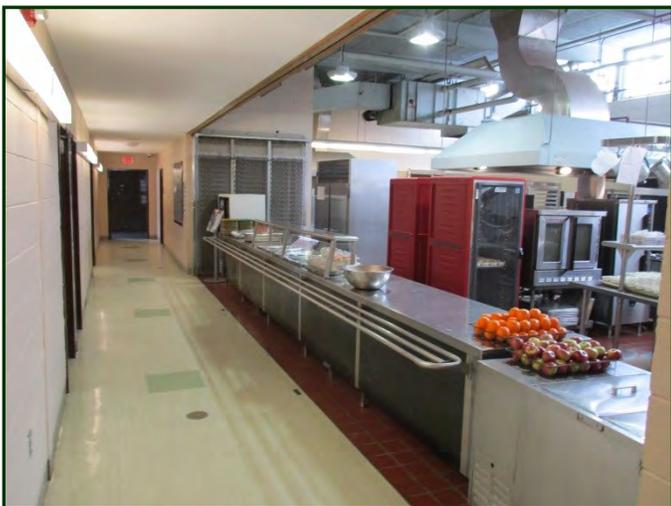
Photo #71: Serving line at kitchen area

| ITEM | | | | | | Immediate | Reserves |
|---|---|--|---|---|---|---|---|
| 19 | 71, 72 | Allowance for general replacement of some commercial kitchen appliances (including two double convection ovens) | 1 | LS | \$50,000.00 | | \$50,000 |

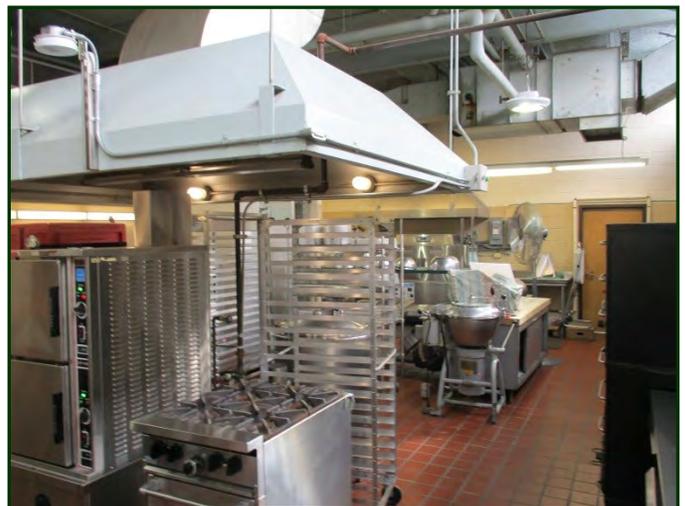
Photo #72: Food preparation area. Note quarry tile floor

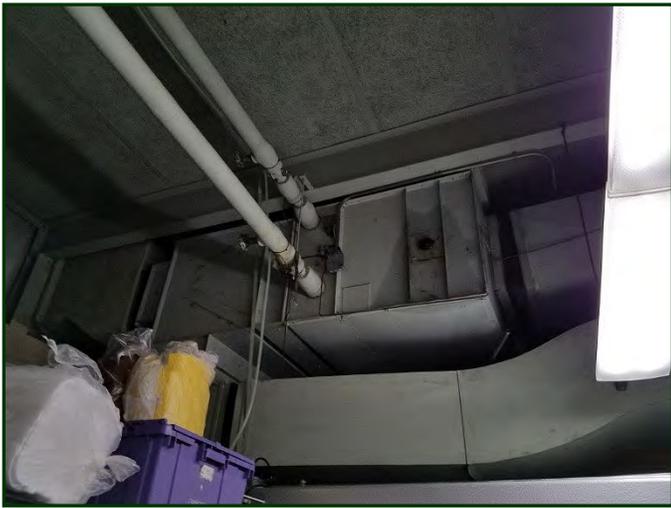
Photo #77: AHU in kitchen area

| ITEM | | | | | | Immediate | Reserves |
|---|---|--|---|---|---|---|---|
| 21 | 77, 78, 80, 81, 82 | Replace constant volume ventilation air handling units and cabinet unit ventilators | 700 | Ton AC | \$2,896.45 | | \$2,027,515 |

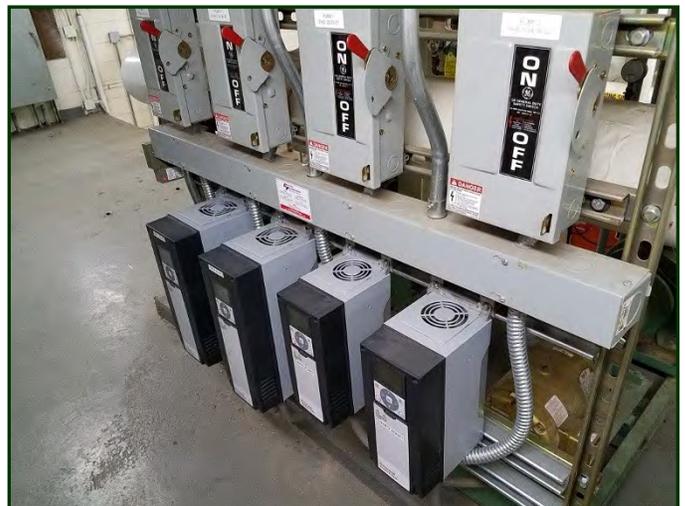
Photo #85: Heating hot water pumps

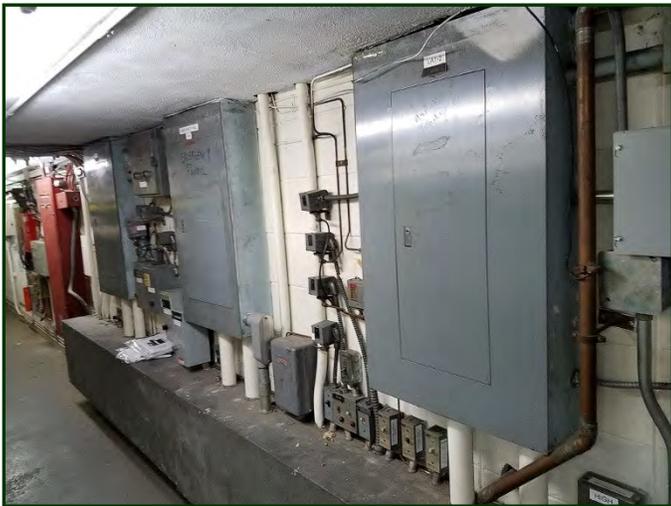
Photo #96: Main 1200-amp panelboard in Boiler Room

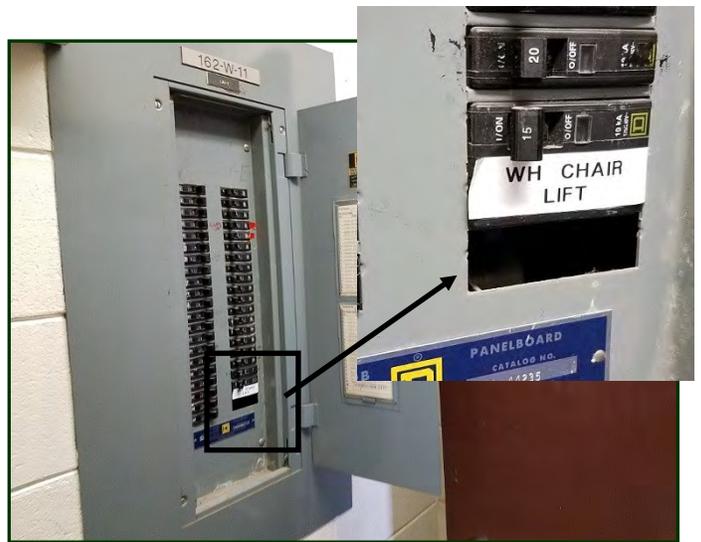
Photo #97: Typical electrical distribution panels in Boiler Room

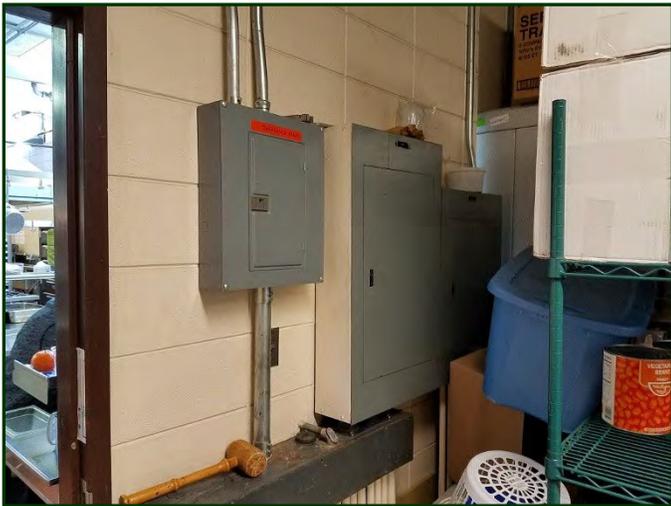
Photo #100: Electrical panels in storage area blocked by materials

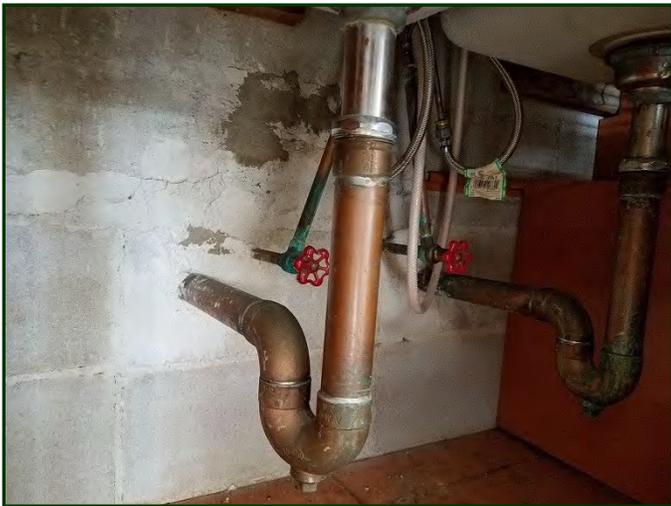
Photo #114: Sink in 1st floor classroom

| ITEM | | | | | | Immediate | Reserves |
|---|---|--|---|---|---|---|---|
| 27 | 114 thru 118 | Budget for replacement of isolation valves | 100 | LS | \$537.20 | | \$53,720 |

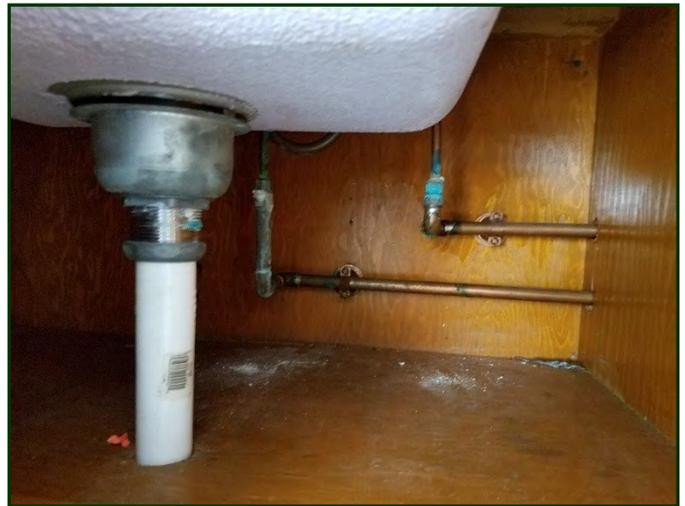
Photo #115: Shutoff valves under sink non operational

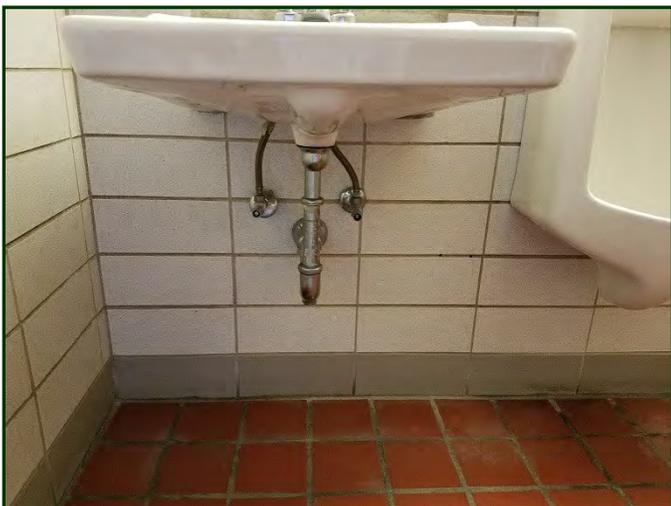
Photo #116: No valves associated with sink fixture

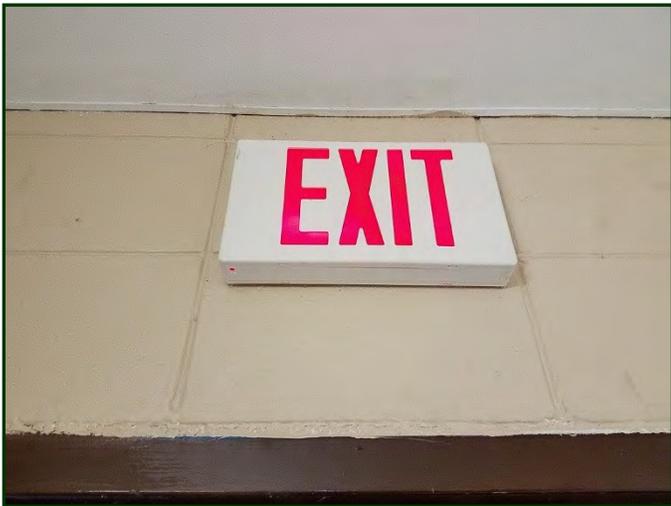
Photo #121: Typical exit sign

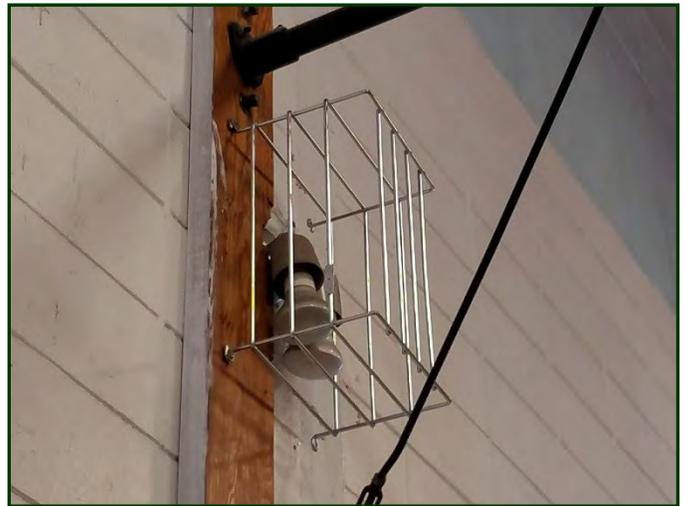
Photo #122: Emergency lighting in gym

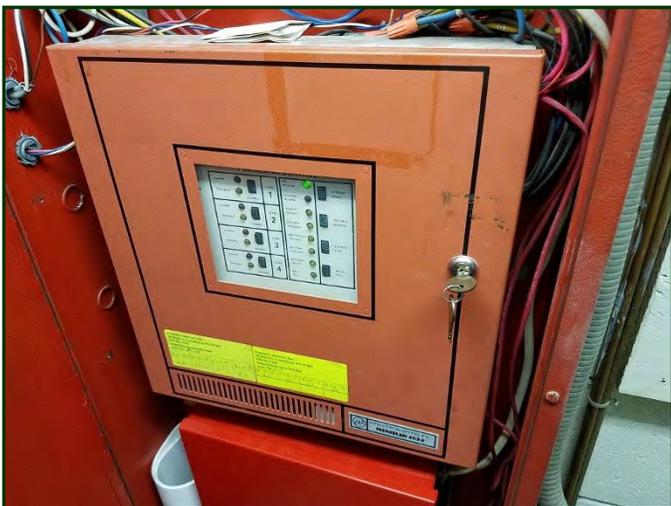
Photo #123: Fire alarm panel in boiler room

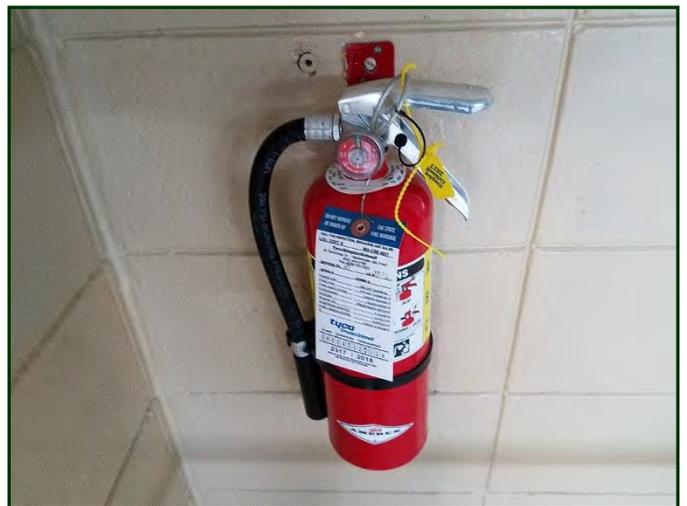
Photo #124: Fire extinguisher and inspection tag

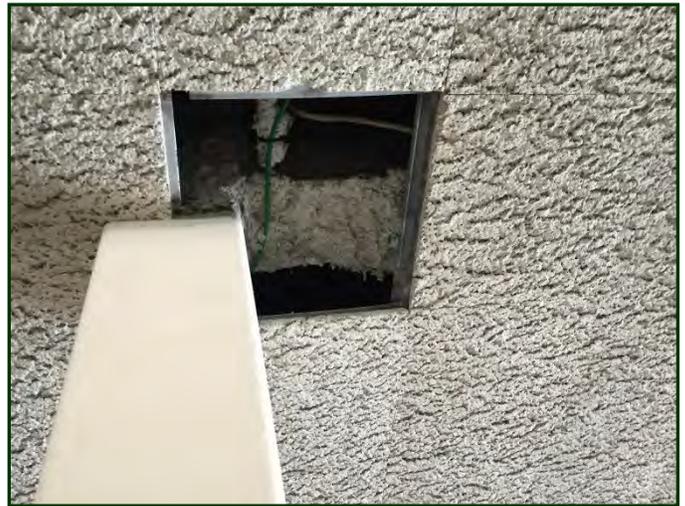
Photo #132: Photograph depicts general view of spray-on fireproofing on beam above the ceiling within a Classroom

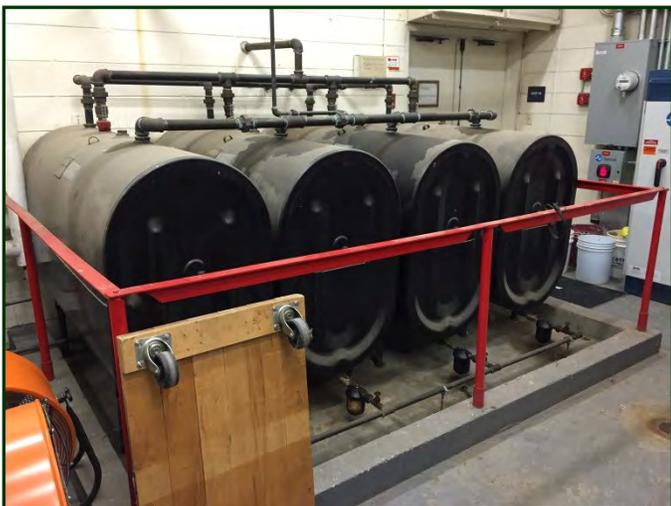
Photo #135: Photograph depicts general view of Heating Oil ASTs within the Boiler Room

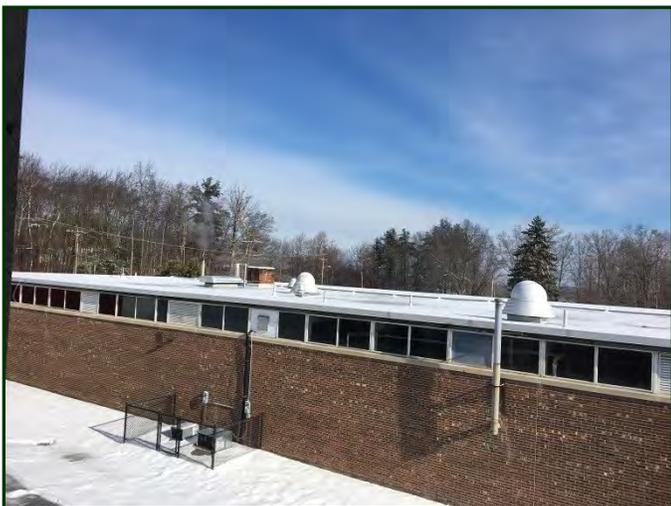
Photo #146: Classroom wing east façade. Note the electrical boxes for the PV Solar Array at the roof.

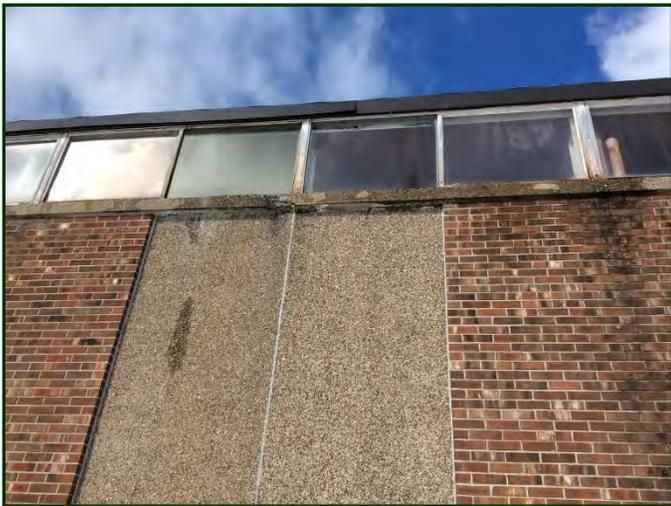
Photo #156: Detail of the southwest corner of the Gym. Note the dripping water and efflorescence below the clere-

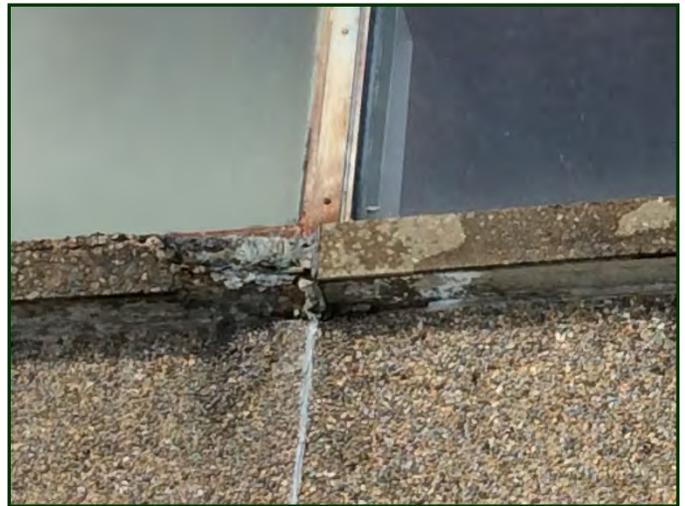
Photo #157: The clerestory and exposed aggregate inter-section at the south wall of the Gym.

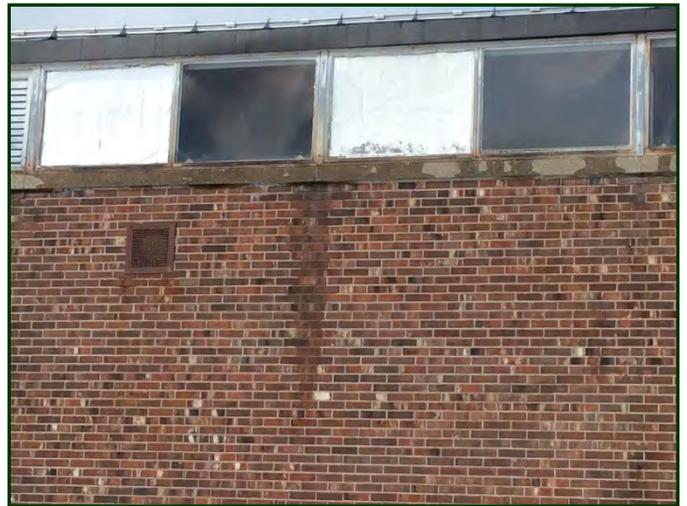
Photo #163: The interior side of the south clerestory at the Gym wing.

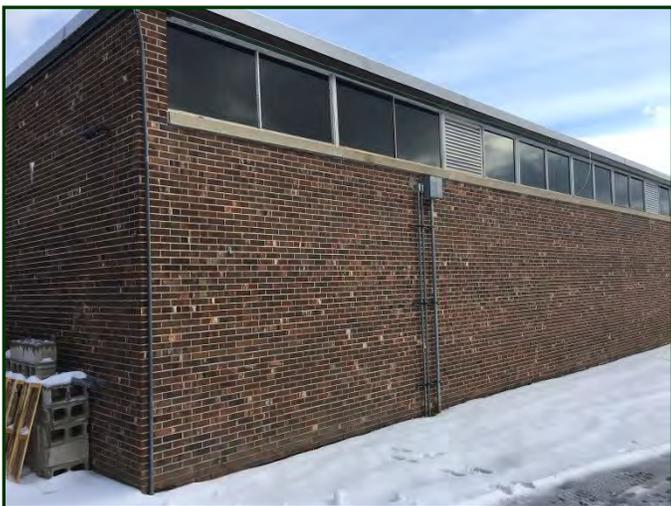
Photo #165: The northwest corner of the Cafeteria wing.
