Turkey Hill Elementary School

Property Condition Assessment

March 9, 2018

VERTEX Project No: 48237

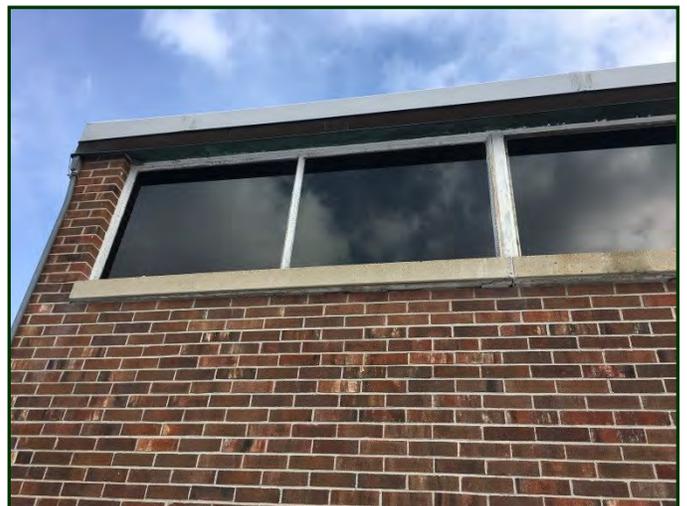
| BUILDING EXTERIOR | | | |
|---|--|---|---|
| | <p><i>framing with missing mortar and damage to the underside of the sill evident in Photo 166. A budgetary estimate of cost is provided in Table 1.</i></p> <p><i>VERTEX did observe some damage and areas of potential water infiltration at the fascia at the top of the metal storefront systems in the connecting corridors and the front administration area. (Photos 170-175). The bus drop-off canopies appear to have some limited water intrusion most likely due to the roof draining system in that area. VERTEX recommends that these repairs be made as soon as possible to prevent water infiltration into the wall assemblies and canopy structures. A budgetary estimate of cost is included in Table 1.</i></p> | | 11 |

Photo #166: Detail of the precast concrete sill at the location shown in Photo 23.

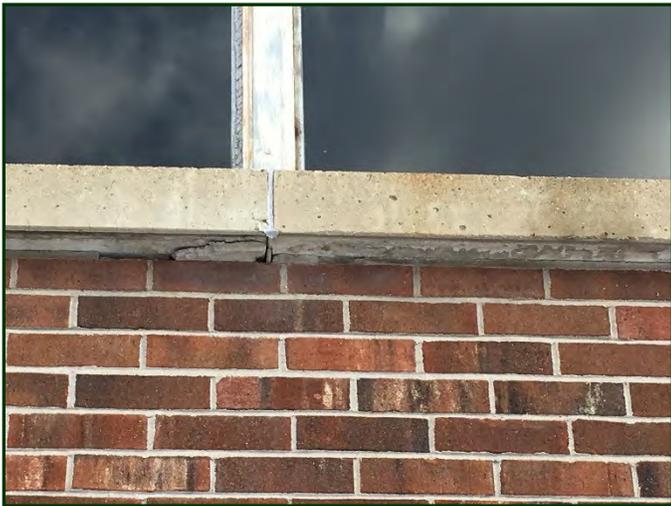
Photo #167: Detail of the protruding concrete sills shown in Photo 23. Note the cracked and missing mortar under the

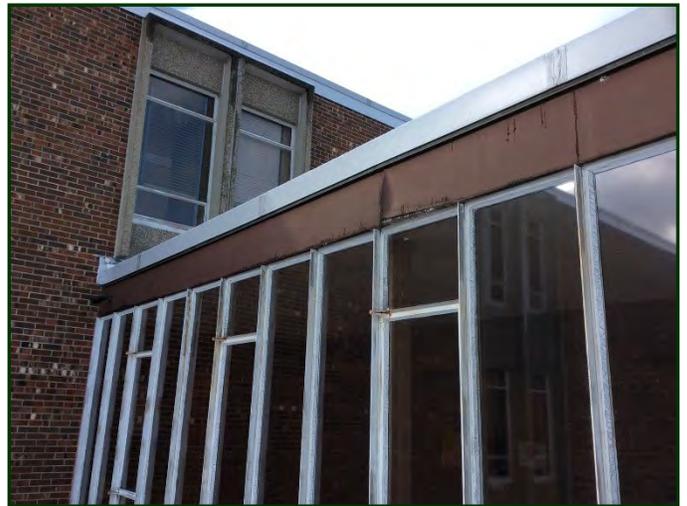
Photo #170: Detail of the fascia from Photo 27. Note the damaged fascia at center.

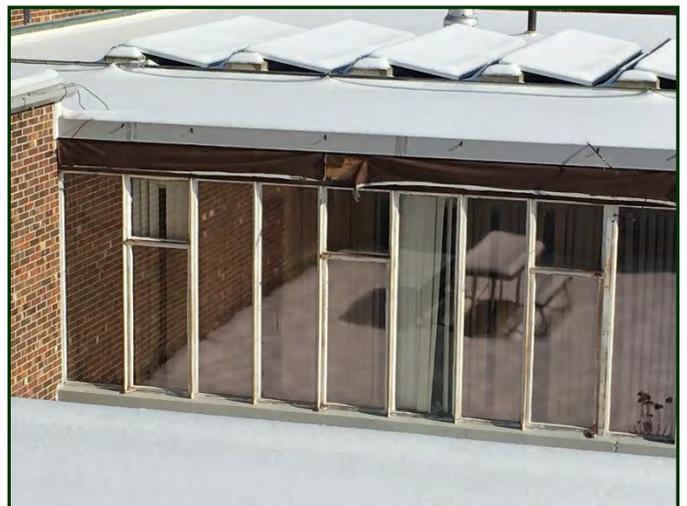
Photo #172: Detail of Photo 29. Note the damaged fascia at center.

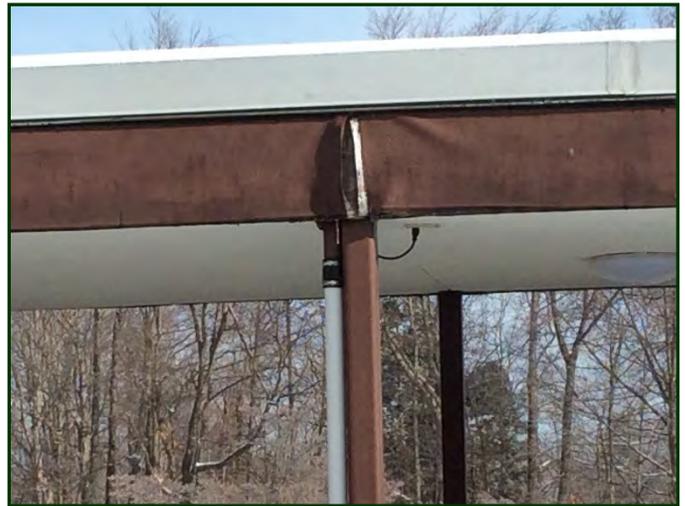
Photo #174: Detail of the fascia and leader at the front canopy. Note the damage at the fascia.

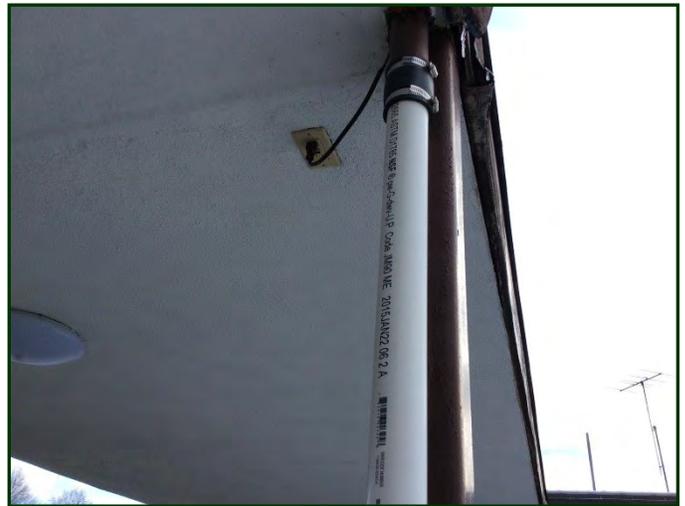
Photo #176: One of the roof drain leaders at the front canopy. Note what appears to be heat trace at the downspout.

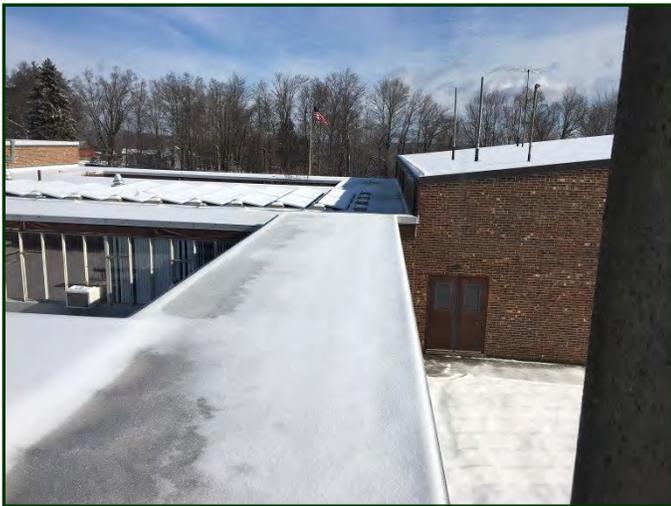
Photo #187: The roof of the south connecting corridor

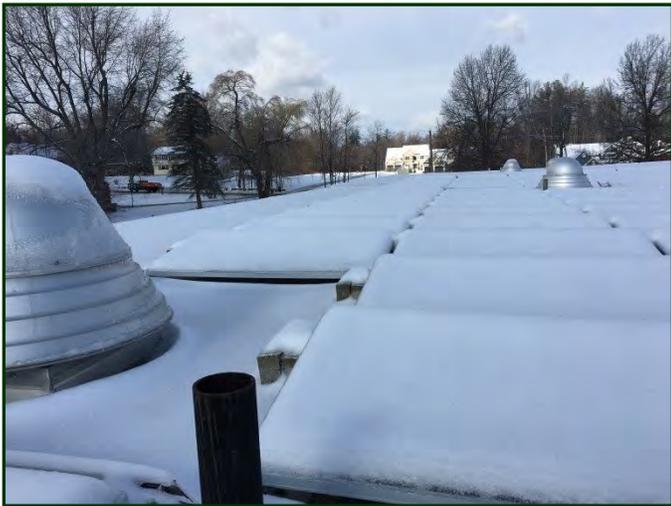
Photo #191: The Classroom wing roof looking north.

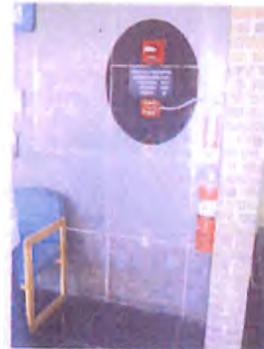
Fire Alarms

The visual alarms located too low. The visual alarms should be at 80" above the floor or 6" below the ceiling, whichever is lower.

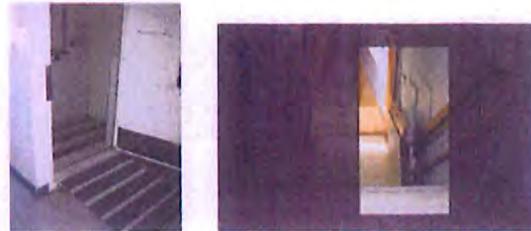
The inclined wheel chair lift going to the gym. The further use of this lift should be reviewed for it might be blocking an egress route.

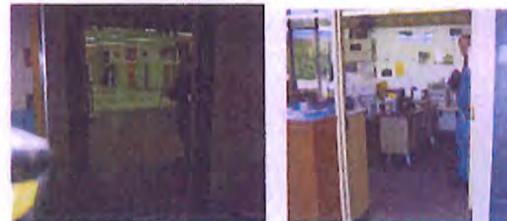
Door Clear Width

Most double doors are too narrow. These need to have at least one leaf with a minimum 32" clear width.

The Principal's Office door is too narrow.

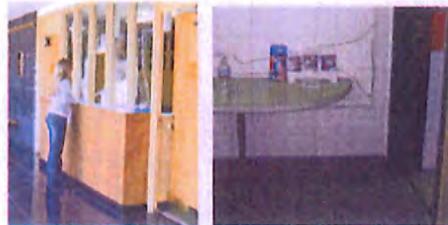
School Office

The Main Office has no accessible counter section. There is a protruding shelf inside the office. The hardware on the door is knob-type.

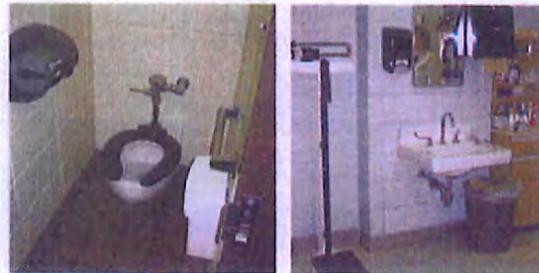
The Nurse's Office has a toilet room with no accessible elements.

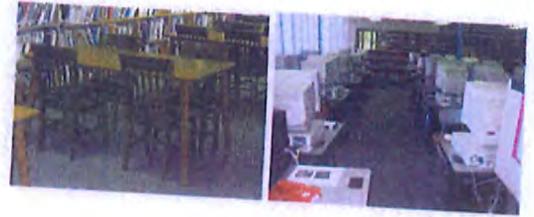
The one table meant to be accessible does not provide adequate knee clearance. There is an insufficient amount of accessible desks.

There are no accessible computer stations.

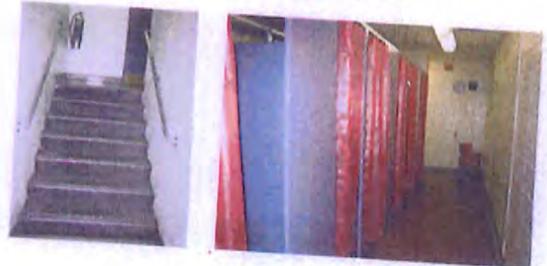
Locker rooms

There are no accessible locker rooms. The Girls' locker room is only reachable by stairs.

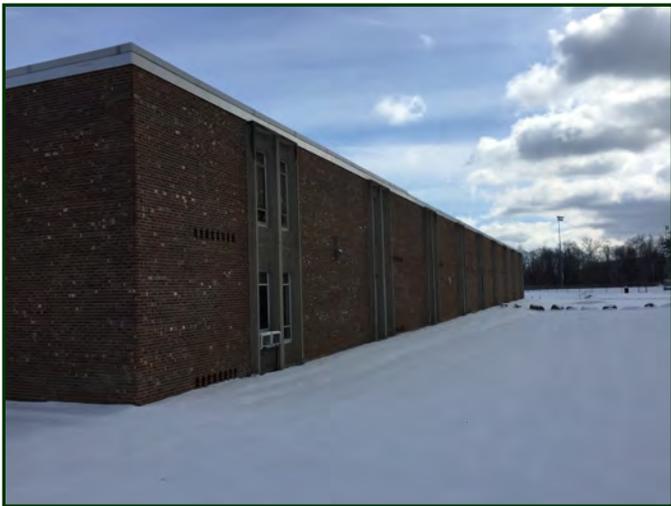
Photo #3: Photograph depicts general view of Side C of the Site Building

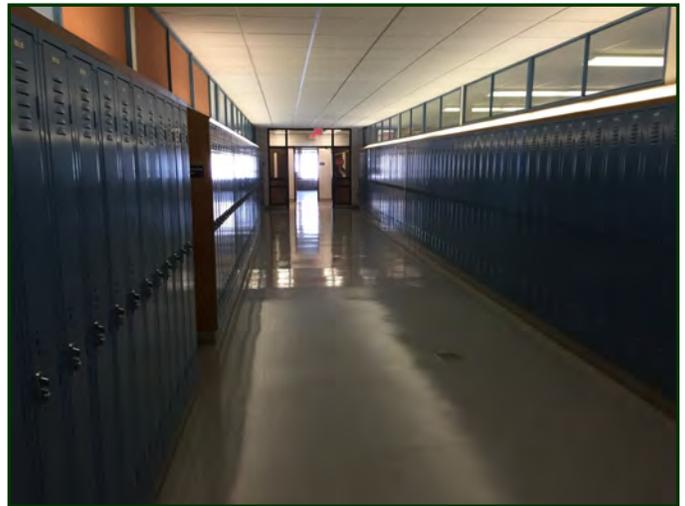
Photo #4: Photograph depicts general view of Classroom Hallway on the First Floor

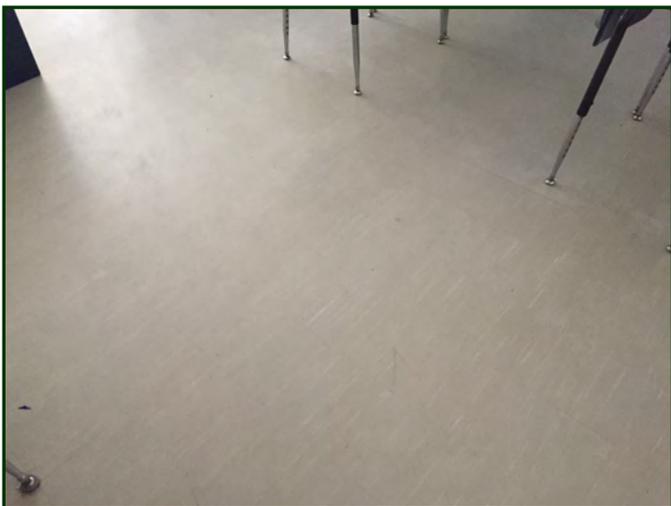
Photo #5: Photograph depicts general view of 9" Floor Tile within Classroom

Prior to any renovation or demolition activities, sampling of suspect ACMs that may be disturbed would need to be conducted in applicable areas to determine asbestos content. A comprehensive ACM survey is required to be conducted to comply with the Environmental Protection Agency (EPA) National Emission Standard for Hazardous Air Pollutants (NESHAPs) 40 CFR Part 61. Until these materials have been sampled and determined to be non-asbestos containing, these materials should be managed in place as presumed asbestos-containing materials (PACMs).

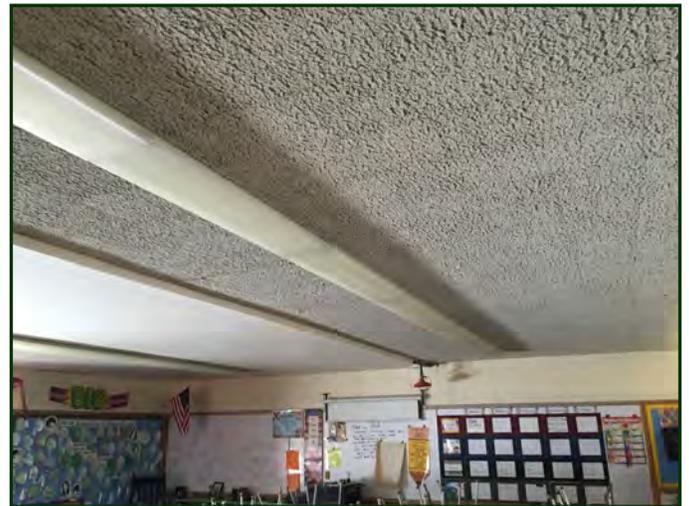
Photo #6: Photograph depicts general view of acoustical spline ceiling tiles within classroom

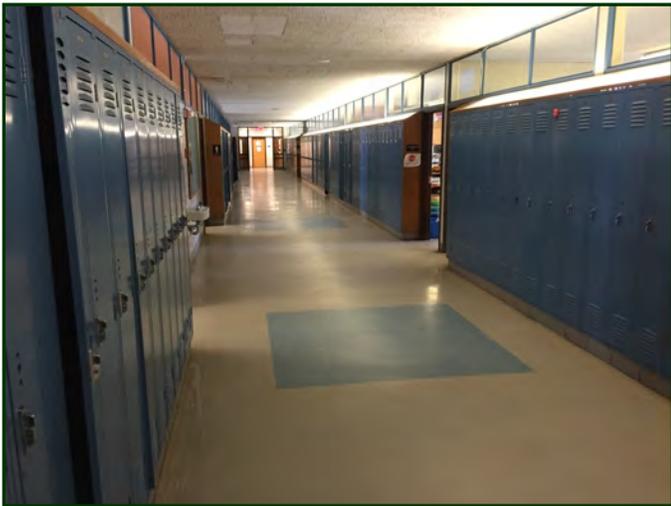
Photo #7: Photograph depicts general view of Classroom Hallway on the Second Floor

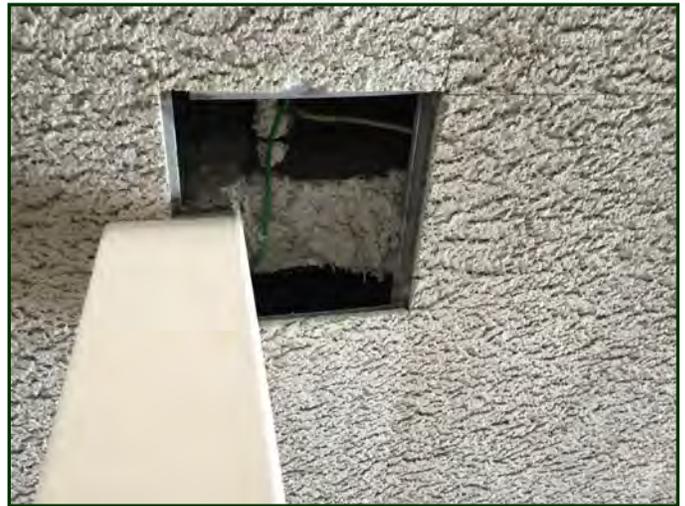
Photo #8: Photograph depicts general view of spray-on fireproofing on beam above the ceiling within a Classroom

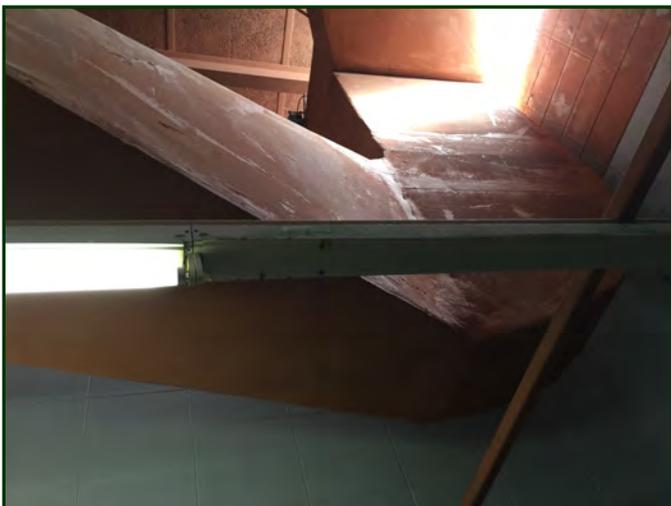
Photo #9: Photograph depicts general view of suspect duct wrap insulation within air handler room adjacent to the Gym

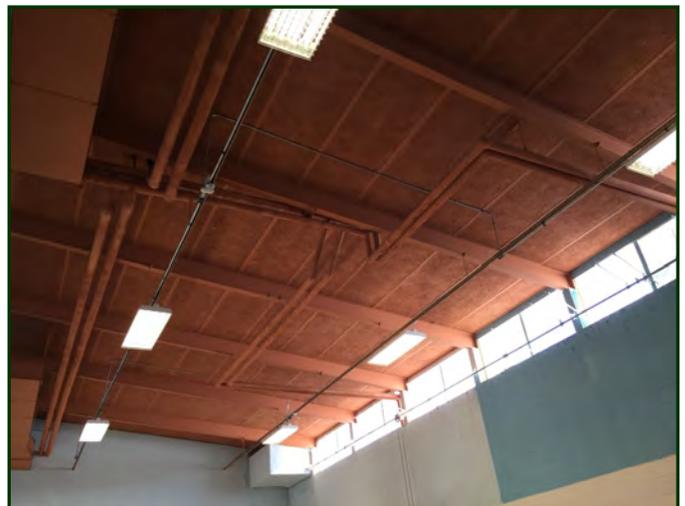
Photo #10: Photograph depicts general view of suspect fitting insulation within resource room adjacent to the Gym

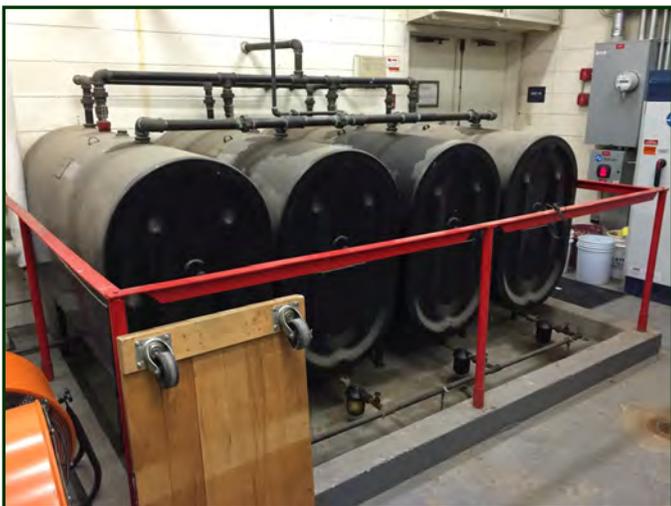
Photo #11: Photograph depicts general view of Heating Oil ASTs within the Boiler Room

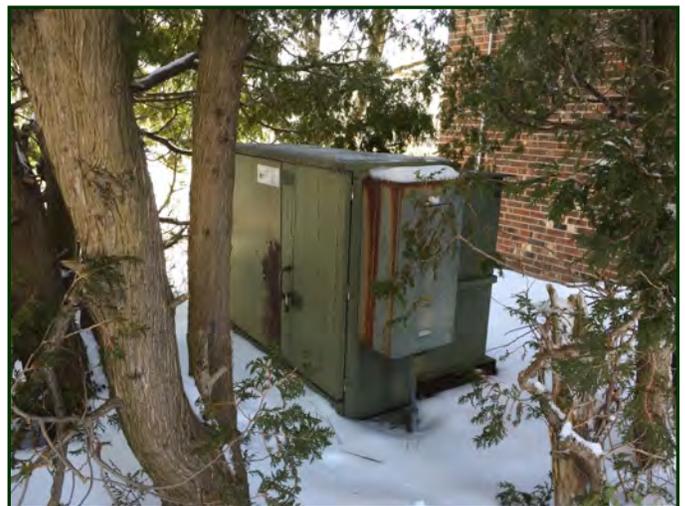
Photo #12: Photograph depicts general view of the Pad Mounted Transformer on the Exterior
