Town Hall
17 Main Street
Lunenburg, MA 01462

Property Condition Assessment

February 6, 2018

VERTEX Project No: 48237

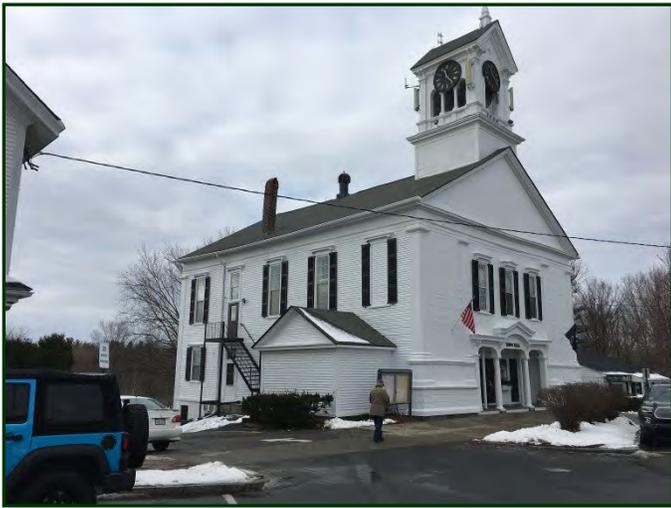
Photo #1: East and south facades showing the driveway and main entry.

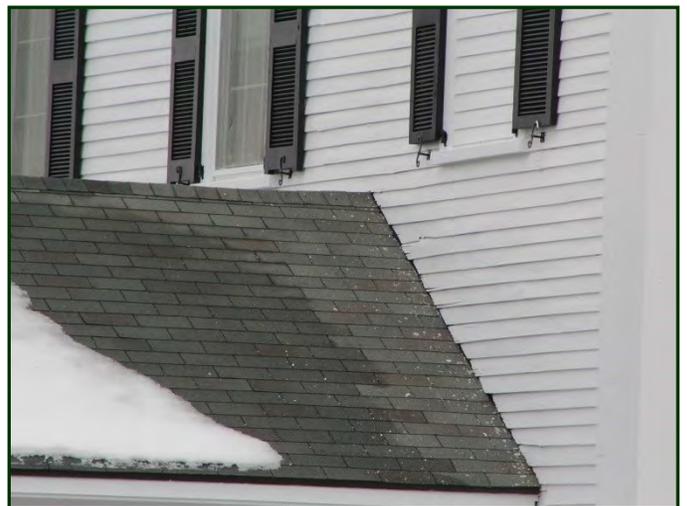
Photo #12: Detail of the roof wall intersection at the bump-out.

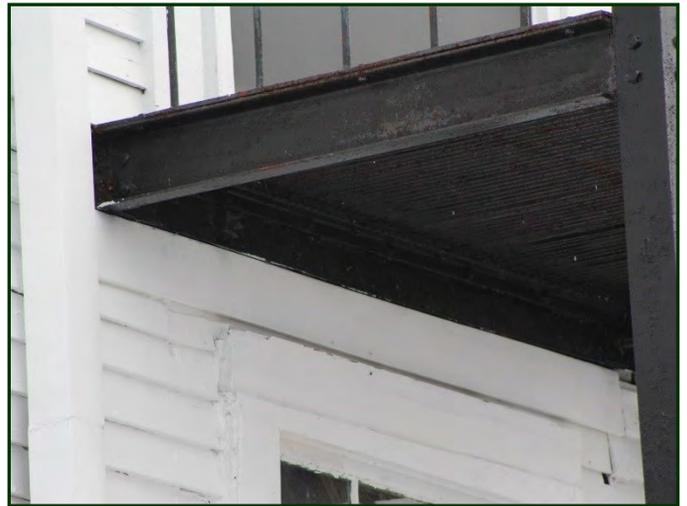
Photo #14: Detail of the metal framing at the second story landing.

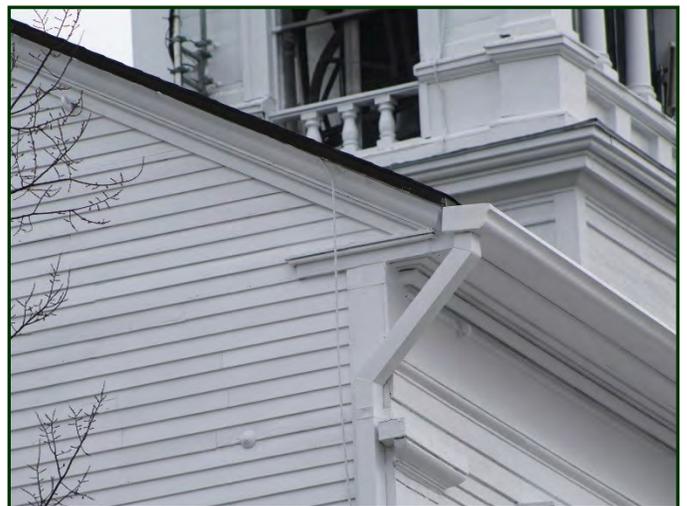
Photo #18: Detail of the gutter and downspout at the southwest corner.

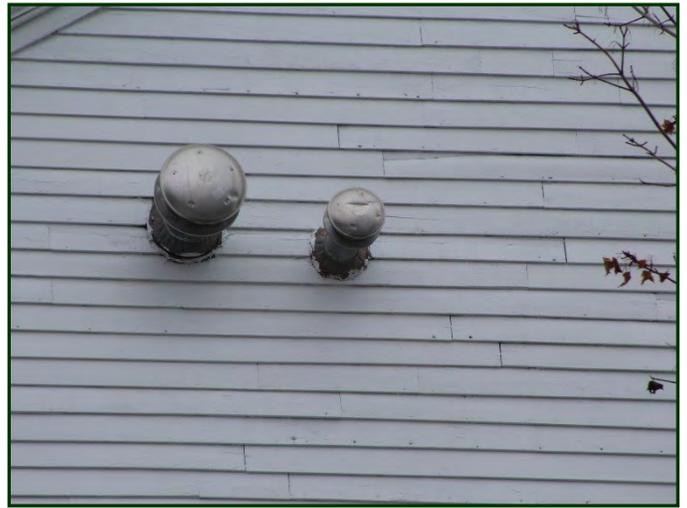
Photo #20: Detail of the mechanical penetrations on the upper portion of the west façade.

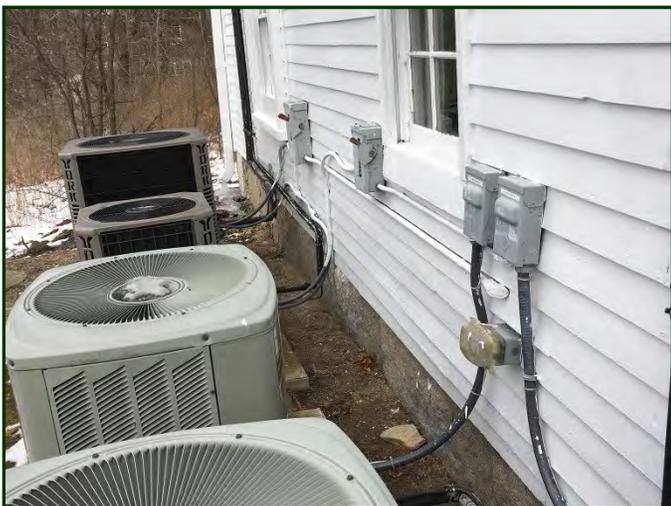
Photo #23: Mechanical penetrations at the west façade at the compressors.

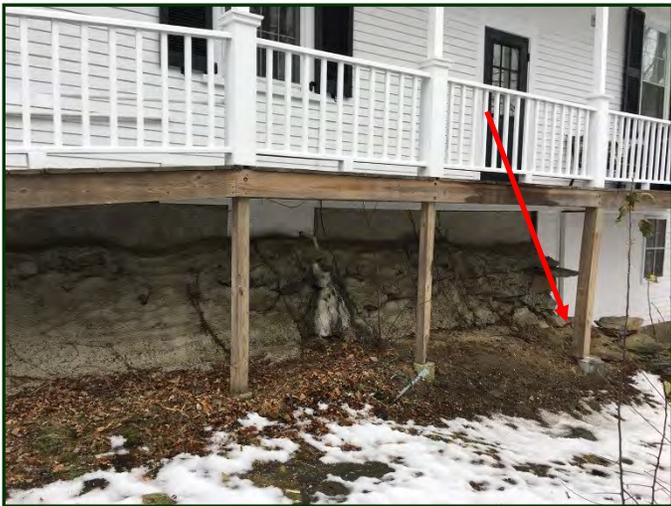
Photo #27: The framing for the accessible entry. Note the post at the left side is not set on the footing completely.

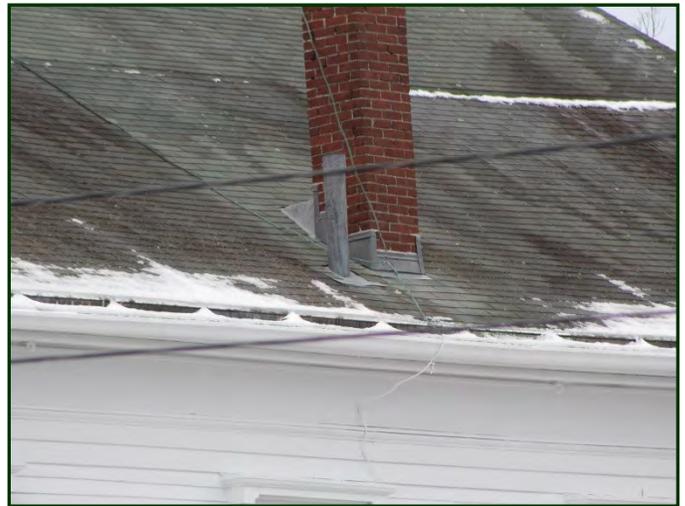
Photo #34: Detail of the flashing at the north chimney.

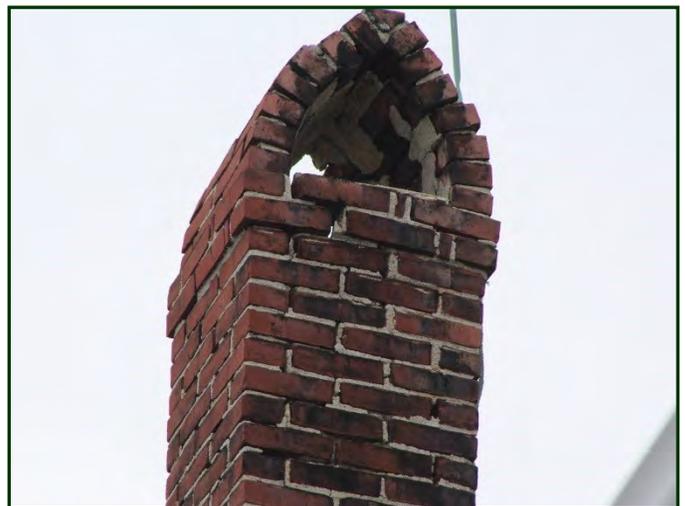
Photo #36: Detail of the south chimney. Note the deteriorated mortar and loose bricks.

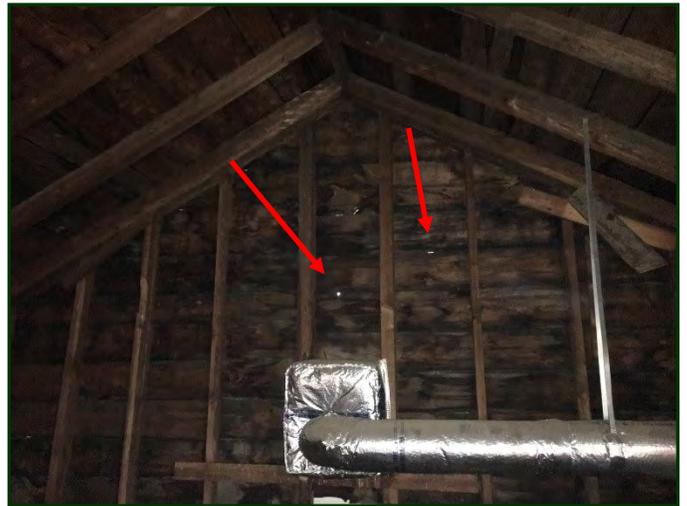
Photo #38: West gable end of the attic. Note the small holes in the boards that allowed light to penetrate the wall.

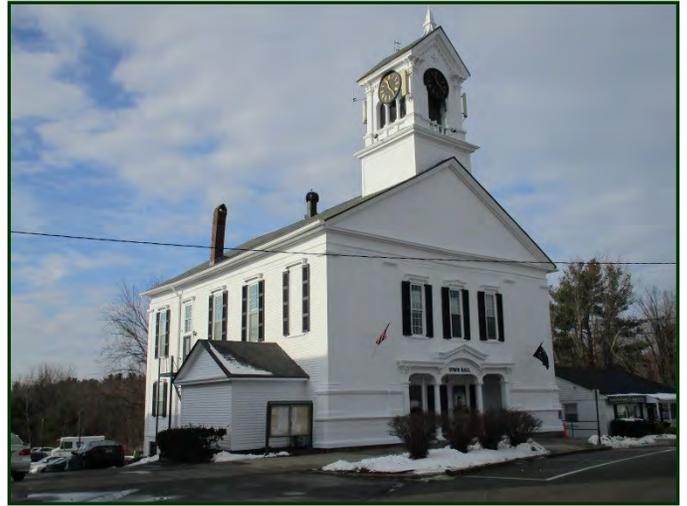
Photo #44: Overview of Town Hall (from southeast corner of building)

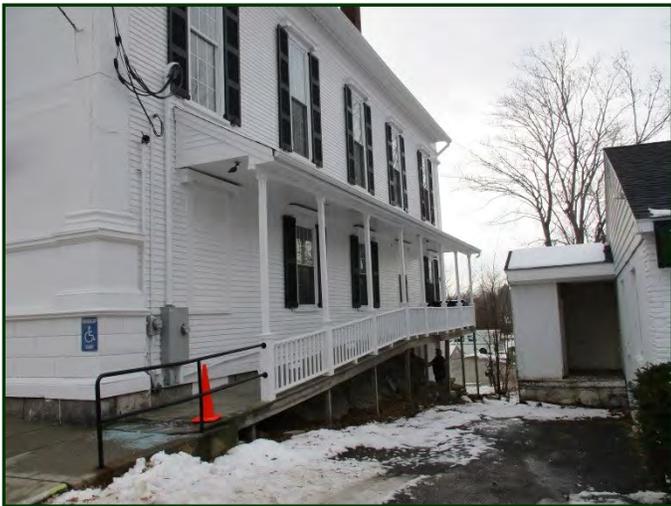
Photo #45: View of covered accessible ramp on north side of building

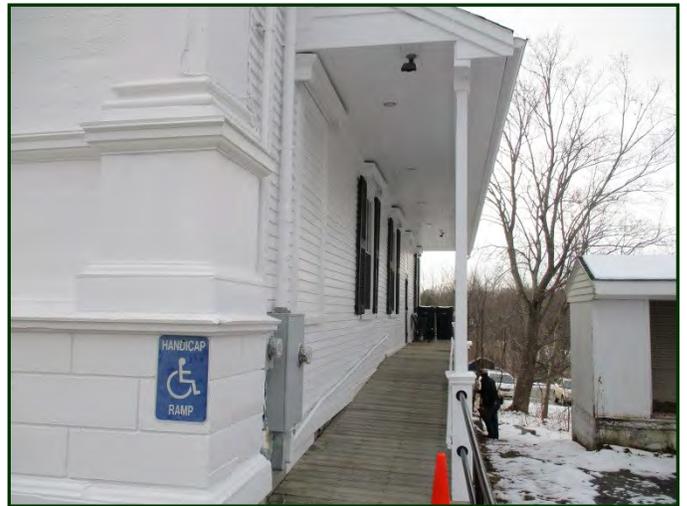
Photo #46: View of accessible ramp with recessed lighting fixtures above

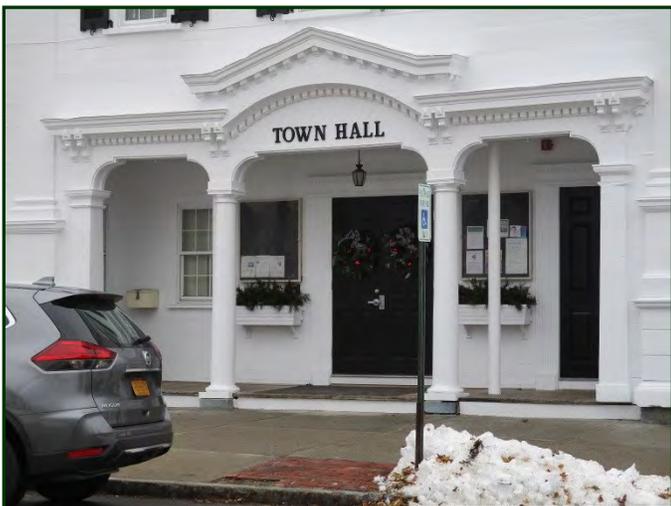
Photo #47: Main front entrance to the building (east elevation). Note accessible parking sign/space in foreground

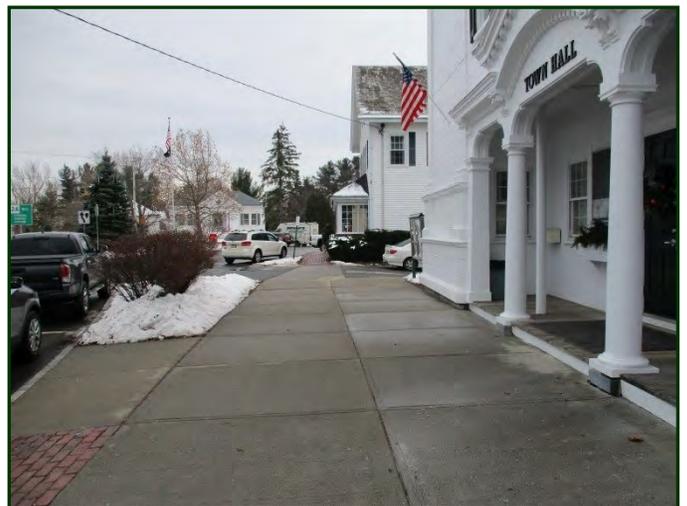
Photo #48: Public sidewalk at front of building

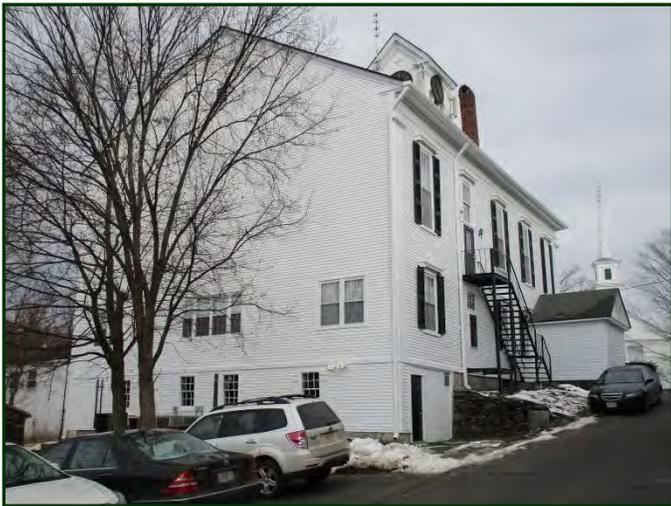
Photo #49: Overview of building from the southwest corner. Note egress stairway at south elevation

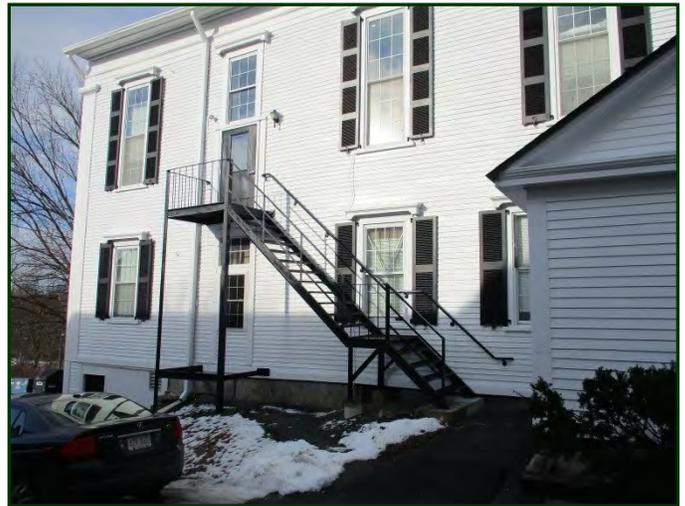
Photo #50: Close-up view of wrought iron egress stairway from second floor level to grade (south elevation)

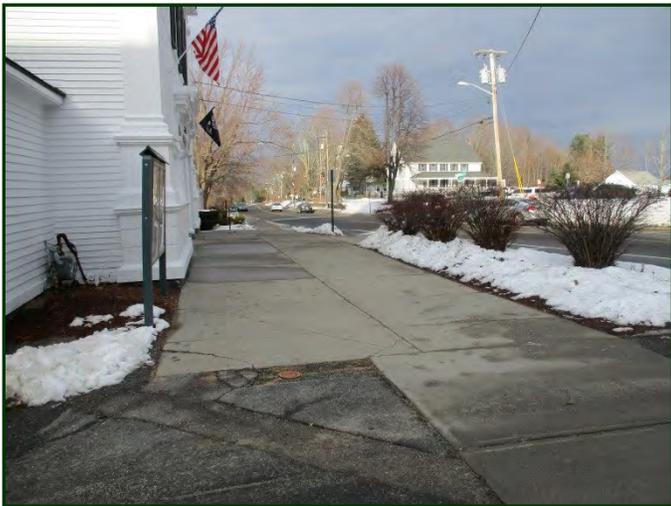
Photo #51: View at front of building looking north

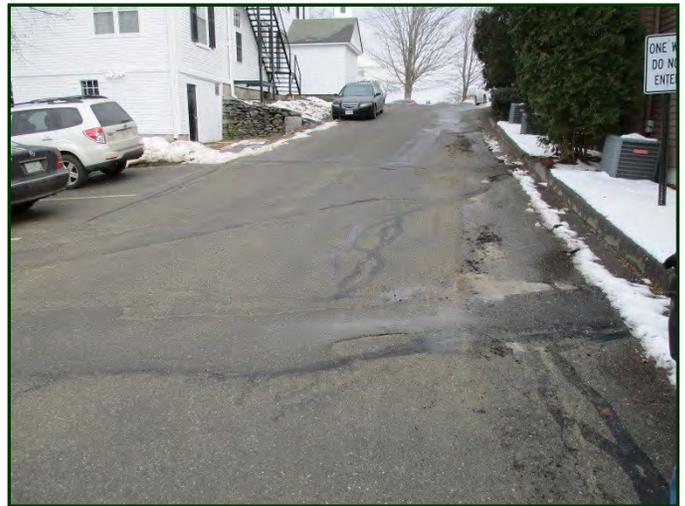
Photo #52: View of driveway at south side of building. Note stone retaining wall at side of building

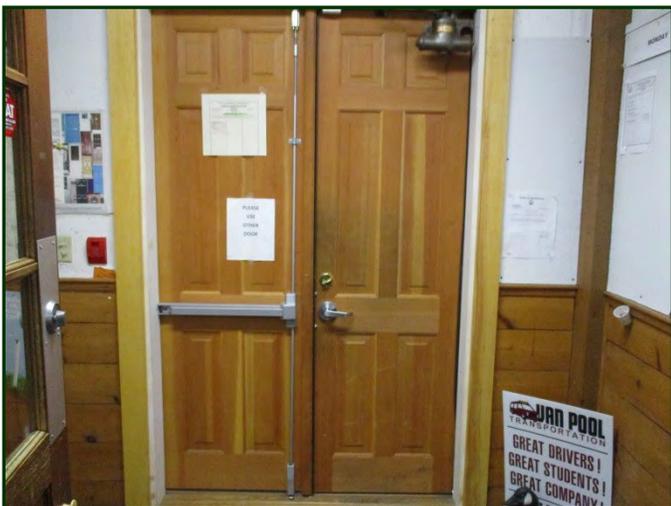
Photo #53: Interior view of main entrance doors at front of building. Note stained wood wainscot

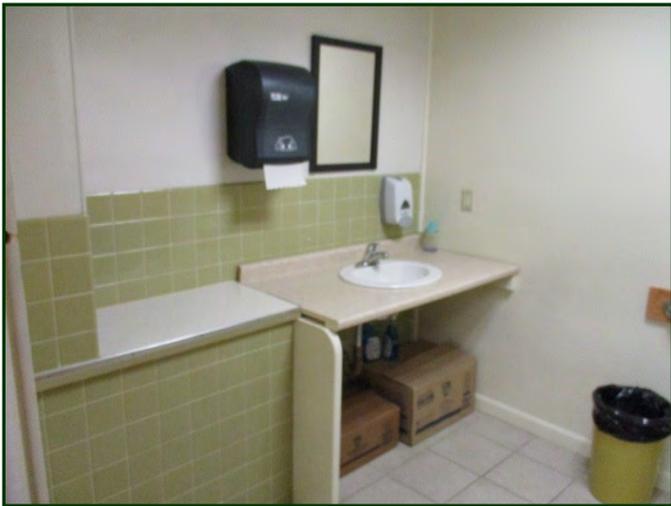
Photo #55: Public toilet room with ceramic tile floor and wainscot (single use)

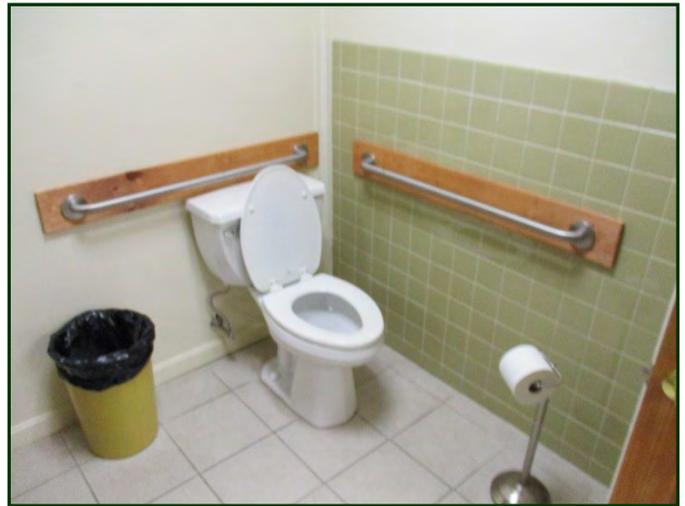
Photo #56: Accessible toilet with grab bars at public toilet room (single use)

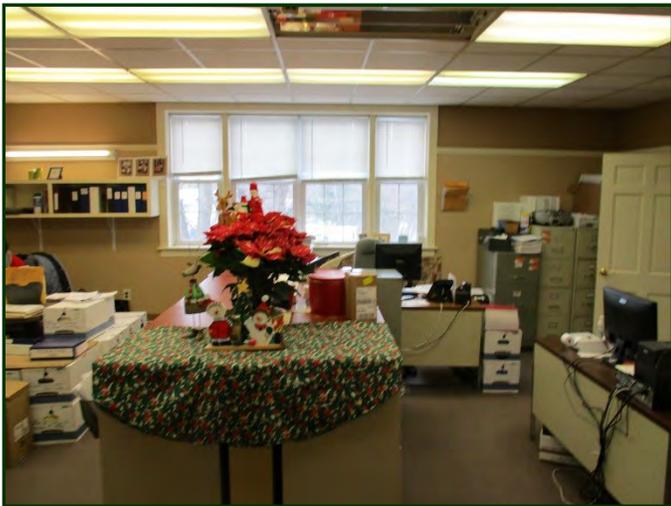
Photo #57: Office space (first floor level) with carpet floor, suspended acoustical ceiling system & painted GWB walls

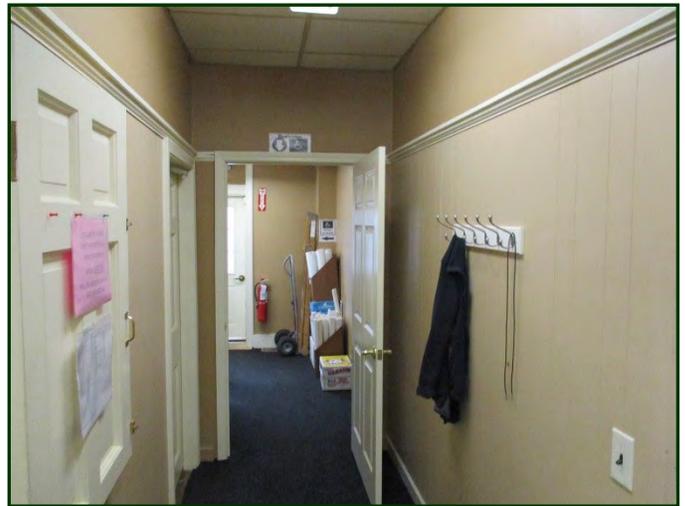
Photo #58: Corridor with carpet floor and suspended acoustical ceiling system

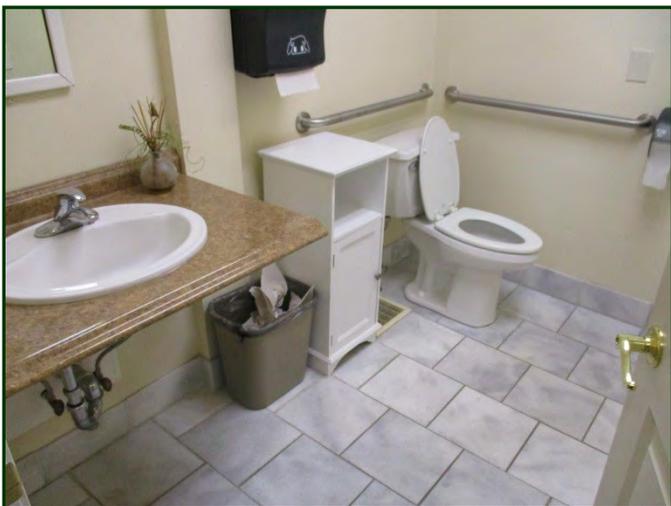
Photo #59: Accessible toilet room on first floor level. Note lack of protection at pipes under counter

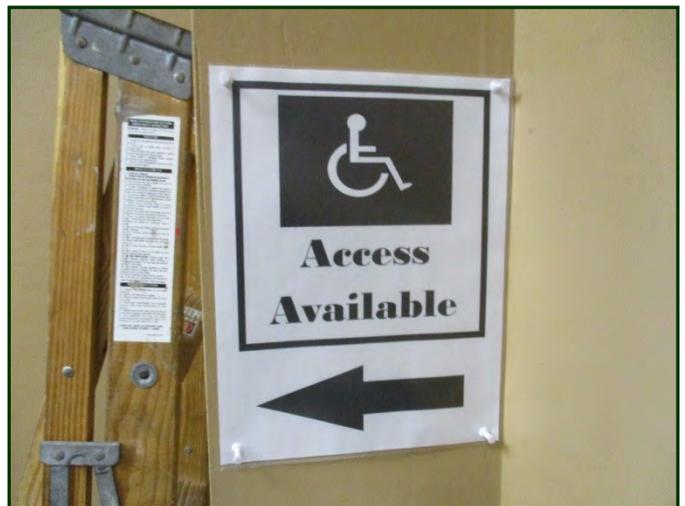
Photo #60: Posted accessible route at first floor level

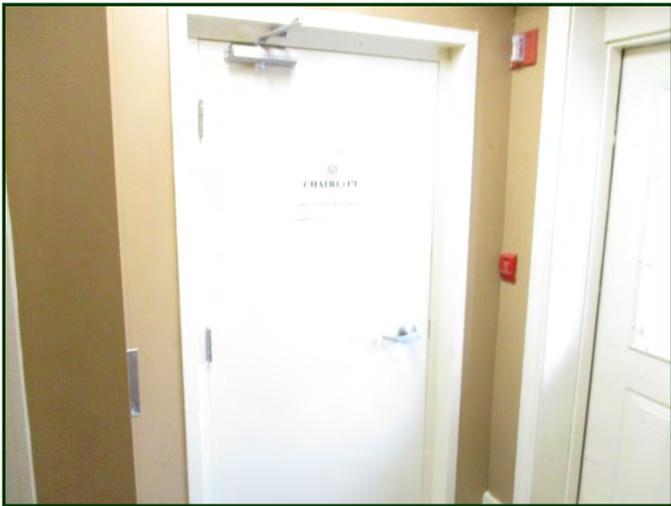
Photo #61: Door at chair lift (north side of first floor adjacent to exterior door at accessible ramp)

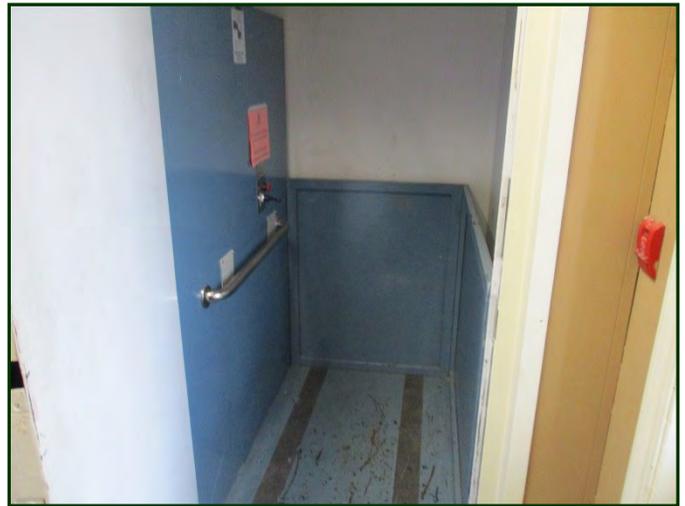
Photo #62: Interior view of chair lift

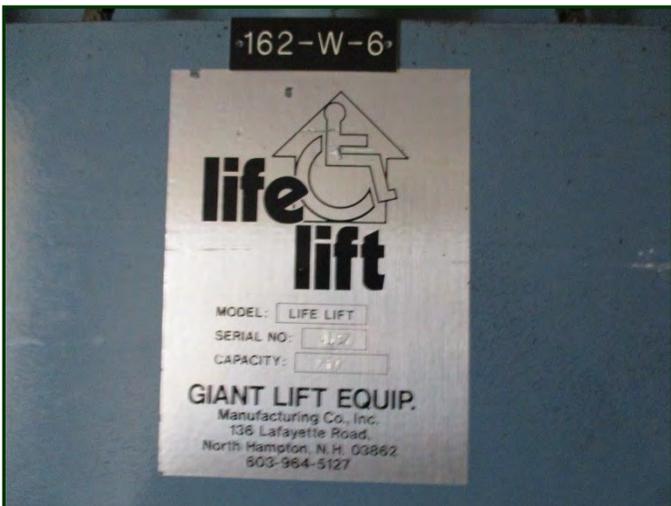
Photo #63: Nameplate posted on chairlift wall

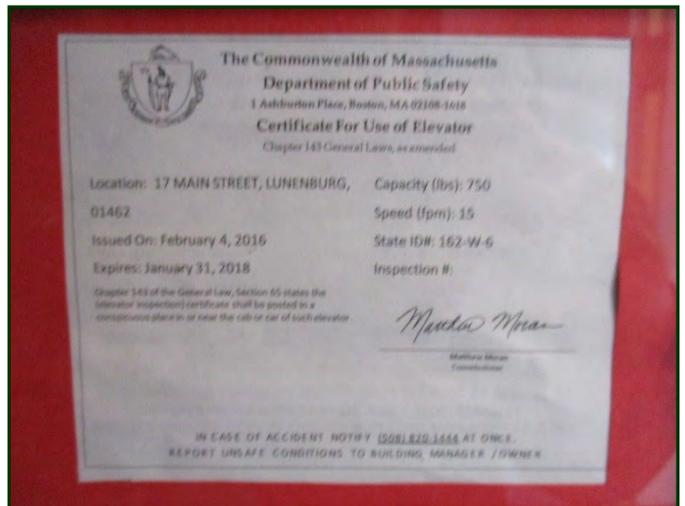
Photo #64: Current inspection certificate posted on wall at chairlift

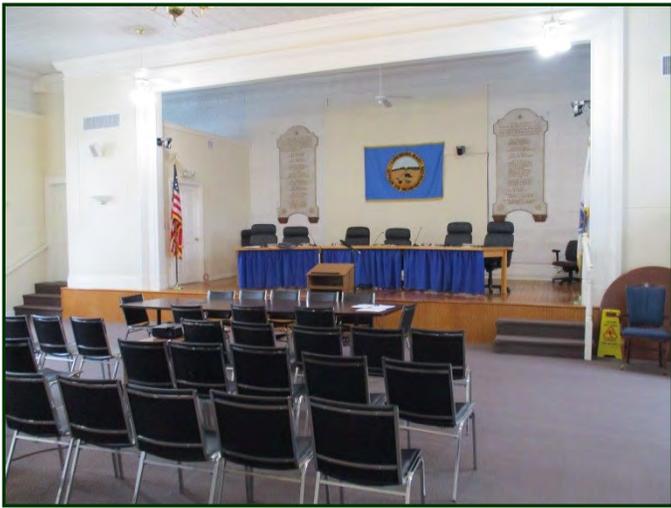
Photo #67: Meeting space with stage at second floor level

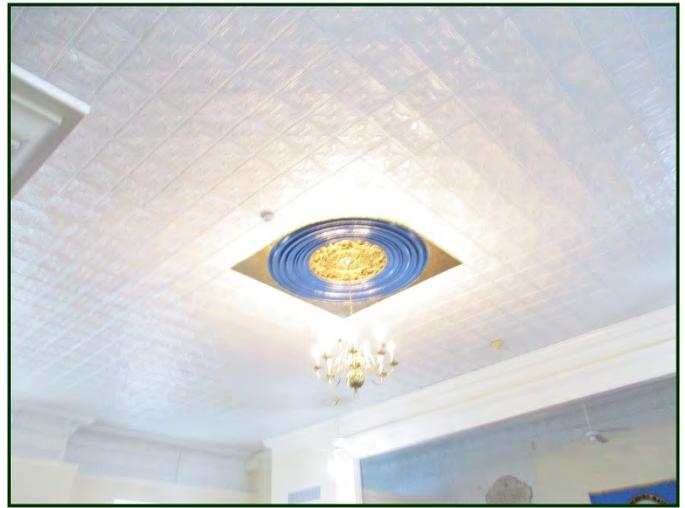
Photo #68: Decorative tin ceiling with pendant-mounted chandelier at meeting space

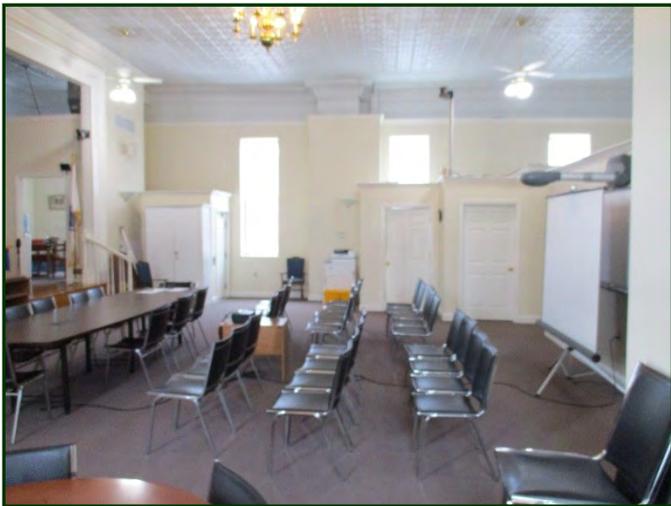
Photo #69: View looking north in meeting space

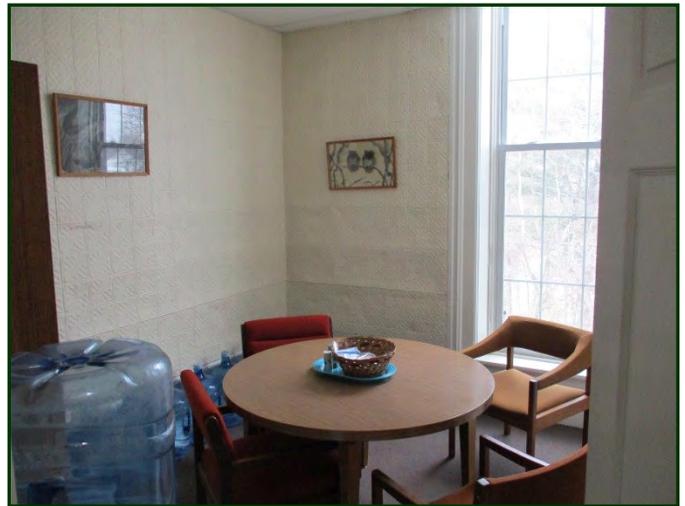
Photo #70: Small meeting room adjacent to main meeting space. Note decorative tin sheeting at walls

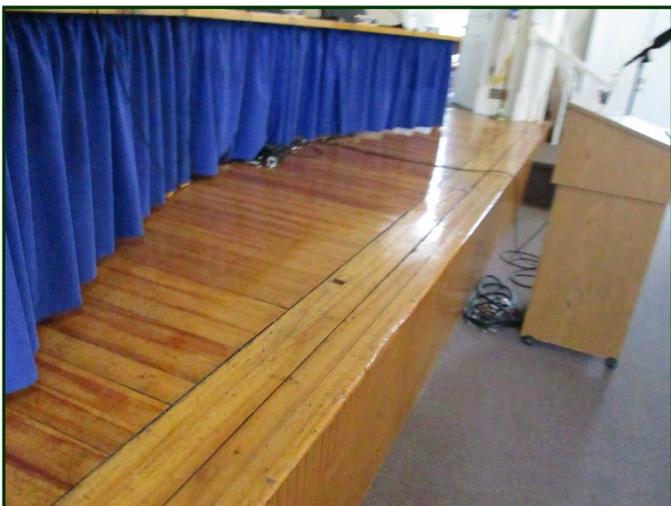
Photo #71: Stained strip wood flooring at stage

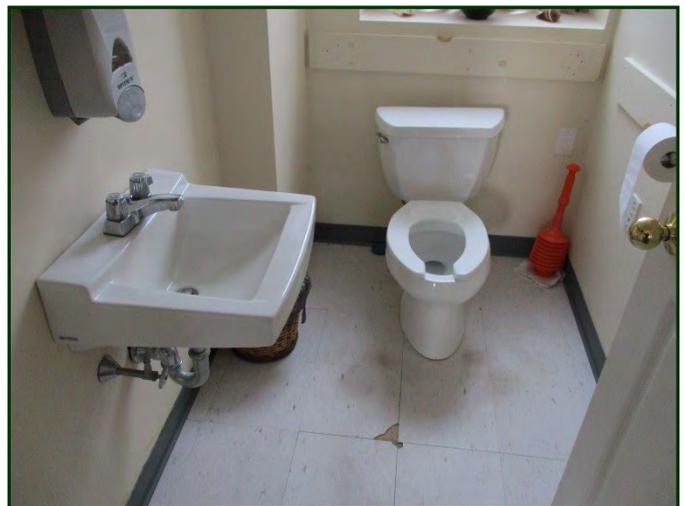
Photo #72: Single user toilet room adjacent to meeting space

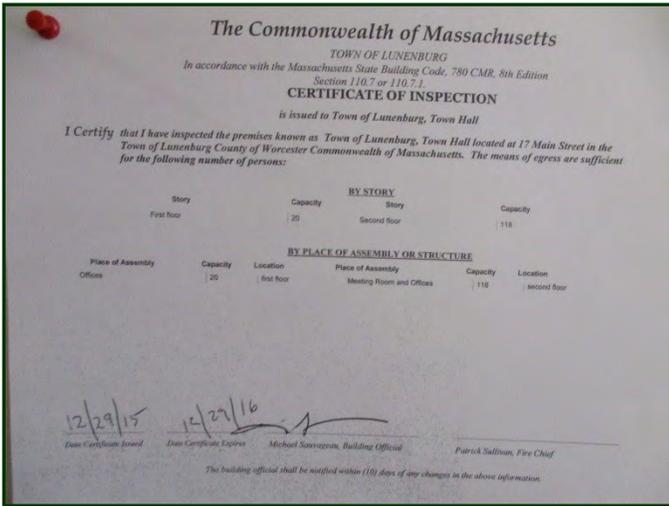
Photo #73: Wall-mounted certificate of inspection indicating allowable capacity of occupants in building

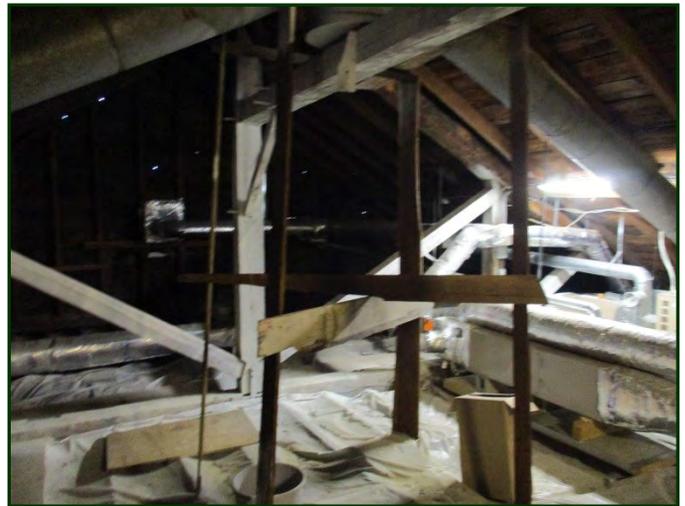
Photo #76: View of attic space. Note post and beam framing

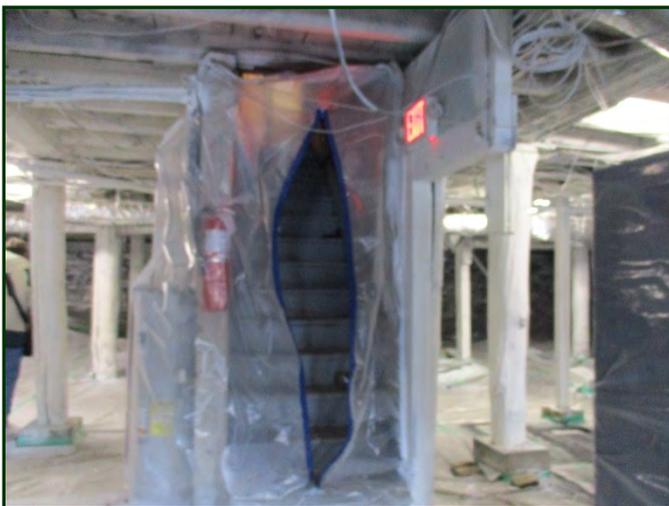
Photo #77: Stairs serving basement with plastic enclosure. Note rough hewn wood posts

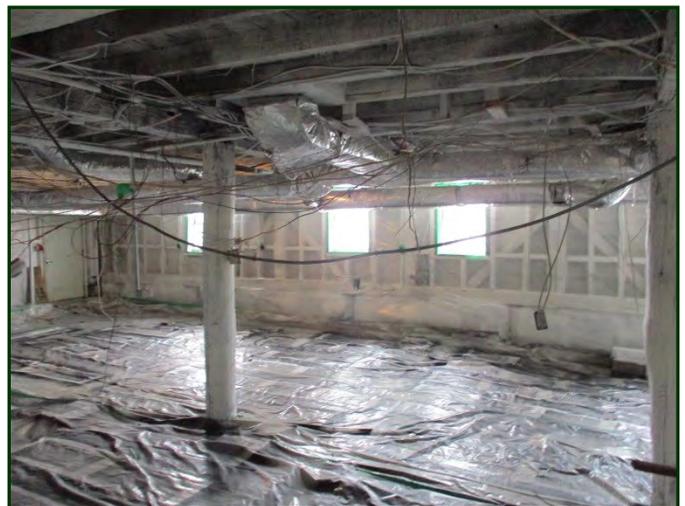
Photo #78: Basement level with plastic sheeting on earth

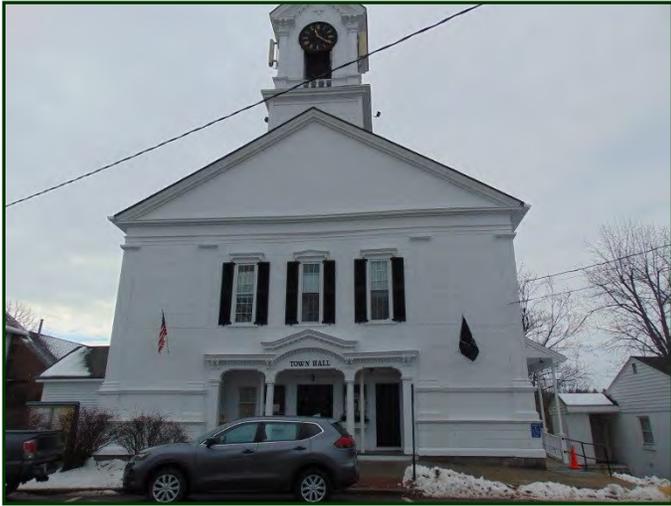
Photo #79: View of the front (east) elevation of the Town Hall.

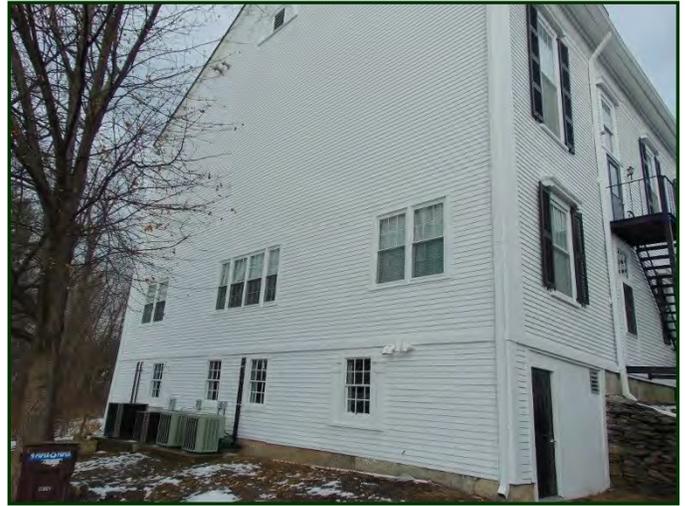
Photo #80: View of the rear (west) elevation of the Town Hall.

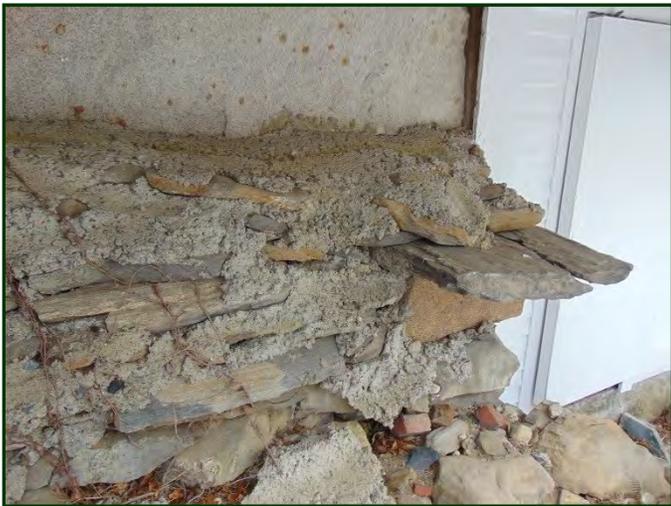
Photo #81: View of the typical stone foundation from the exterior.

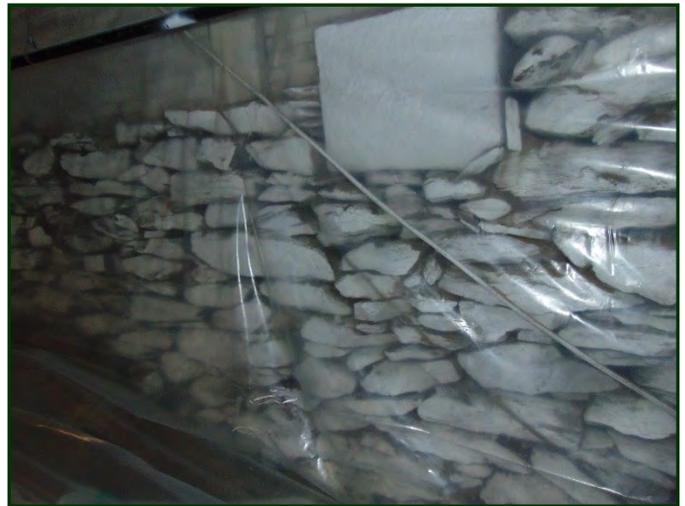
Photo #82: View of the stone foundation from inside the basement.

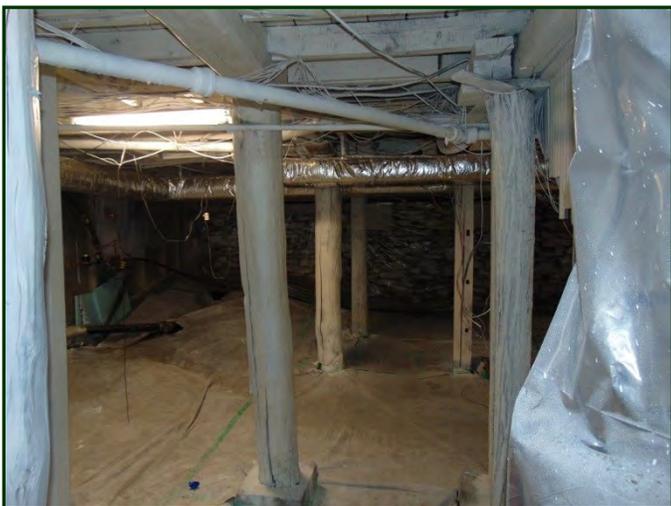
Photo #83: View of typical round wood posts supporting the first floor of the building.

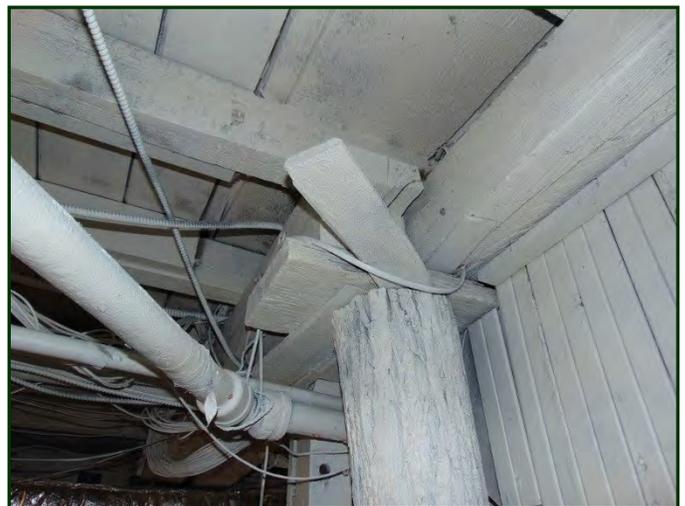
Photo #84: View of a wood post supporting a first floor girder. Note various shims installed at the top of the post.

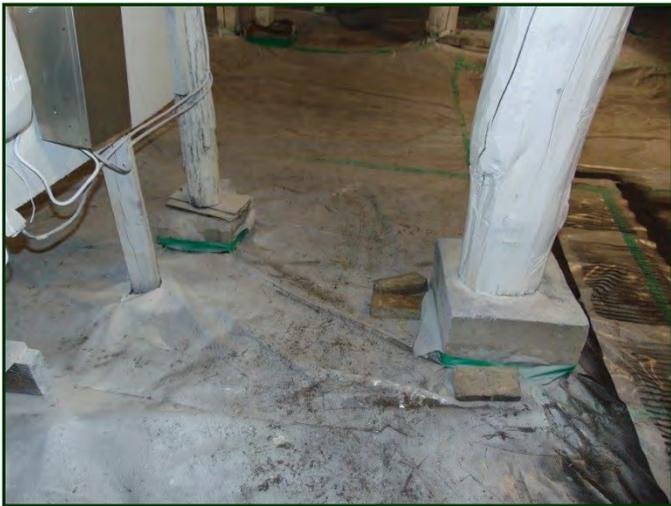
Photo #85: View of concrete and stone blocks supporting the wood posts.

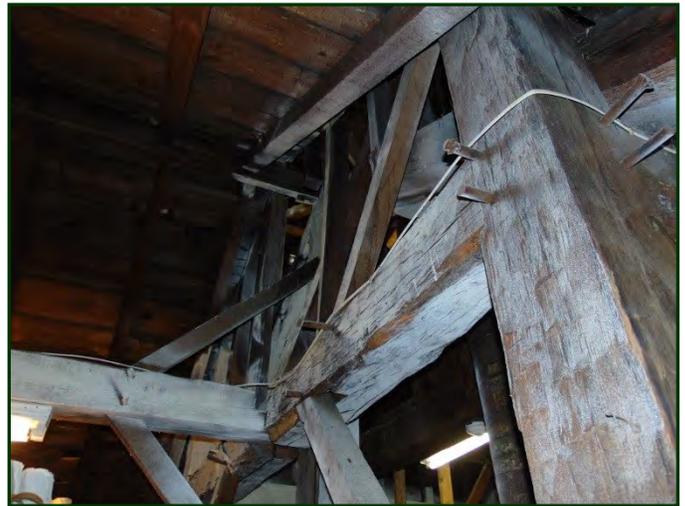
Photo #86: View of a typical wood truss supporting roof purlins and rafters.

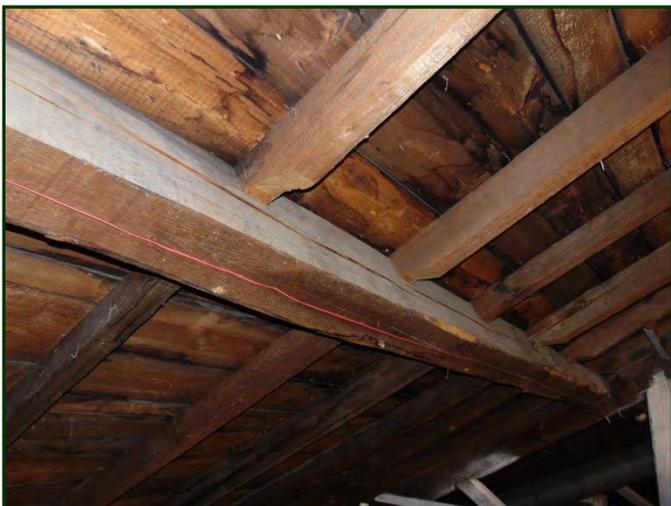
Photo #87: View of a typical purlin supporting wood rafters.

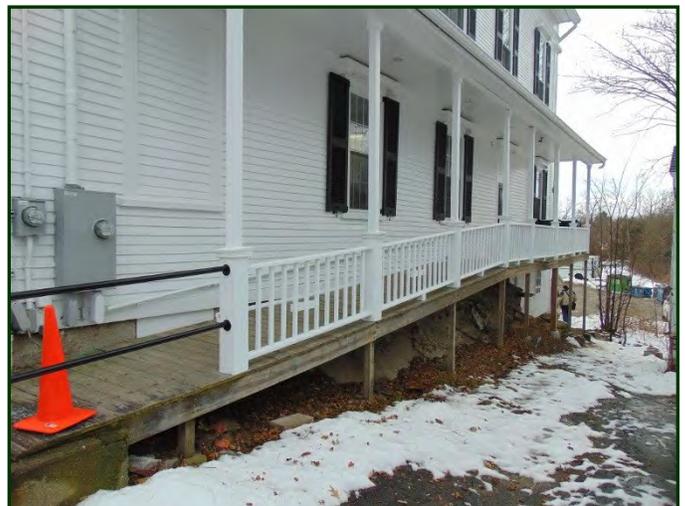
Photo #88: View of the handicap ramp on the north side of the building.

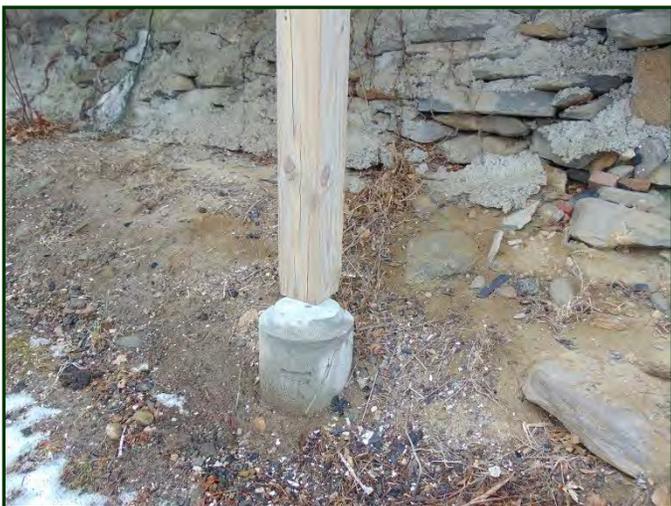
Photo #89: View of a wood post supporting the handicap ramp disconnected from the concrete foundation.

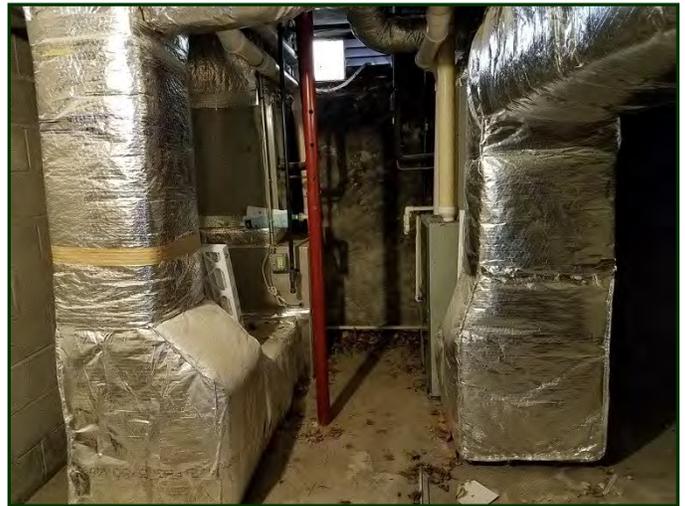
Photo #92: Typical air handling units

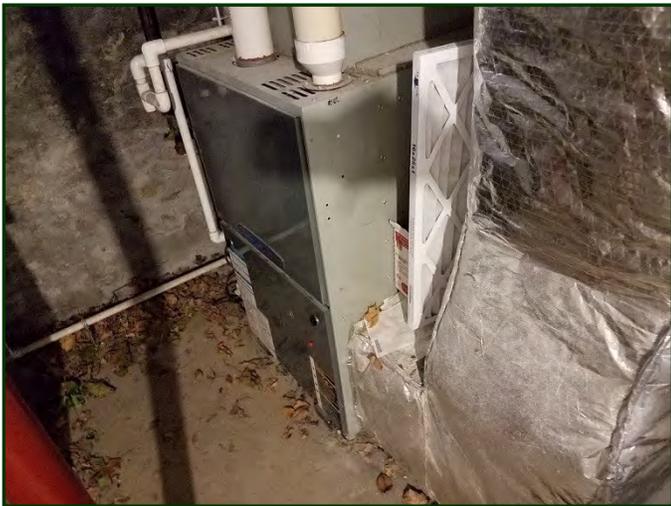
Photo #93: Typical air handling unit, no direct outdoor ventilation

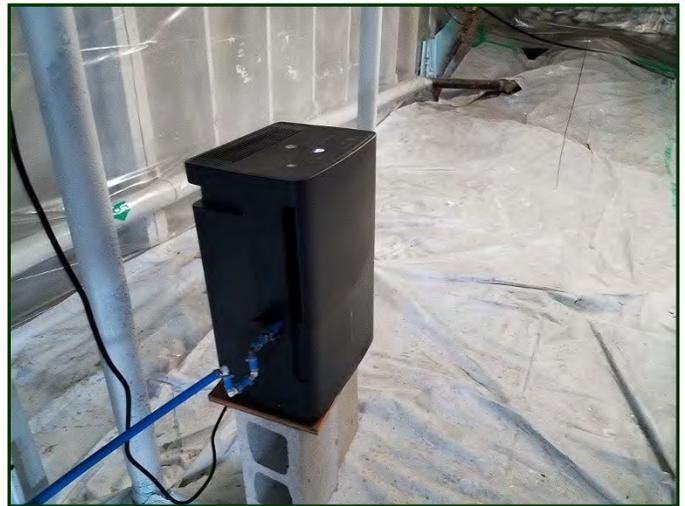
Photo #94: Standalone portable dehumidifier in basement

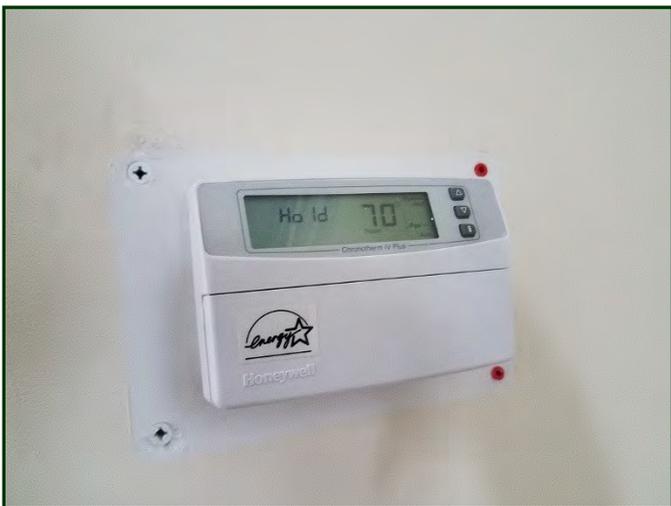
Photo #95: Typical thermostat for air handling unit system

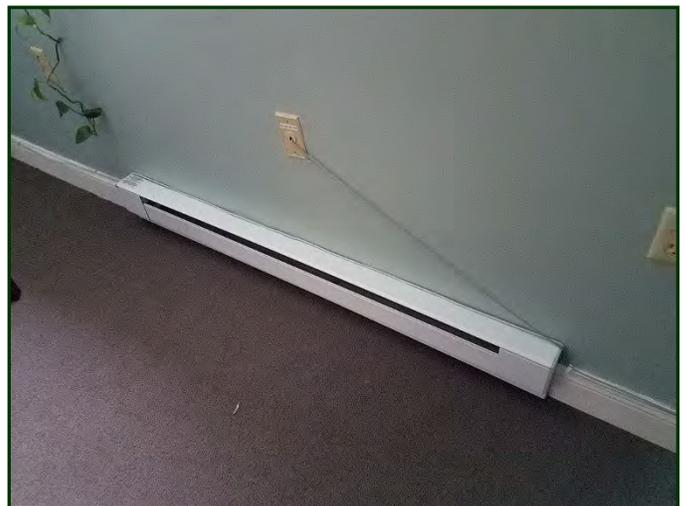
Photo #96: Typical baseboard heating in office areas

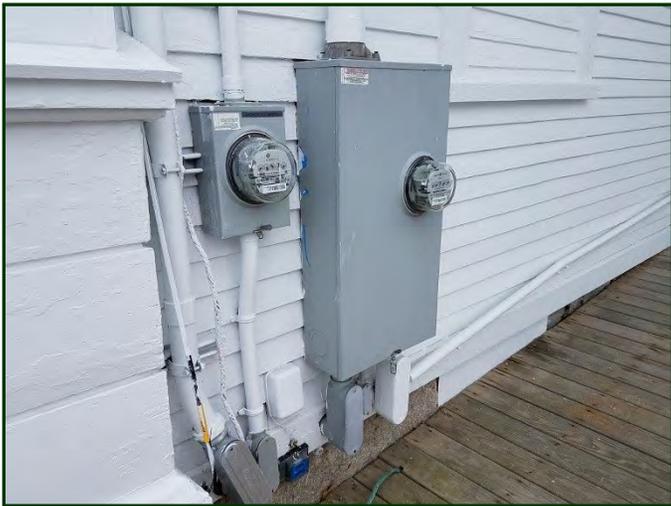
Photo #97: Main electric meters at exterior of building

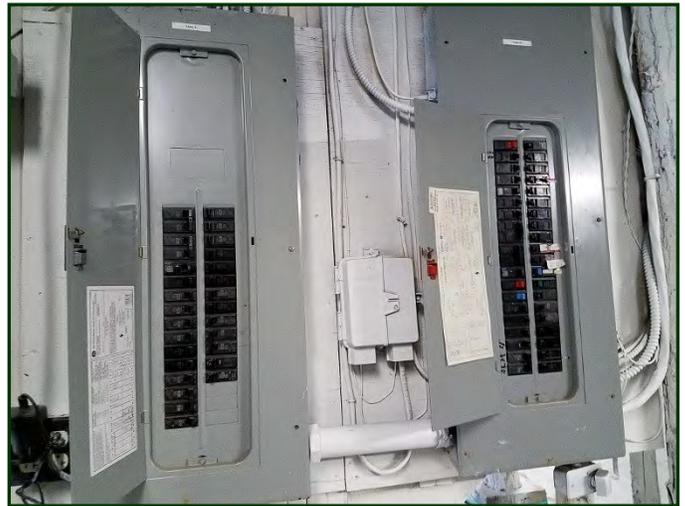
Photo #98: Main electrical panels in basement

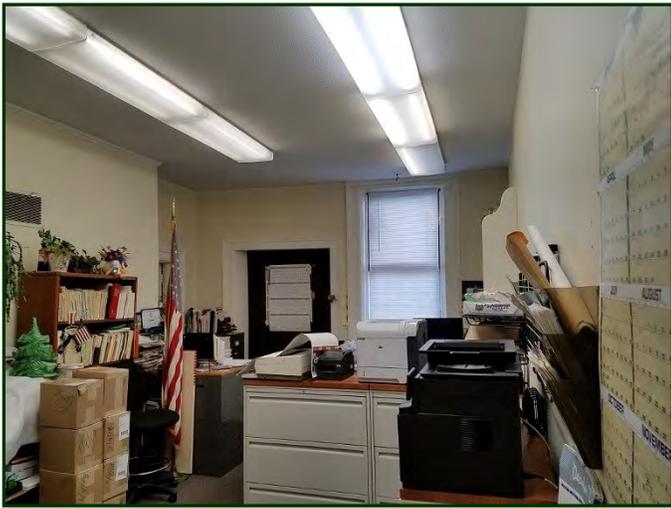
Photo #103: Typical lighting in office area

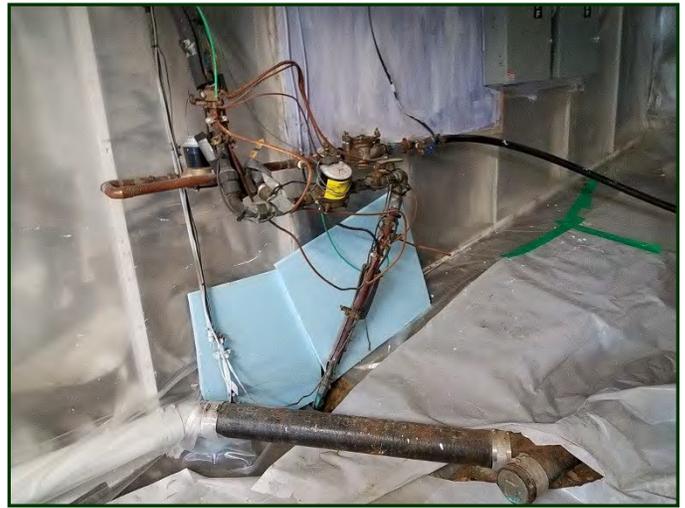
Photo #104: Domestic water service connections and meters. Piping not secured to wall

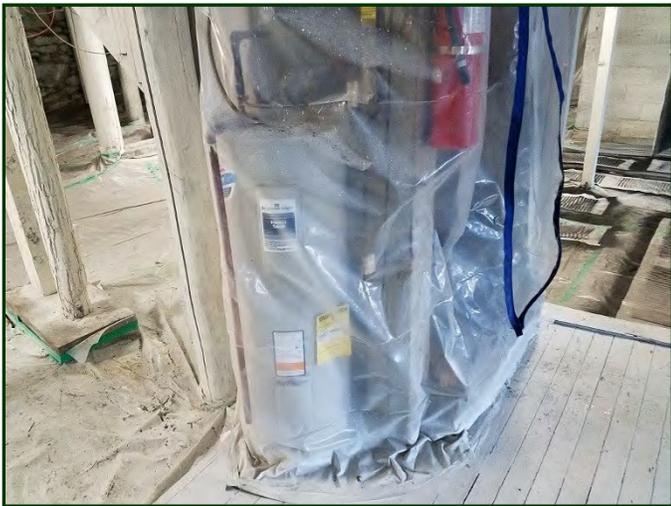
Photo #105: Domestic electric hot water heater

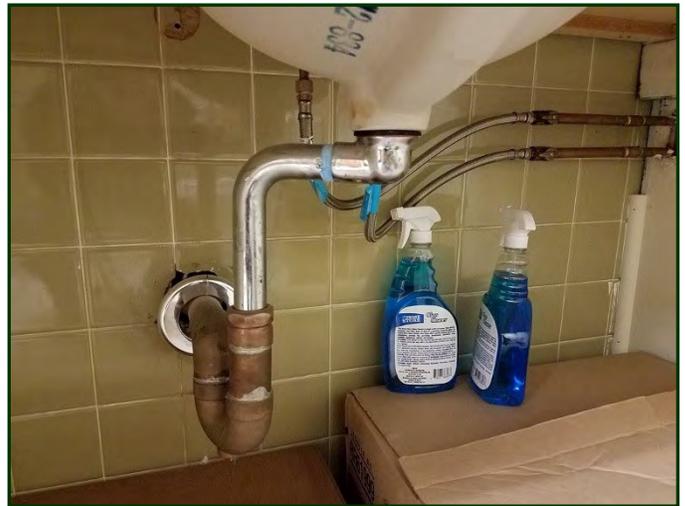
Photo #106: Typical domestic water piping under sinks

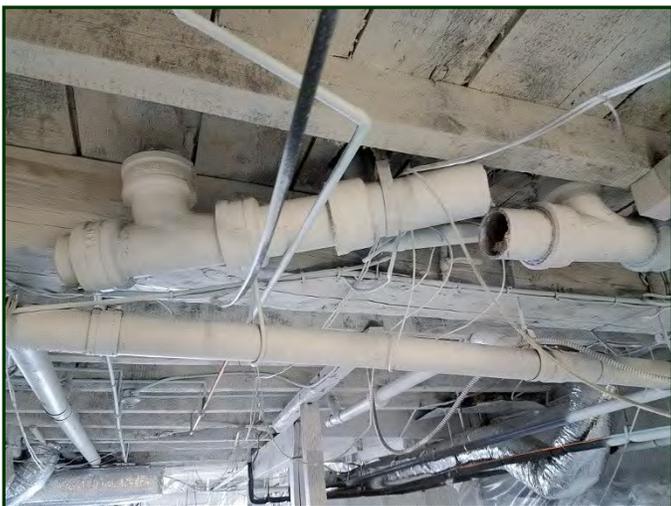
Photo #107: Typical abandoned sanitary sewer lines in basement
