Town Hall
17 Main Street
Lunenburg, MA 01462

Property Condition Assessment

February 6, 2018

VERTEX Project No: 48237

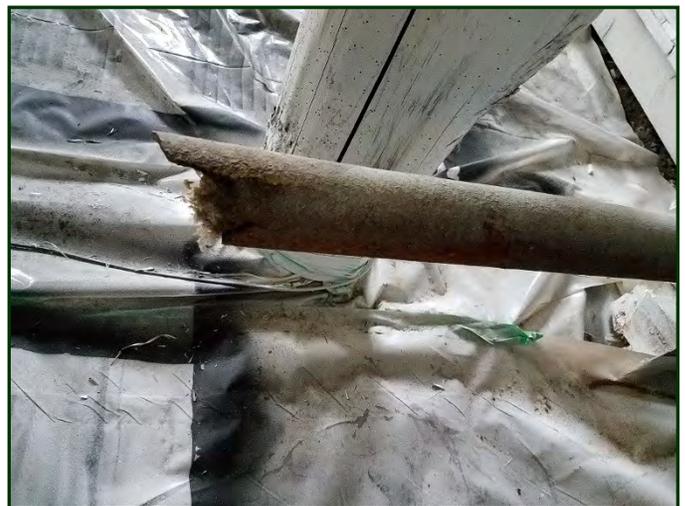
Photo #108: Typical abandoned sanitary sewer lines in basement

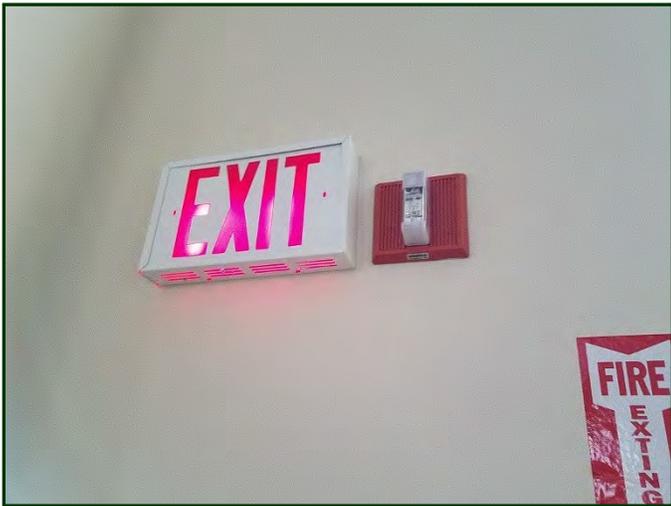
Photo #109: Typical exit signage and fire alarm strobe

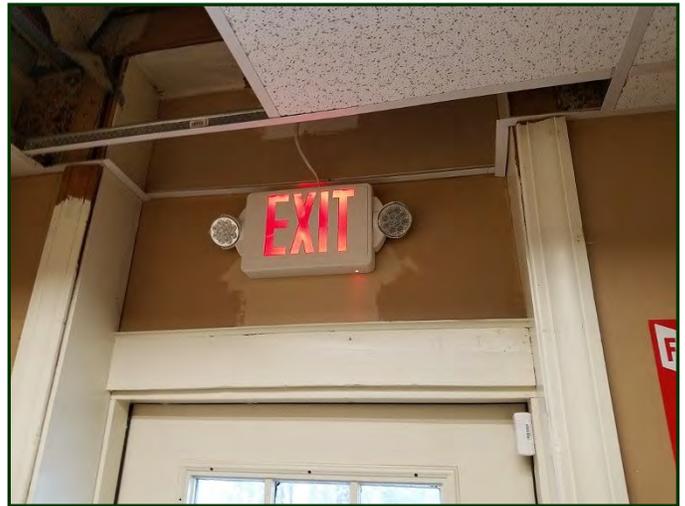
Photo #110: Exit signage with battery backup

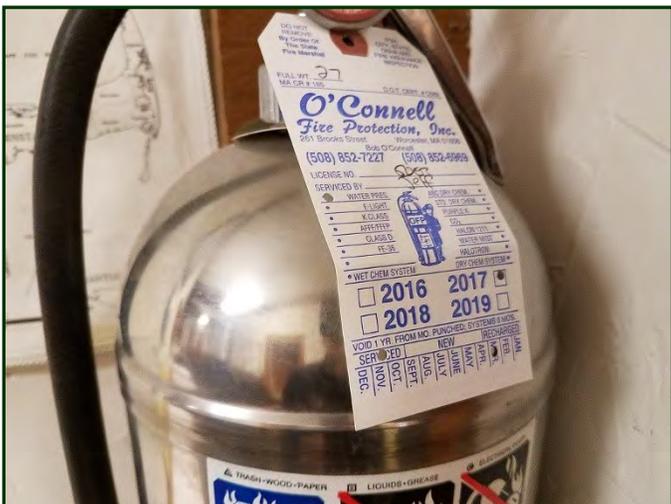
Photo #113: Fire extinguisher and inspection tag
