Lunenburg Primary School

30 School Street
Lunenburg, MA 01462

Property Condition Assessment

February 6, 2018

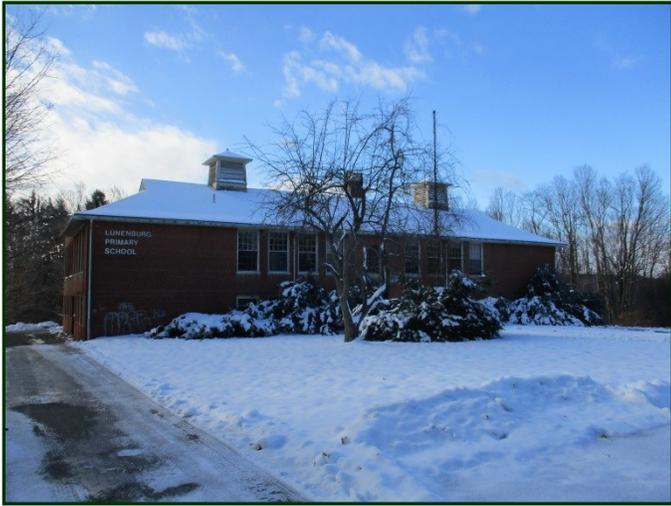
Photo #1: Overview of school (north elevation)

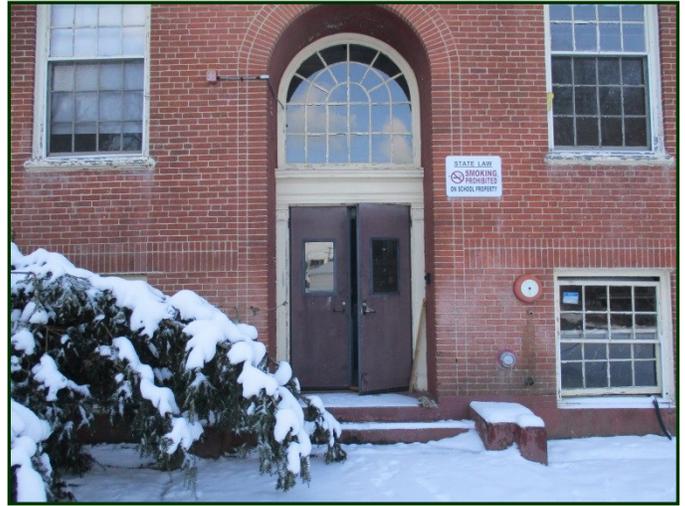
Photo #2: Main front entrance to building (north elevation)

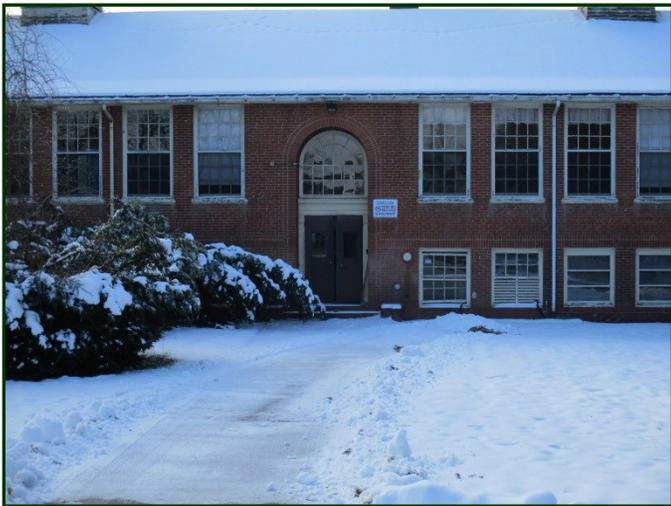
Photo #3: Close-up view of north elevation

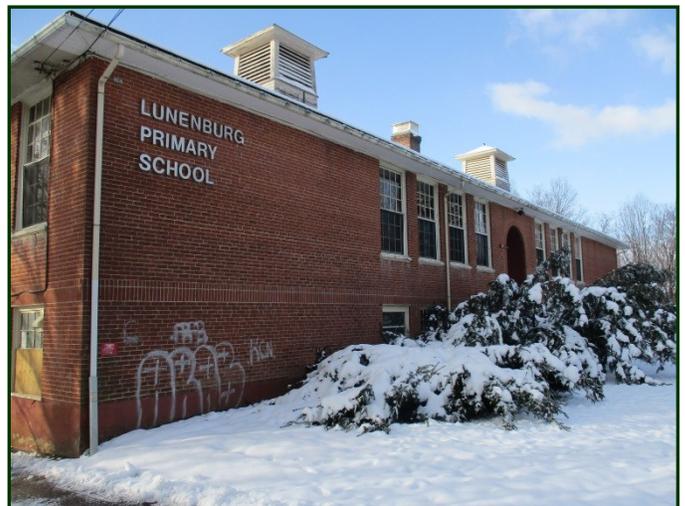
Photo #10: North elevation as viewed from the northeast corner of building

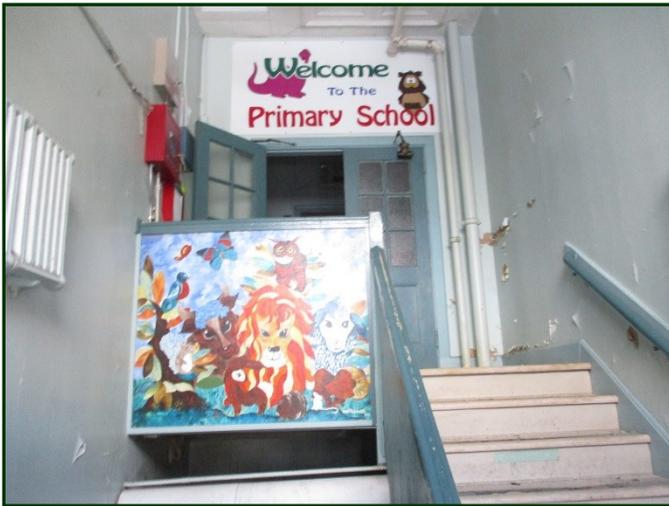
Photo #13: View of upper level at entrance stairs

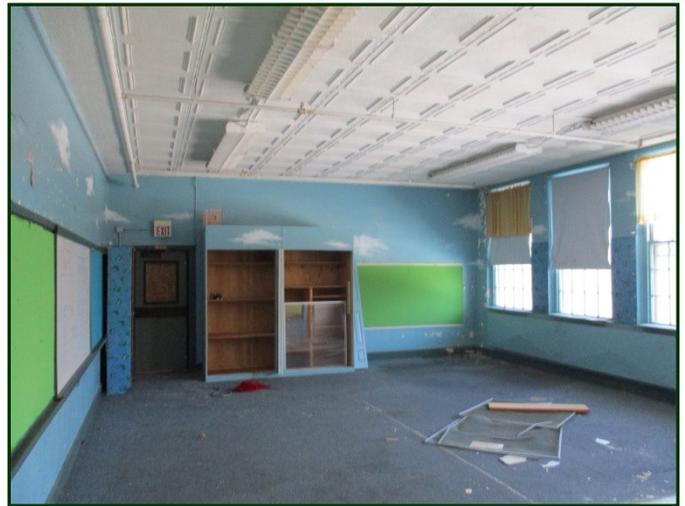
Photo #14: Upper level classroom with carpet floor, painted plaster walls and tin ceiling

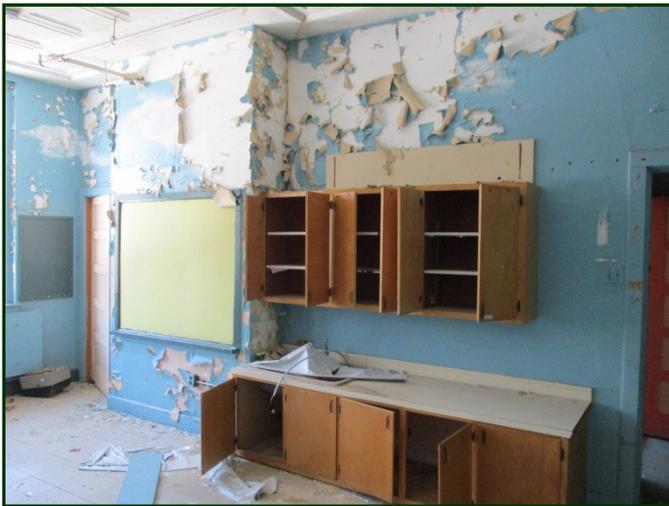
Photo #15: Wood cabinetry in classroom

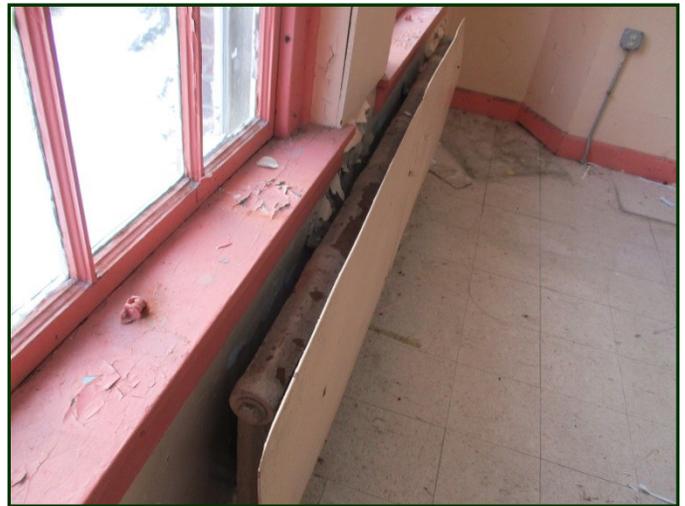
Photo #16: Cast iron steam radiators with steel shields in classroom-typical

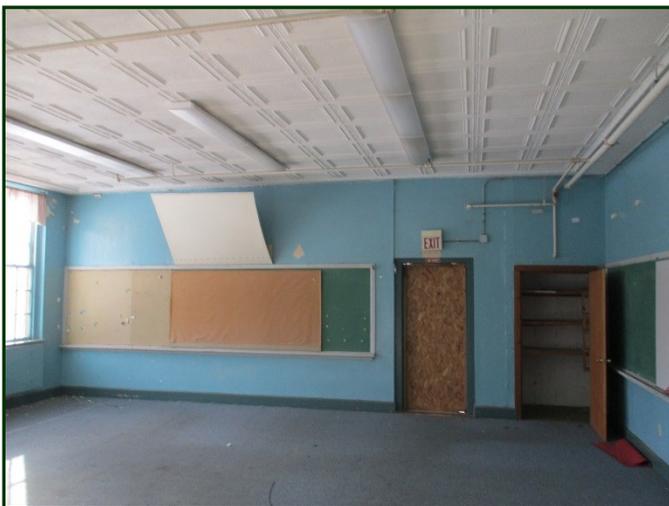
Photo #17: Upper level classroom at south east corner of building

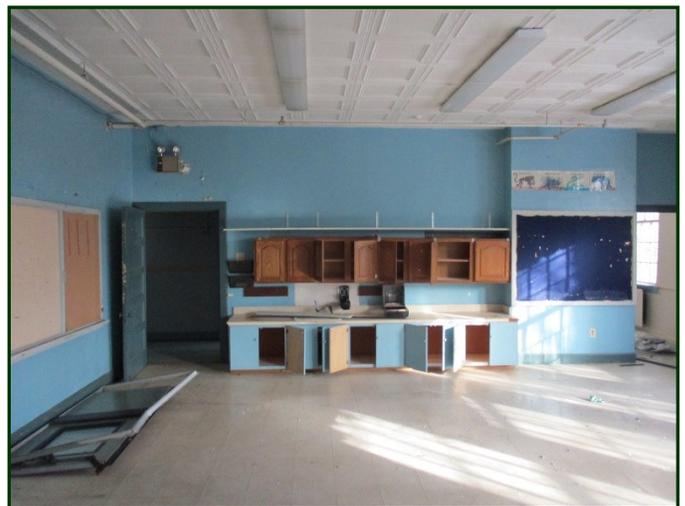
Photo #18: Upper level classroom with vinyl floor and tin ceiling

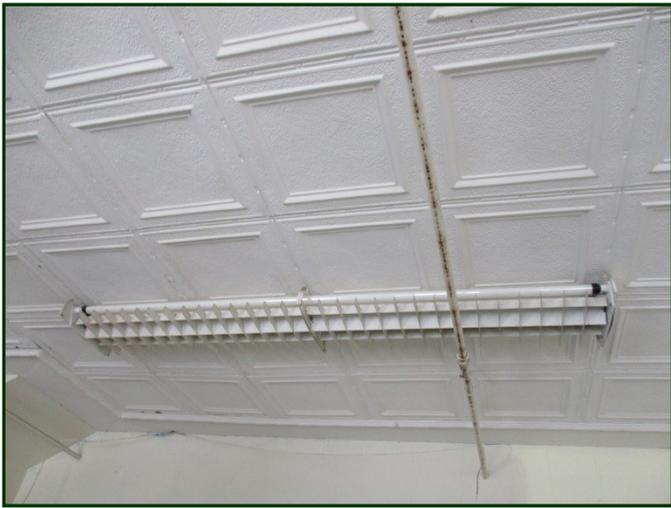
Photo #19: Painted tin ceiling with fluorescent lighting fixture and sprinkler system

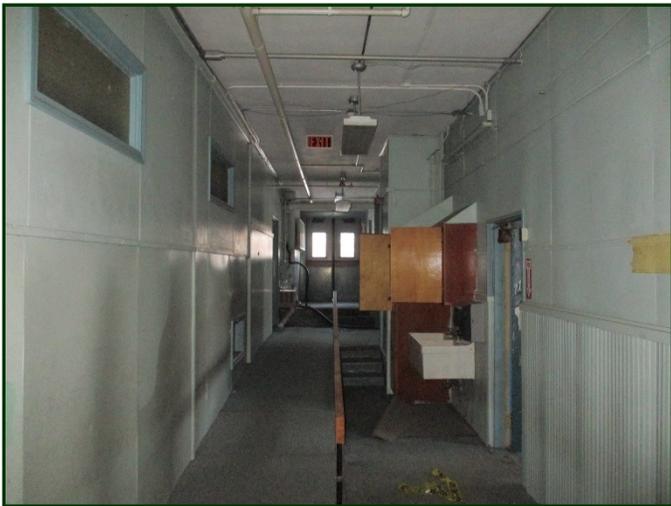
Photo #21: Corridor at lower level

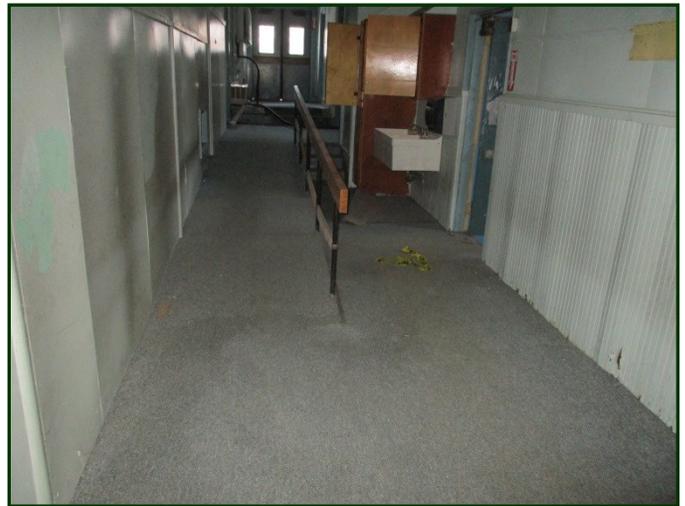
Photo #22: View of ramp and stairs at lower level corridor

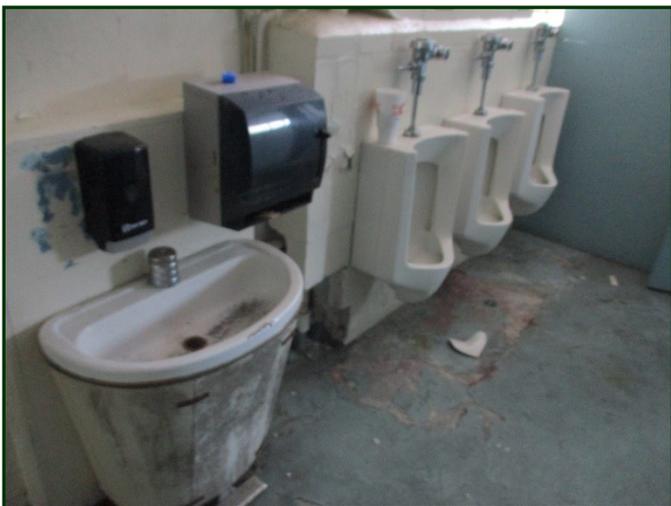
Photo #23: Boy's toilet room at lower level

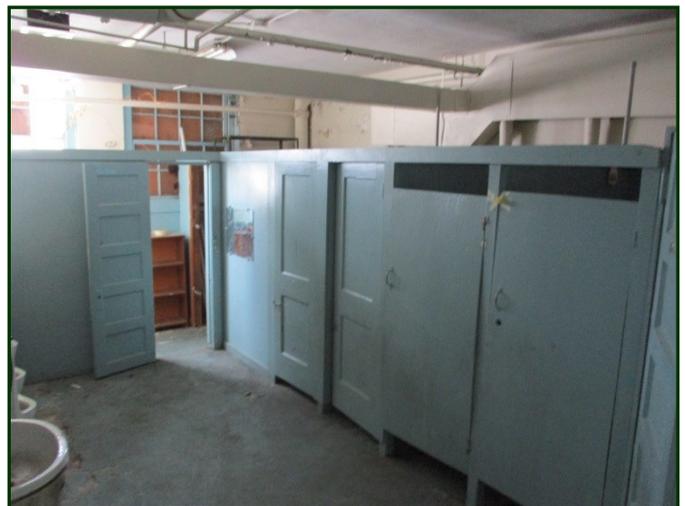
Photo #24: Painted wooden partitions in boy's toilet room

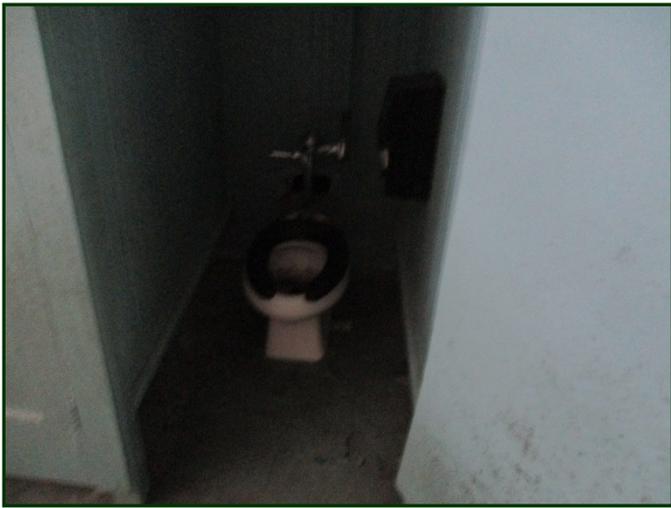
Photo #25: Toilet stall in boy's toilet room

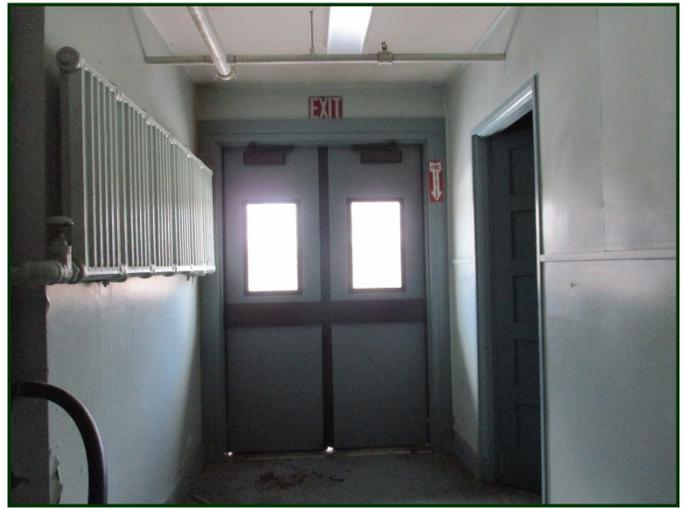
Photo #26: Egress doorway at lower level west side

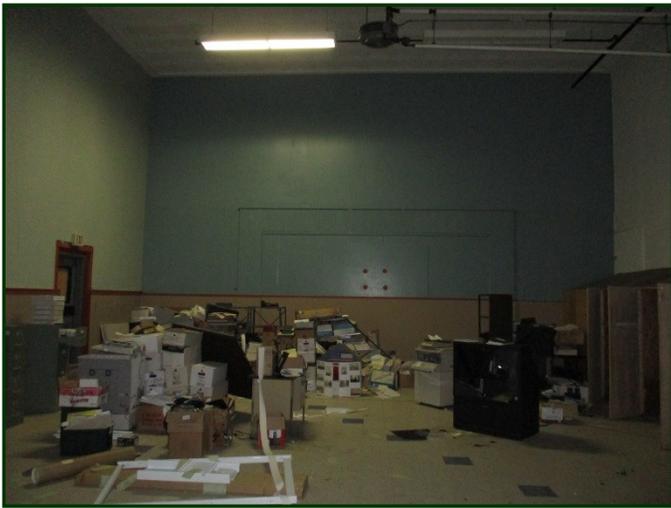
Photo #27: Gymnasium in lower level

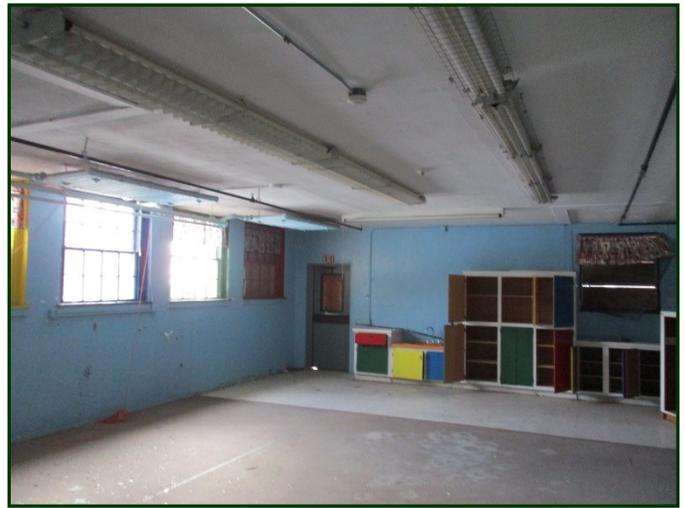
Photo #28: Classroom at lower level

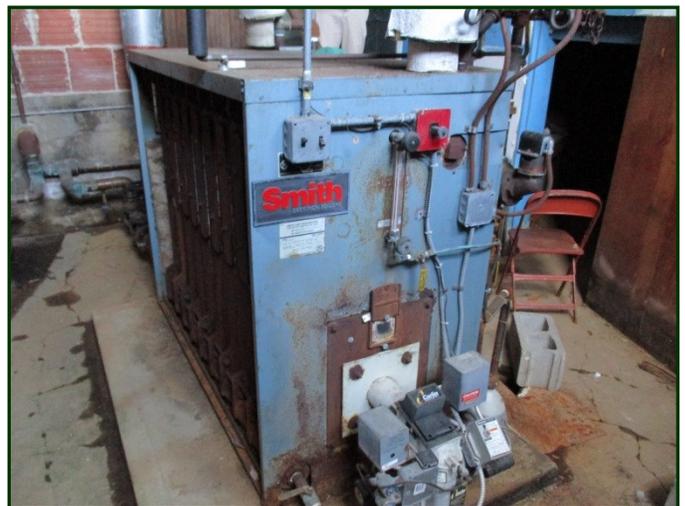
Photo #30: Oil-fired steam boiler in lower level mechanical room. Note oil tank has reportedly been removed

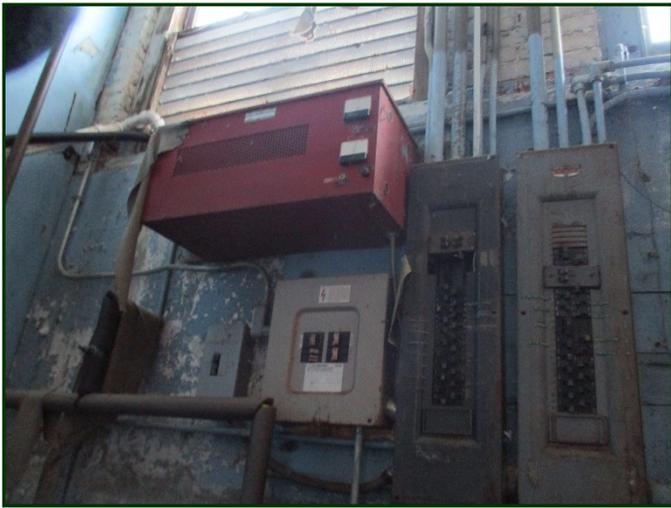
Photo #31: Main electrical service in mechanical room lower level

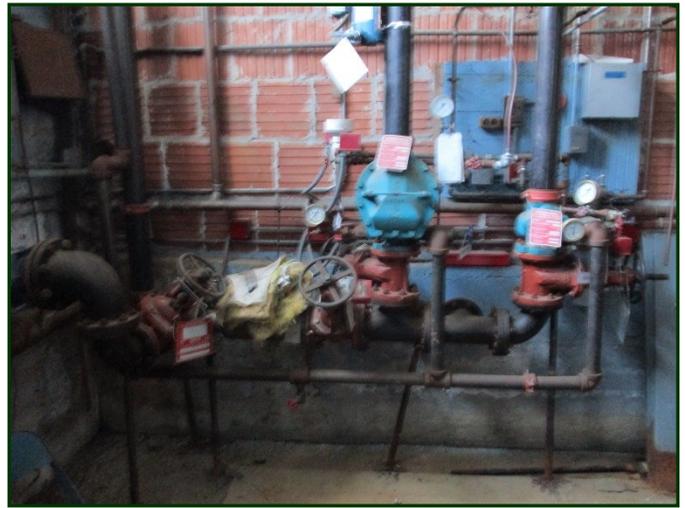
Photo #32: Wet-type sprinkler service in mechanical room

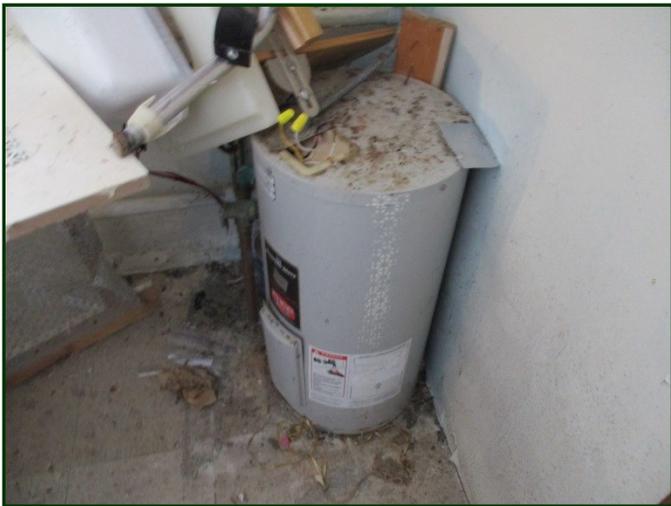
Photo #33: Electric domestic water heater in lower level east side

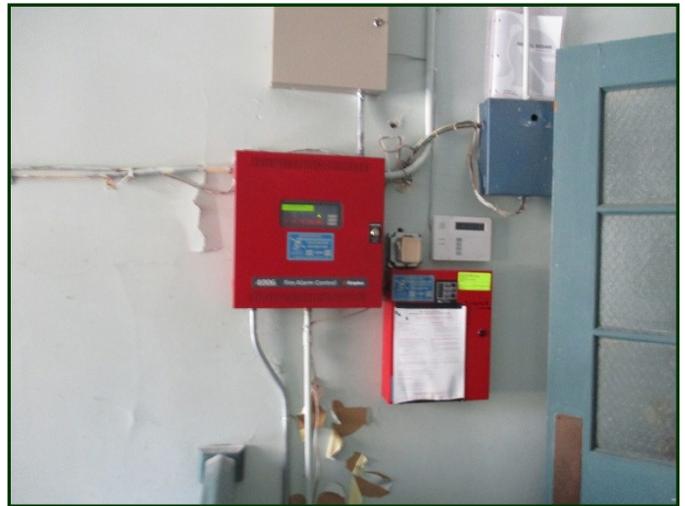
Photo #34: Fire Alarm Control Panel at upper level stair landing

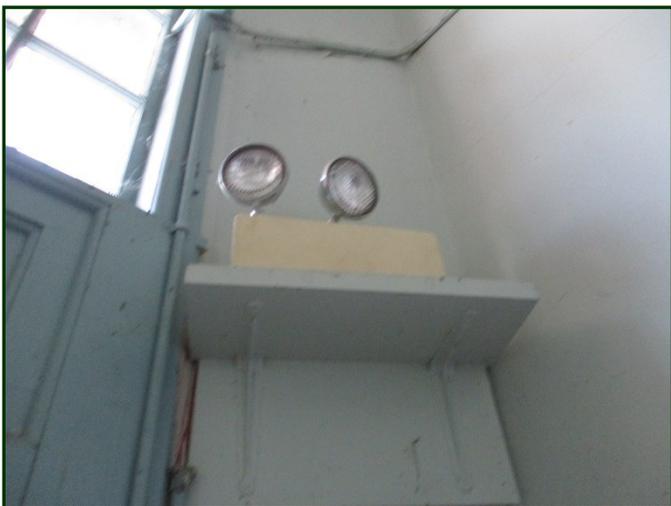
Photo #35: Shelf-mounted emergency egress lighting fixture

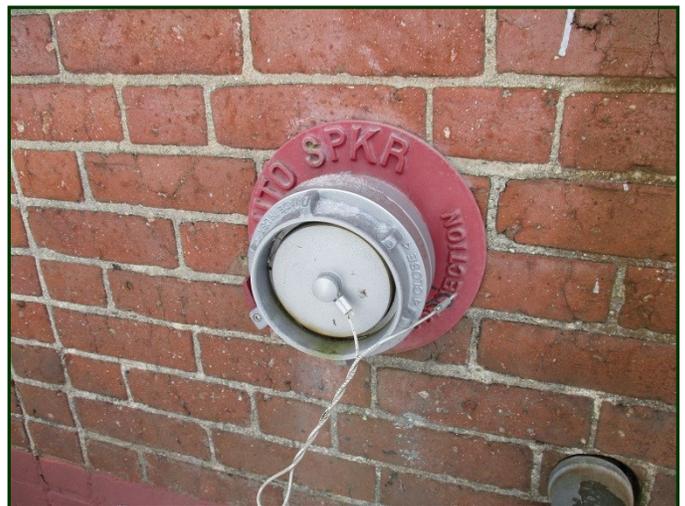
Photo #36: Fire department hose connection (adjacent to front door)

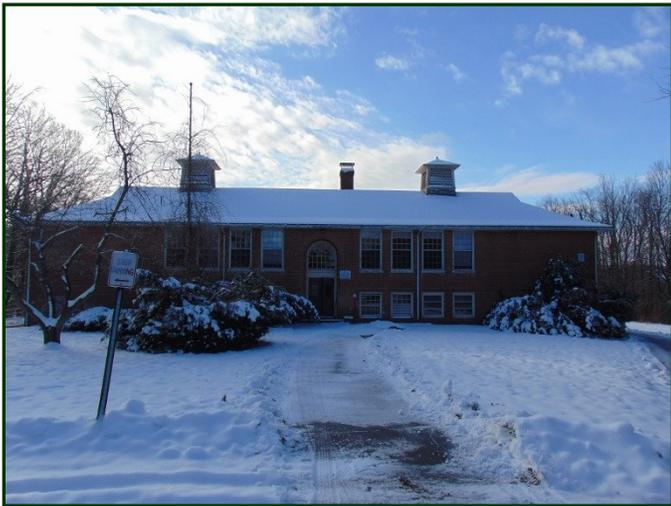
Photo #37: Front (north) elevation of the Primary School.

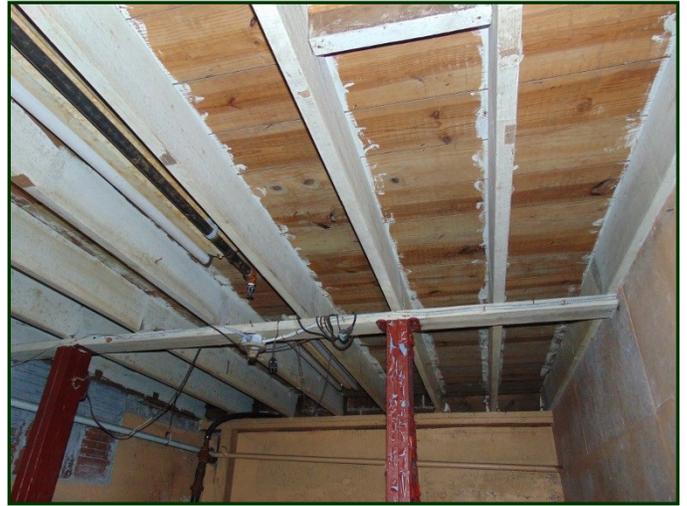
Photo #44: Wood framing below 1st floor classroom.

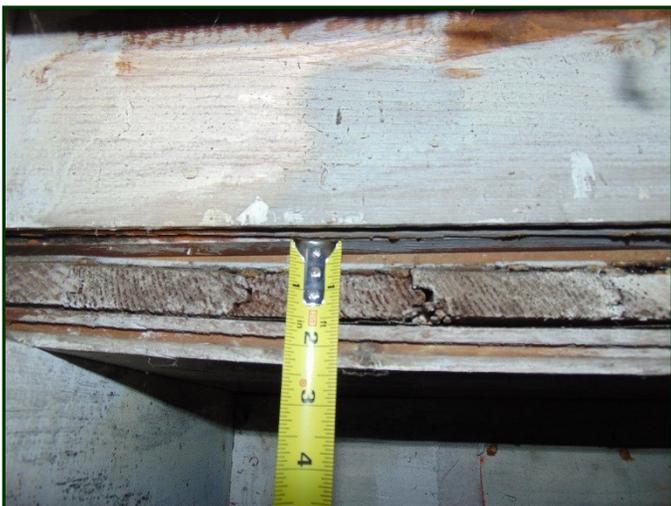
Photo #47: View of typical floor system. Note tongue and groove wood deck.

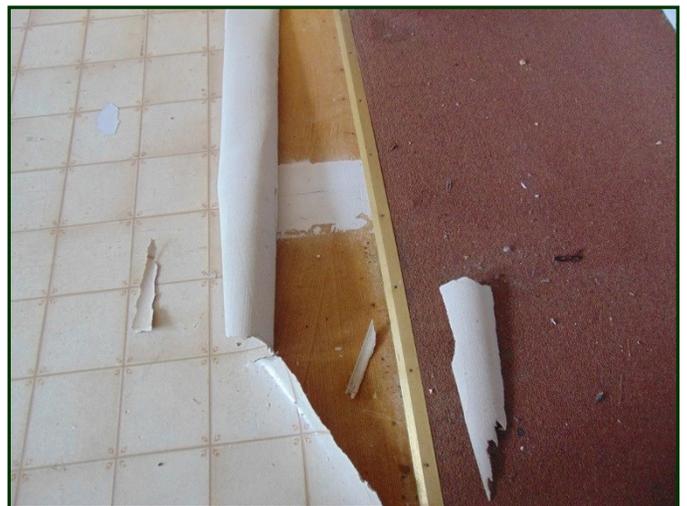
Photo #48: View of subfloor below flooring system.

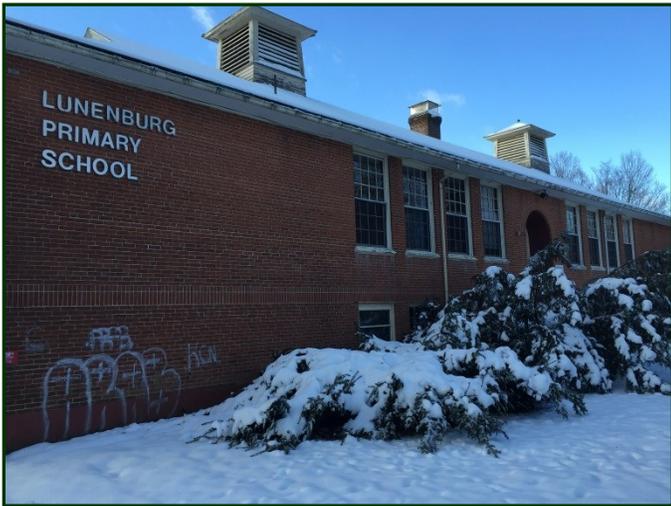
Photo #49: Photograph depicts general view of Side A

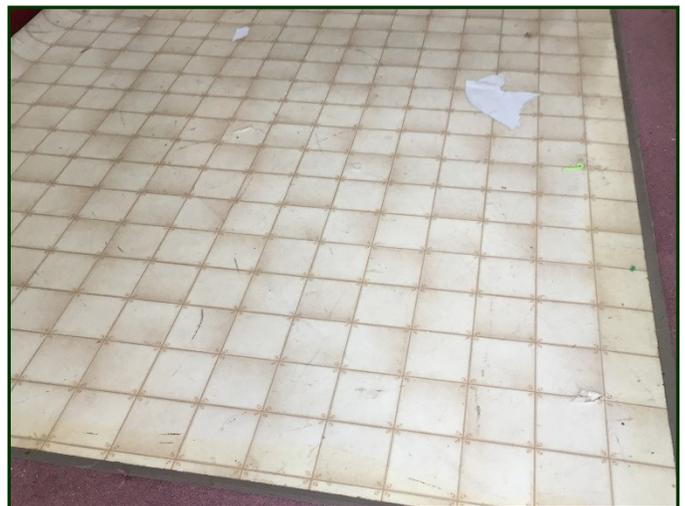
Photo #54: Photograph depicts general view of sheet flooring within a Classroom

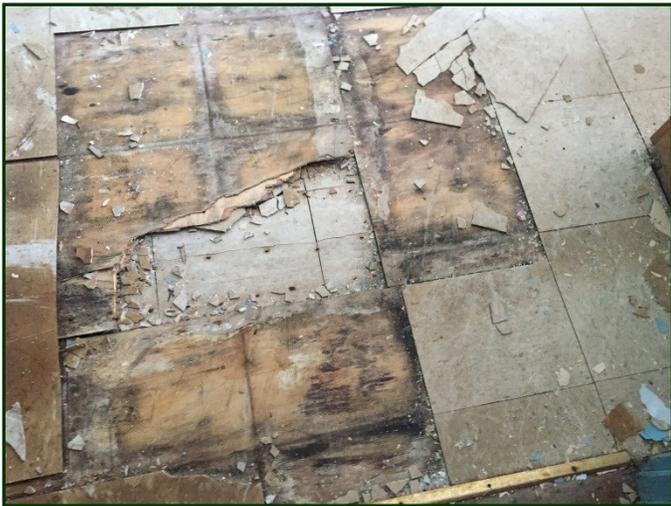
Photo #55: Photograph depicts general view of floor tile under subfloor within a classroom

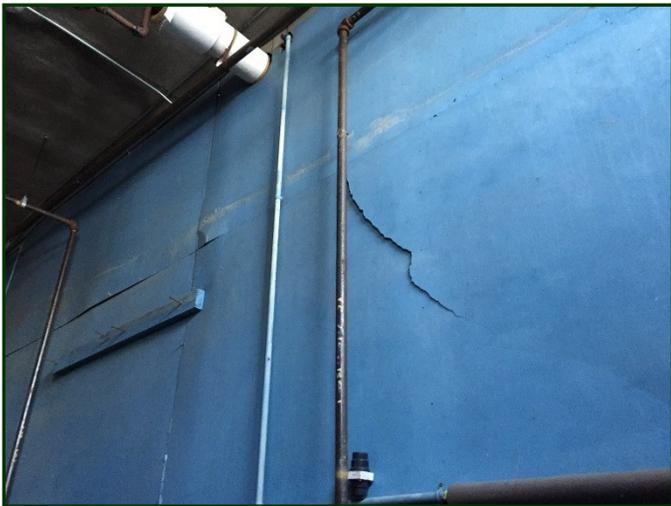
Photo #57: Photograph depicts general view of cement board paneling within the Boiler Room

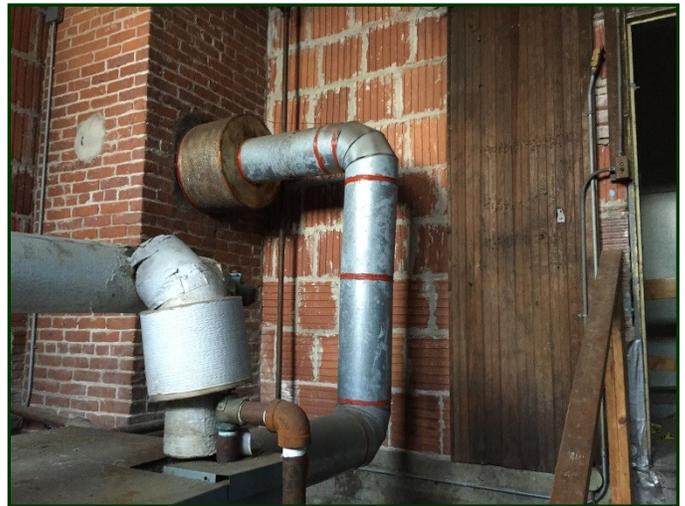
Photo #58: Photograph depicts general view of red duct sealant within the Boiler Room

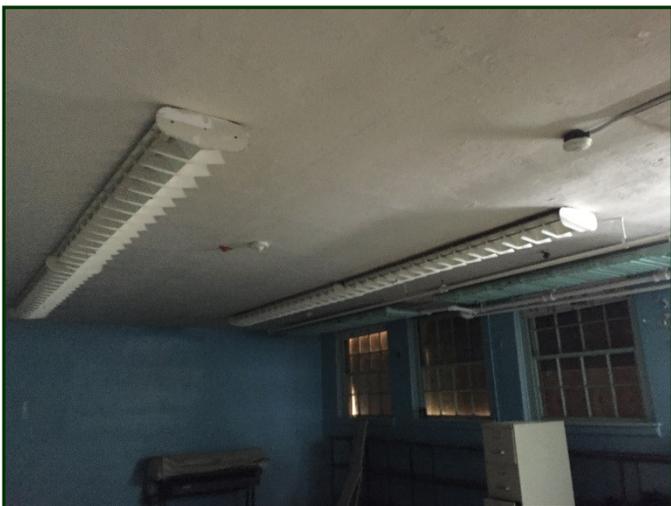
Photo #59: Photograph depicts general view of fluorescent lighting fixtures within a classroom

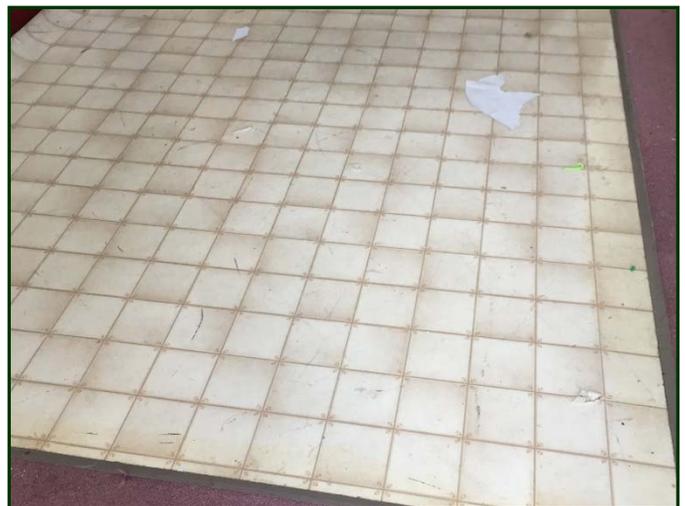
At the time of the assessment, the suspect ACMs identified were observed to be in fair to poor condition. Please refer to Attachment A which includes photographic documentation of the suspect ACMs identified during the assessment.

Photo #54: Photograph depicts general view of sheet flooring within a Classroom

Prior to any renovation or demolition activities, sampling of suspect ACMs that may be disturbed would need to be conducted in applicable areas to determine asbestos content. A comprehensive ACM survey is required to be conducted to comply with the Environmental Protection Agency (EPA) National Emission Standard for Hazardous Air Pollutants (NESHAPs) 40 CFR Part 61. Until these materials have been sampled and determined to be non-asbestos containing, these materials should be managed in place as presumed asbestos-containing materials (PACMs).

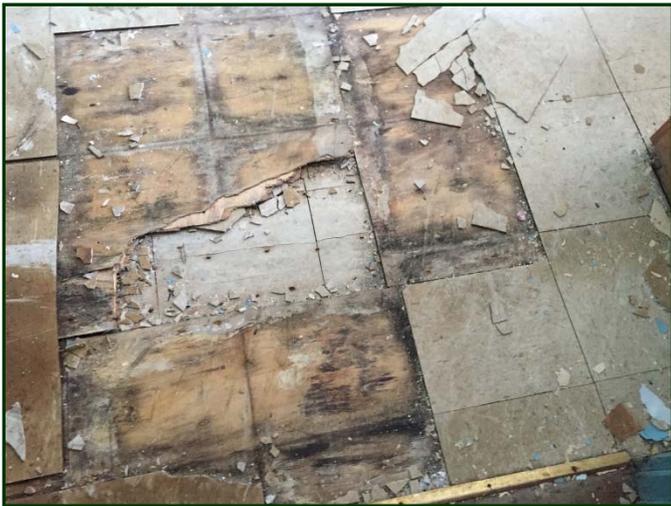
Photo #55: Photograph depicts general view of floor tile under subfloor within a classroom

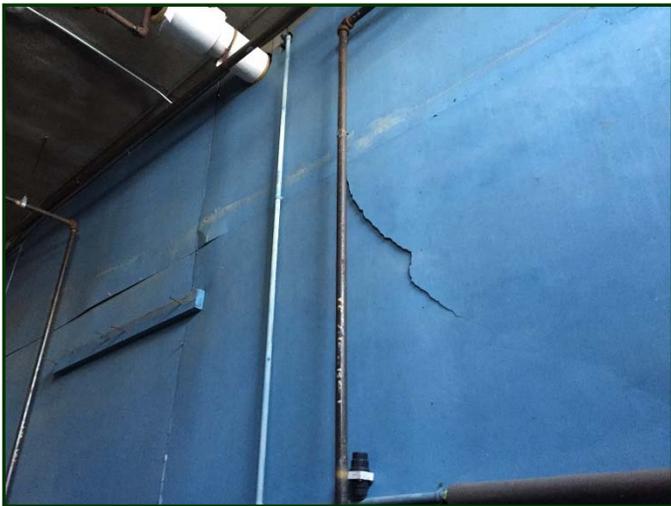
Photo #57: Photograph depicts general view of cement board paneling within the Boiler Room

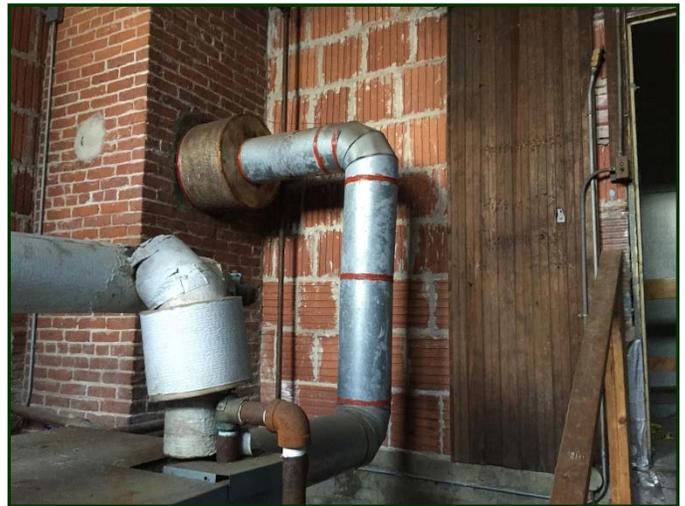
Photo #58: Photograph depicts general view of red duct sealant within the Boiler Room

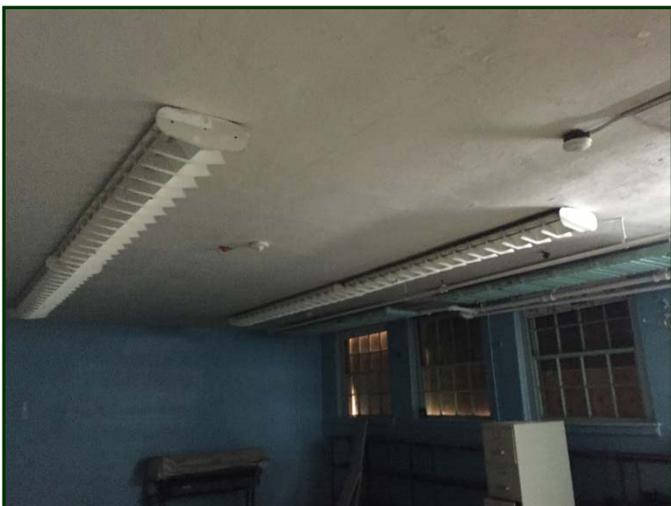
Photo #59: Photograph depicts general view of fluorescent lighting fixtures within a classroom

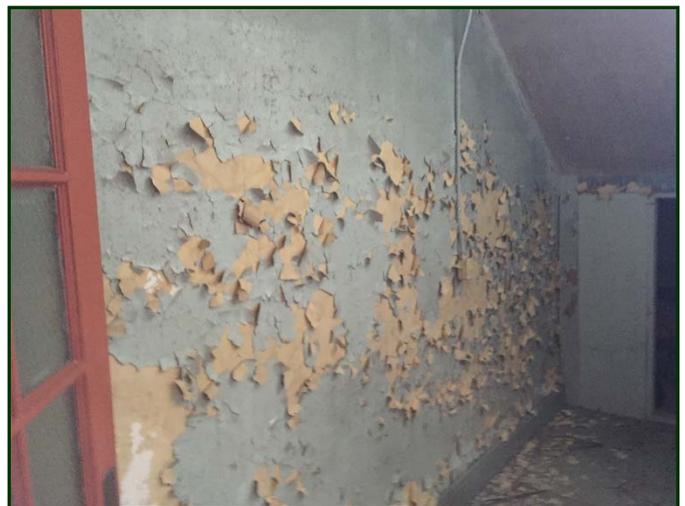
Based on the age of the site building (1926) it likely that LBPs are present at the site building. Various colored painted surfaces were observed to be in poor condition on the interior as well as exterior. Please refer to Attachment A which includes photographic documentation of the suspect LBP surfaces identified during the assessment.

Photo #60: Photograph depicts general view of peeling/flaking paint within the lower level corridor
