**Ritter Memorial Building**

960 Massachusetts Avenue
Lunenburg, MA 01462

Property Condition Assessment

February 6, 2018

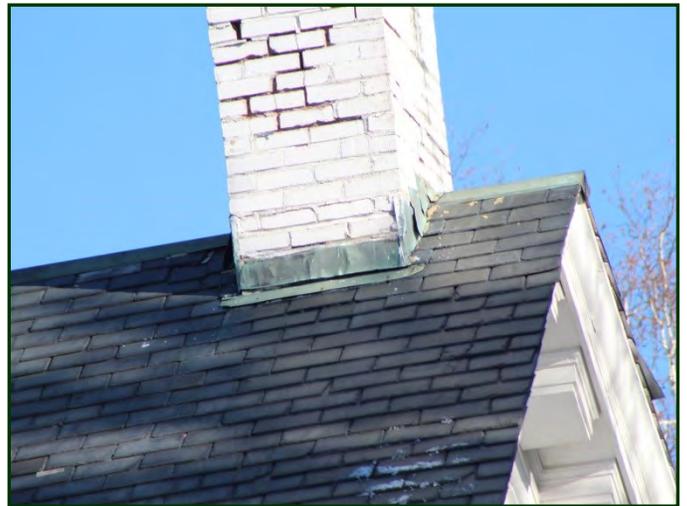
Photo #10: Detail of the chimney flashing.

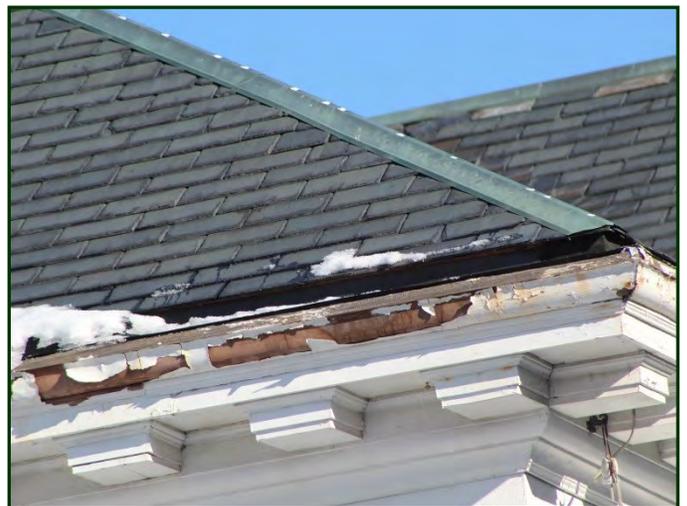
Photo #12: Detail of the eave at the northwest corner of the front facade.

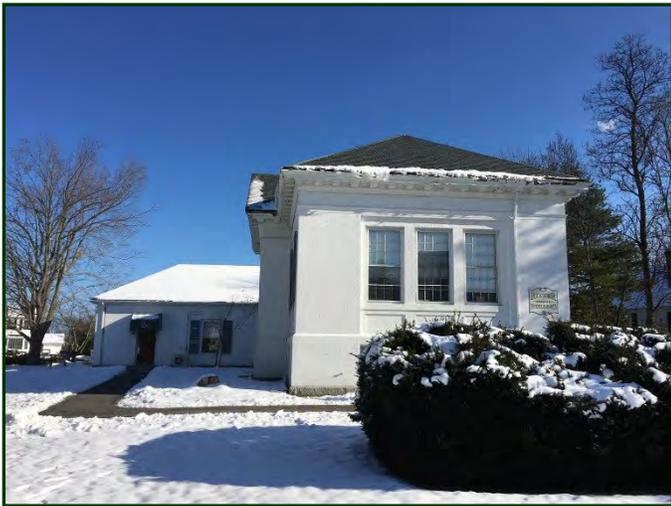
Photo #25: The west façade of the original building appeared free of masonry cracks.

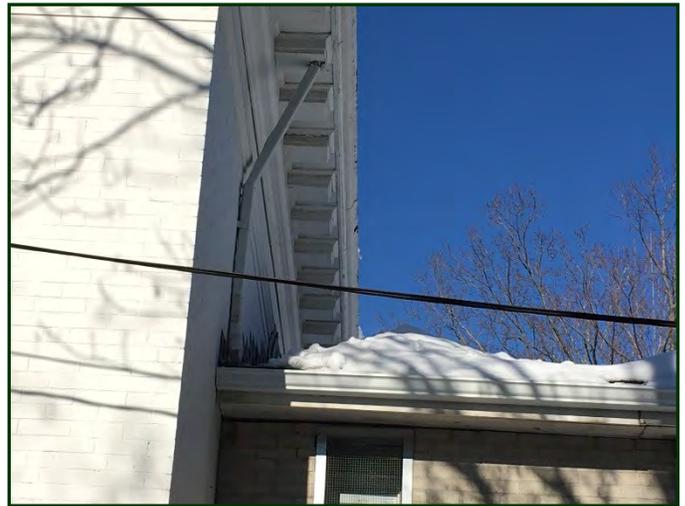
Photo #32: Detail of connection between the east façade of the original structure and the roof of the addition.

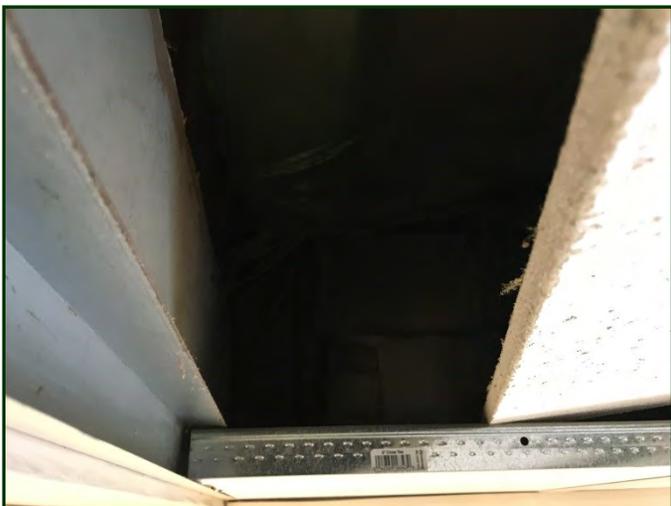
Photo #33: The drop ceiling was moved to witness the intersection at the addition connection.

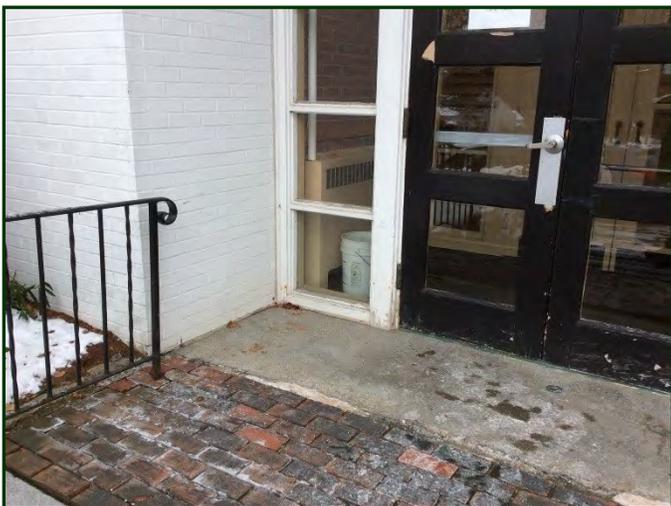
Photo #35: Detail of the main entry door and sidelight.

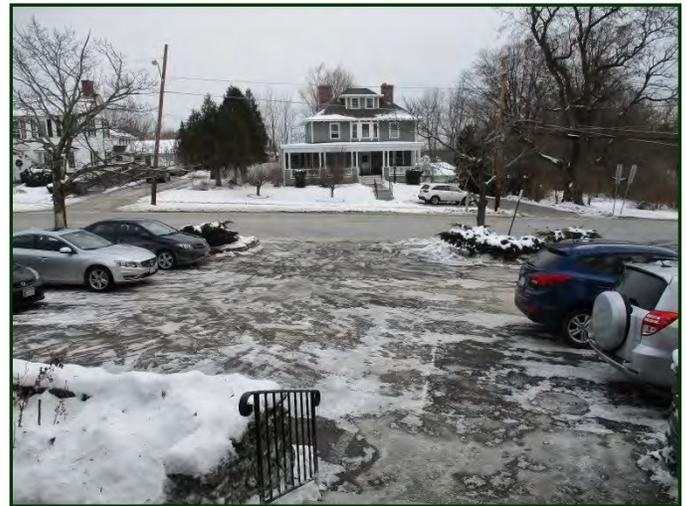
Photo #40: Asphalt-paved parking lot at east side of site (looking east)

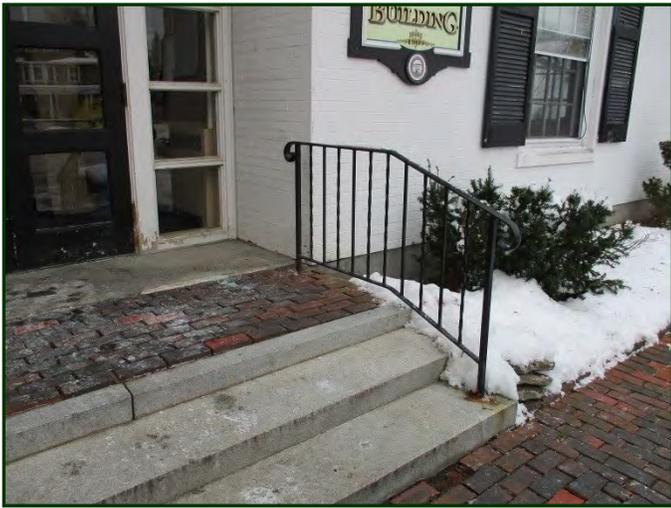
Photo #43: Close-up view of steps at front entrance.

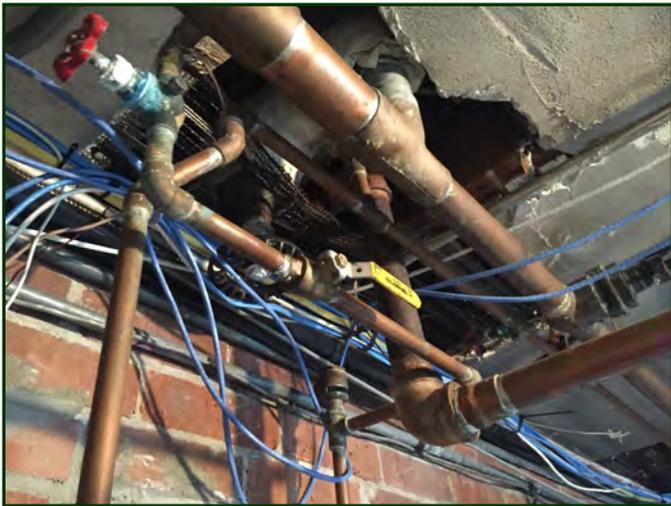
Photo #78: Photograph depicts general view of pipe wrap within Lower Level Utility Closet

Prior to any renovation or demolition activities, sampling of suspect ACMs that may be disturbed would need to be conducted in applicable areas to determine asbestos content. A comprehensive ACM survey is required to be conducted to comply with the Environmental Protection Agency (EPA) National Emission Standard for Hazardous Air Pollutants (NESHAPs) 40 CFR Part 61. Until these materials have been sampled and determined to be non-asbestos containing, these materials should be managed in place as presumed asbestos-containing materials (PACMs).

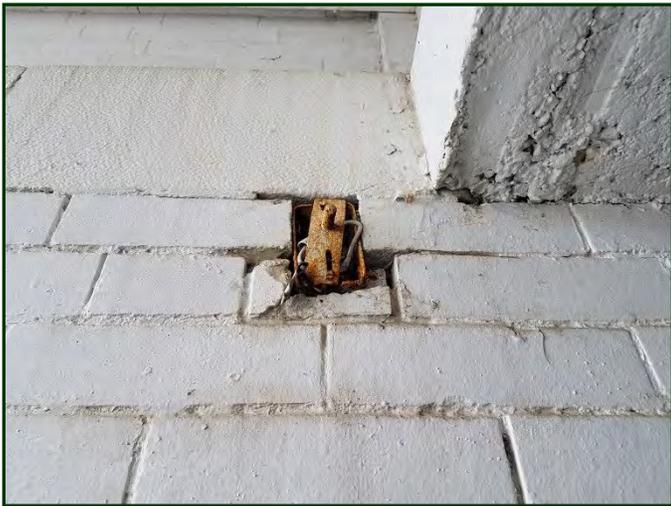
Photo #96: Exposed Romex wiring in IT Room

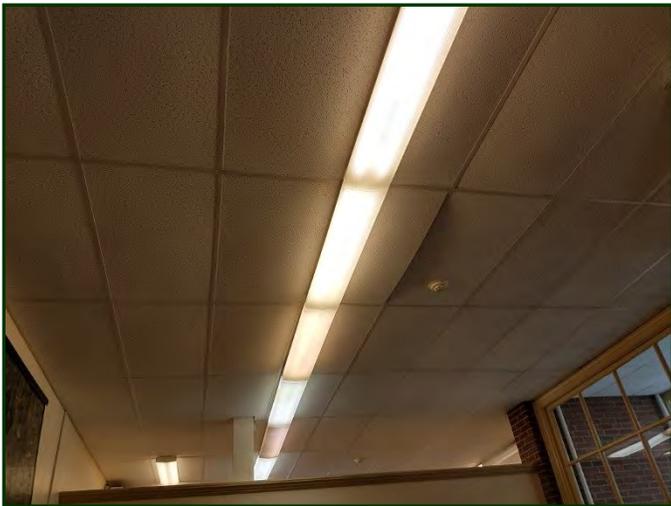
Photo #99: Typical lighting in office areas

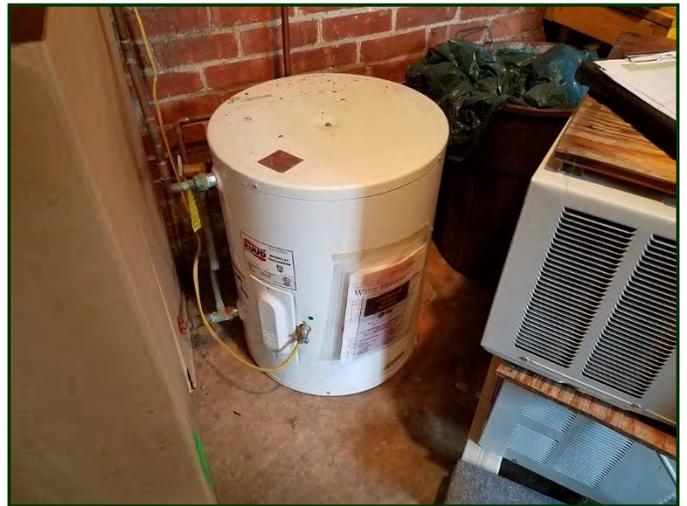
Photo #100: Domestic electric water heater in boiler room

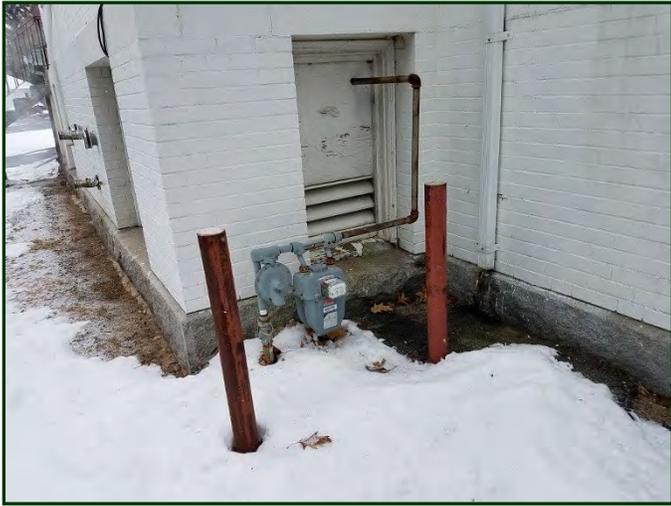
Photo #103: Natural gas meter

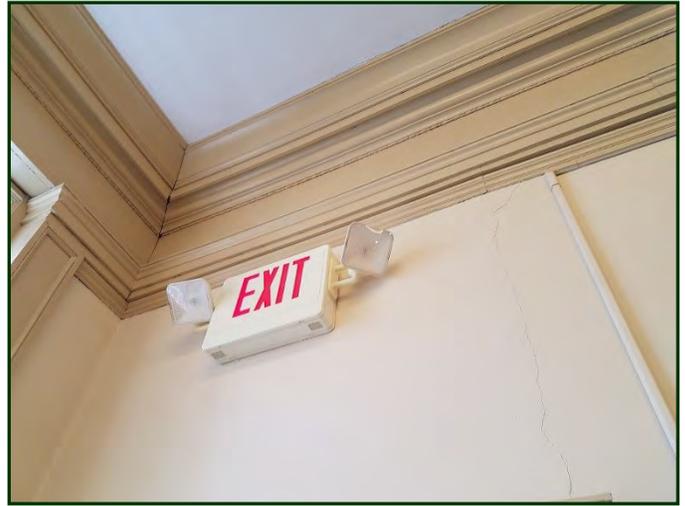
Photo #104: Typical exit sign with battery backup

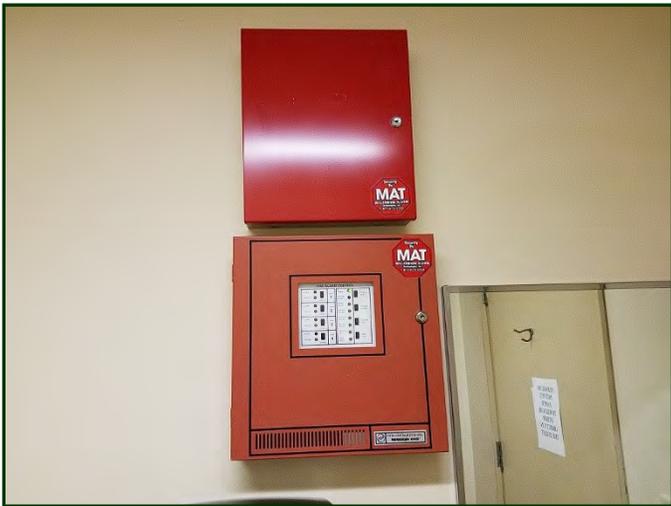
Photo #105: Fire alarm panel in Mens Room

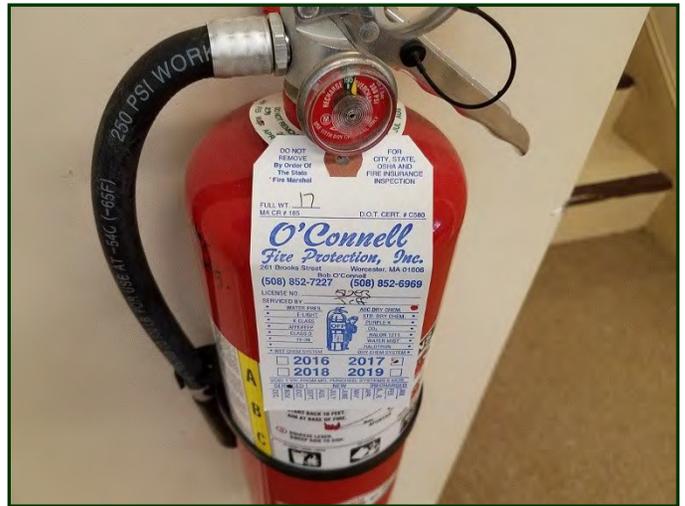
Photo #106: Fire extinguisher and inspection tag

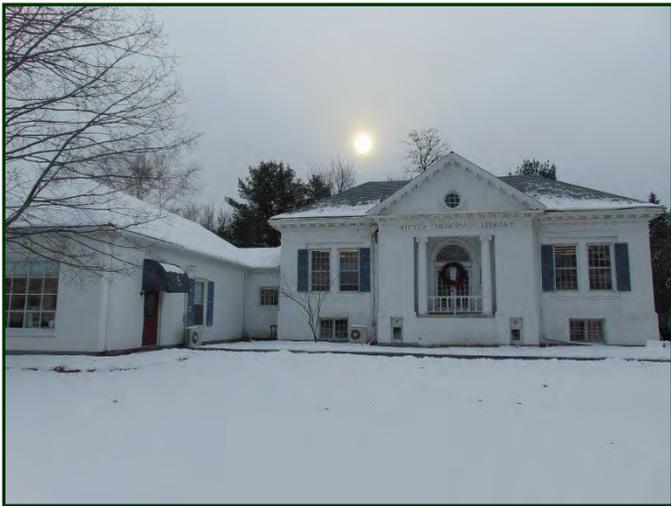
Photo #107: View of the front (north) elevation of the Ritter Building.

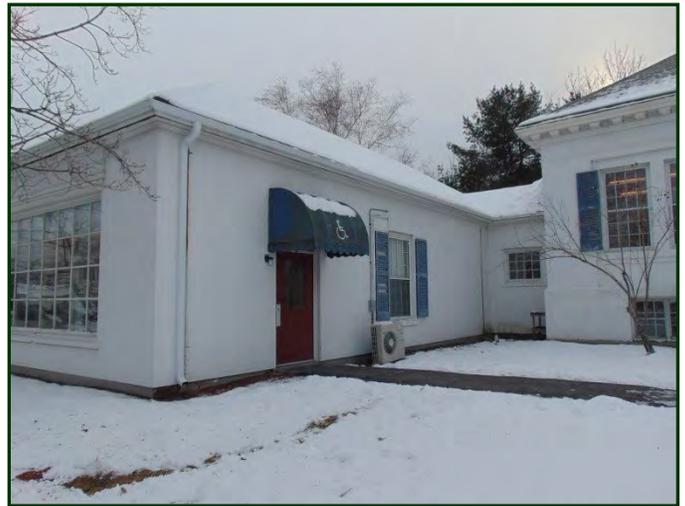
Photo #108: View of the west elevation of the addition to the Ritter Building.

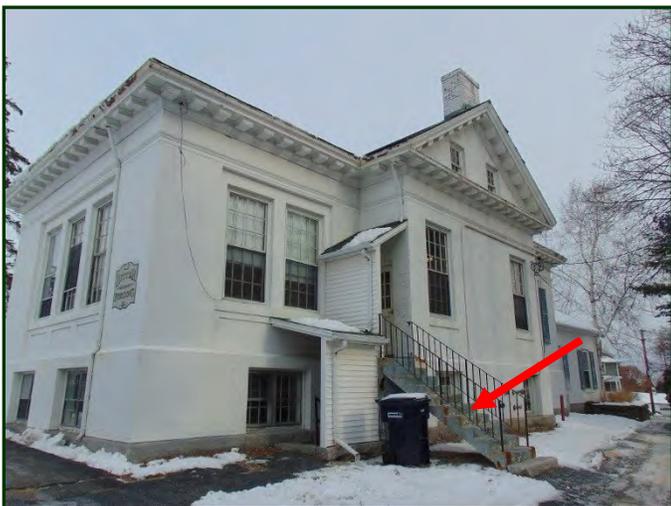
Photo #111: View of the south elevation of the Ritter Building. Note the concrete stairs.

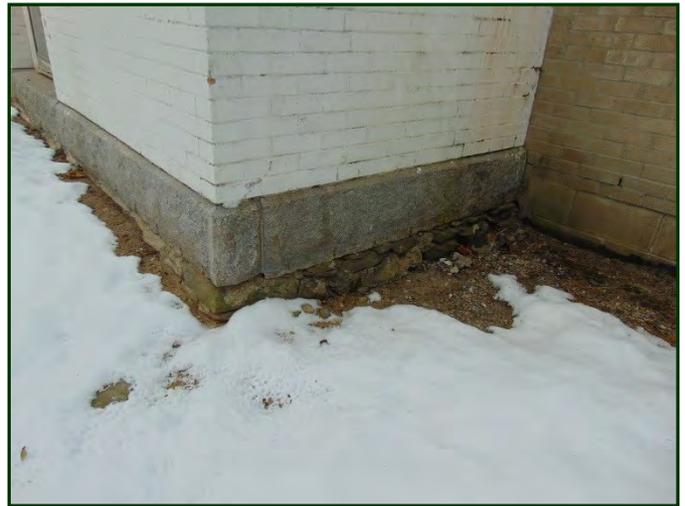
Photo #114: View of the typical foundation at the Ritter Building.

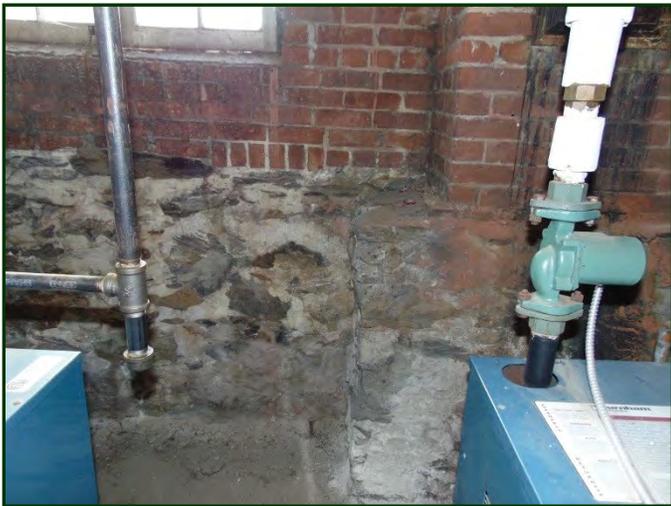
Photo #115: View of the stone foundation from the interior.

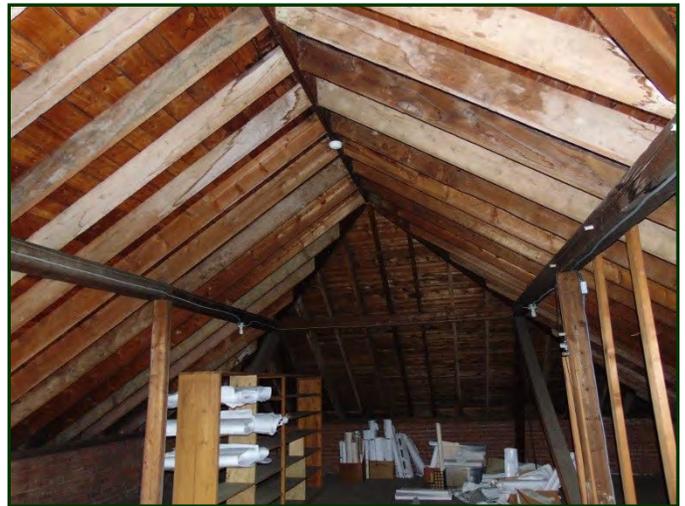
Photo #116: View of the typical wood rafter framing in the original section of the Ritter Building.

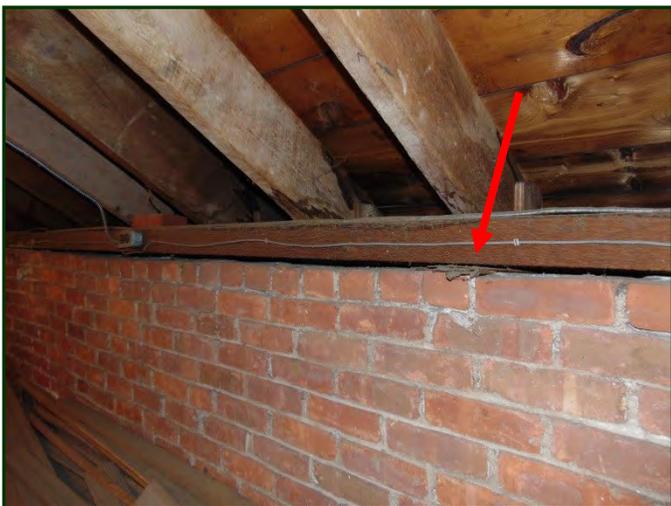
Photo #117: View of a rotated wood plate supporting the roof rafters. Note the shims installed in the open gap.

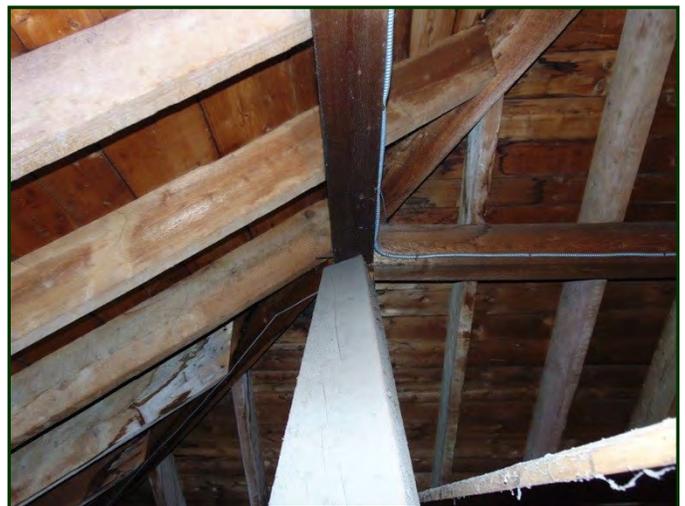
Photo #118: View of a rotated truss web member in the attic of the Ritter Building.

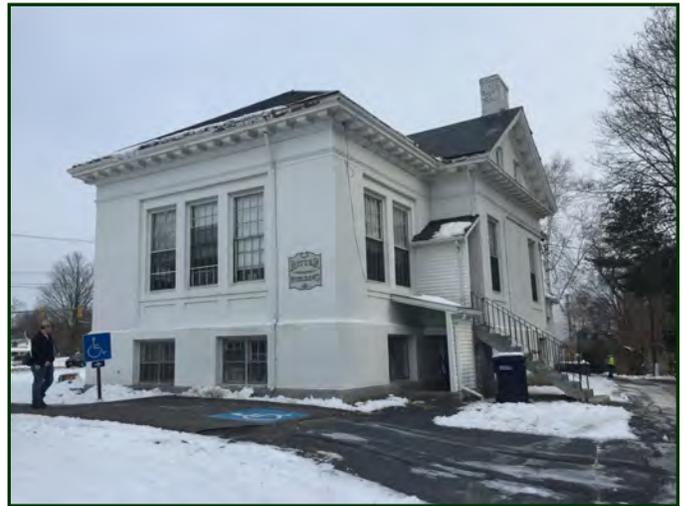
Photo #2: Photograph depicts general view of Side B

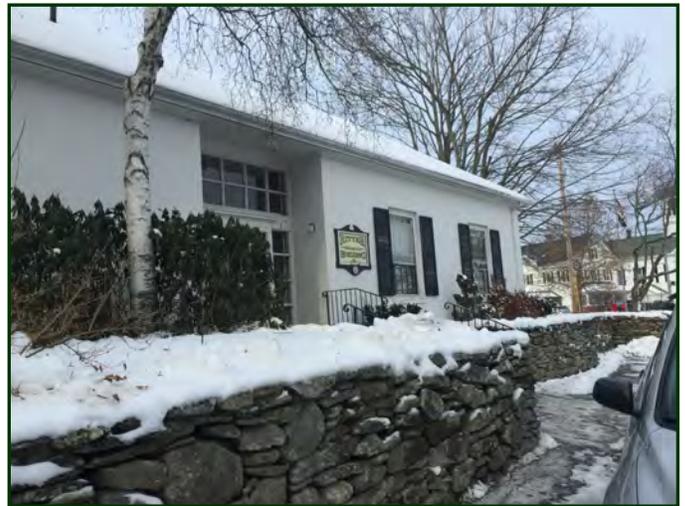
Photo #4: Photograph depicts general view of Side D

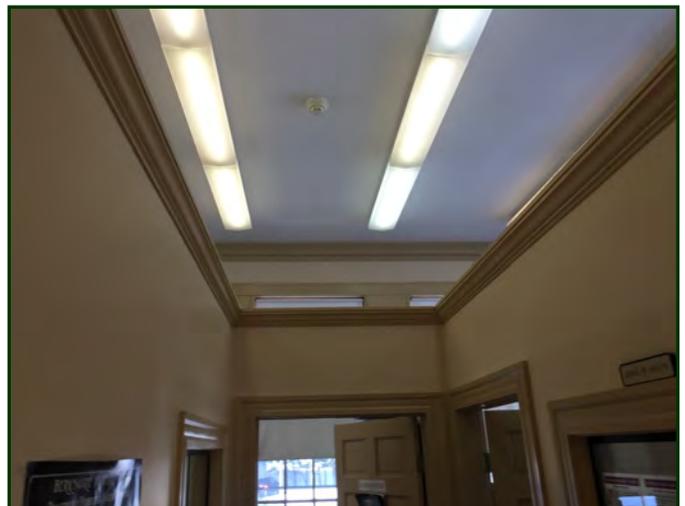
Photo #10: Photograph depicts general view of interior finish materials within the Original Section of the Site Build-
